## SECTION 13

### WATER QUALITY

#### 13.1 INTRODUCTION

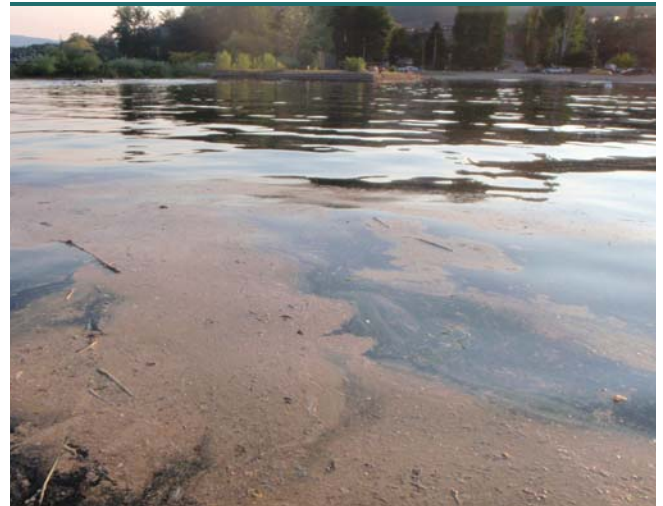
**Figure 13.2: Urban Stream Hydrology; Powers Creek Inflow Plume**

The increased volume of stormwater also hits water courses in shorter, larger peaks from urban areas (Figure 13.2).

Most streams convey stormwater after they pass through an urban area in the Central Okanagan. Stormwater-laden creek flows enter Okanagan Lake and form plumes (Figure 13.2). A surface flow of buoyant debris is often visible following a storm but the travel path of the plumes is more complicated. If the particulate load is heavy during the initial flush of rain washing materials off the streets into the stormwater, then the inflow can form a density plume that travels along the lake bottom like a dirty cloud. During the summer, the stormwater plume should be trapped by the thermocline and remain in the surface water. It will often travel parallel to the shore dropping large particulates quickly while finer particulates and bacteria will travel further. During the non-stratified winter period, stormwater can form a deep pool in front of the outfall or creek and travel as a packet of water, diluting as it moves with water currents.

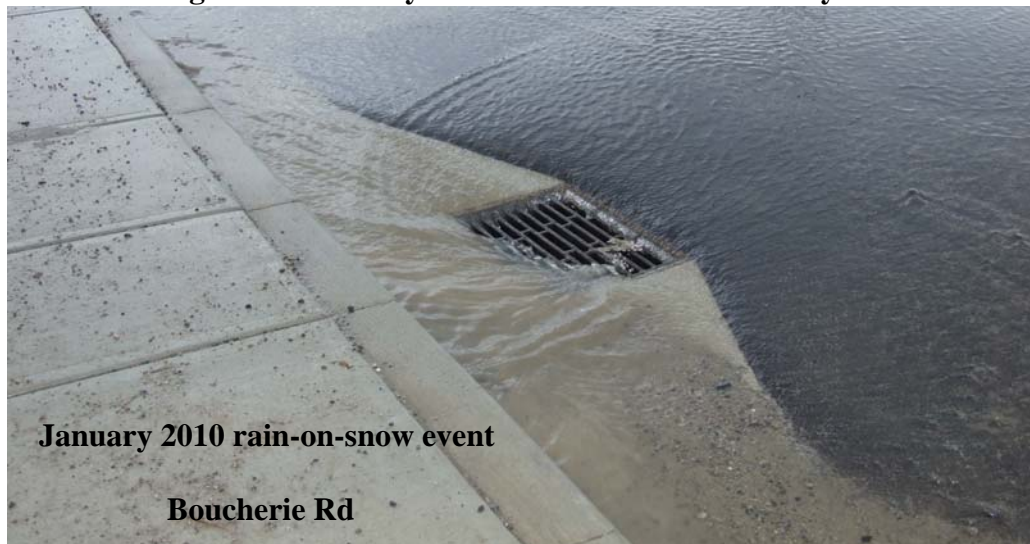
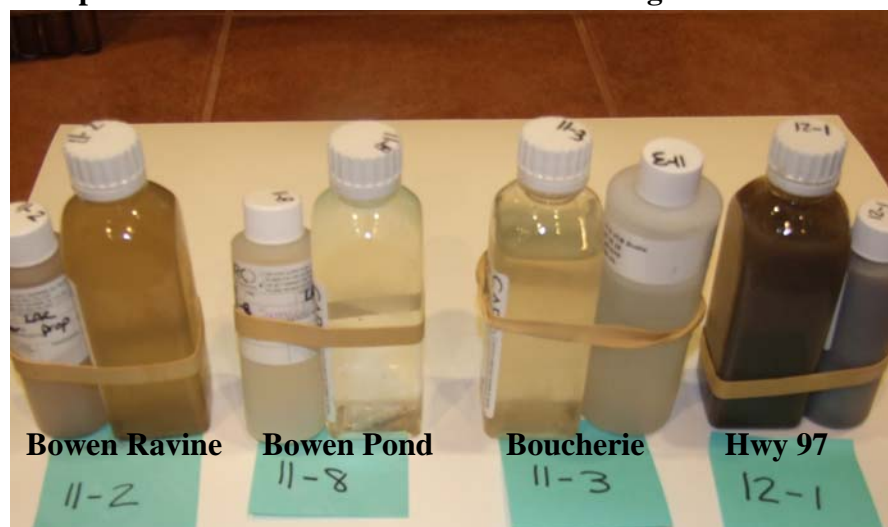
**Figure 13.3: Heavy Stormwater Flows in January 2010**

**Examples of turbid and clear stormwater during rain-on-snow event**

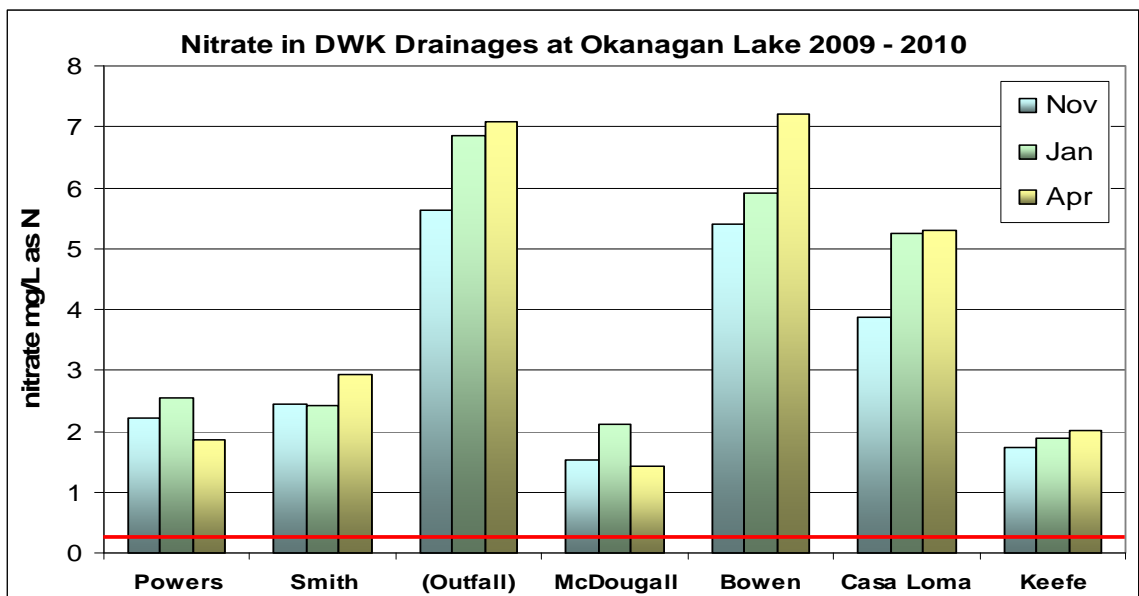
**Figure 13.6: DWK Creek Discharges to Okanagan Lake with Stormwater Influence**

NOTE: Red line is Okanagan Lake average nitrate concentration

At the time of sampling, both McDougall and Keefe Creeks had riparian areas capable of removing nutrients and they had the lowest nutrient concentrations on all three sample dates (Figure 13.6, 13.7). Unfortunately, both were damaged after the sampling concluded. Several large areas of the McDougall riparian buffers have been stripped back to 15 m or less during 2010 to allow for subdivision development and an automotive repair centre within WFN jurisdiction. A boat storage facility within WFN jurisdiction punctured LID's main water line in summer 2010 and the flows were diverted to Keefe Creek where they caused extensive siltation. Both streams may now have reduced capacity to filter nitrates.

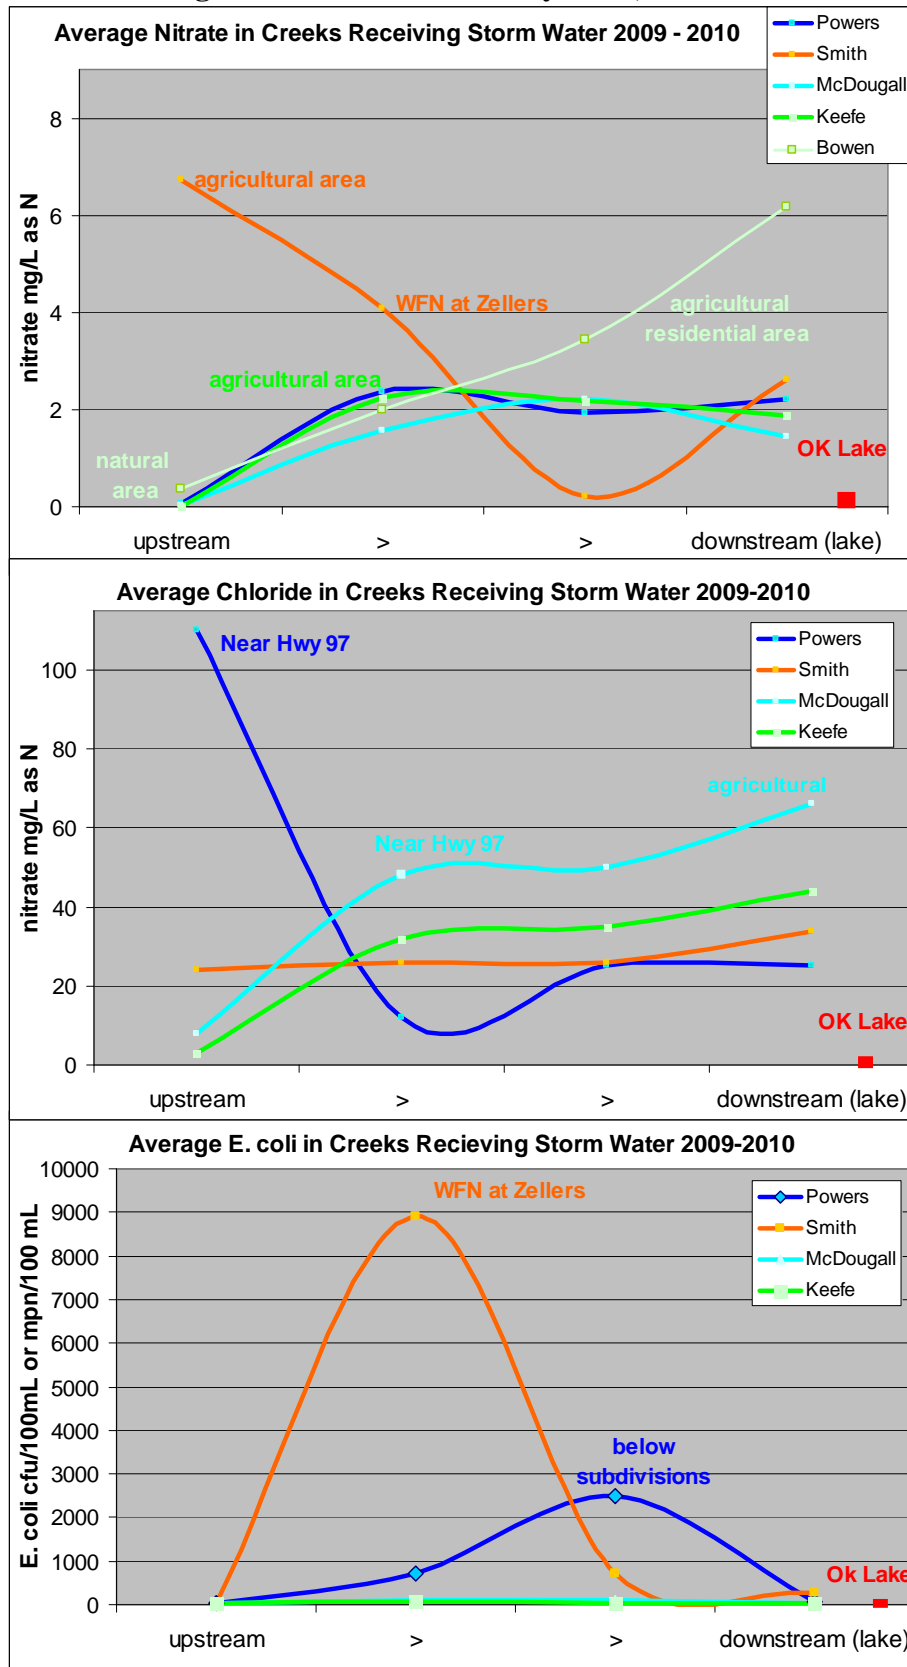
Figure 13.7: Average Parameters in Creek Systems, District of West Kelowna

*E. coli* counts were low (20 – 40 cfu/100 mL) for raw water in the upper reaches of every creek system of West Kelowna (Figure 13.5, 13.7). Once the drainage system received run-off from urban paved areas, *E. coli* counts climbed.

Bacterial numbers were very high at urbanized sites in the January samples despite low temperatures (Figure 13.7). By observation, fewer pet owners pick up dog feces in the winter. In contrast, bacterial numbers were generally moderate in April. Pet feces have been noted on streets throughout district, and especially at the Smith Ck dog beach in the winter months.

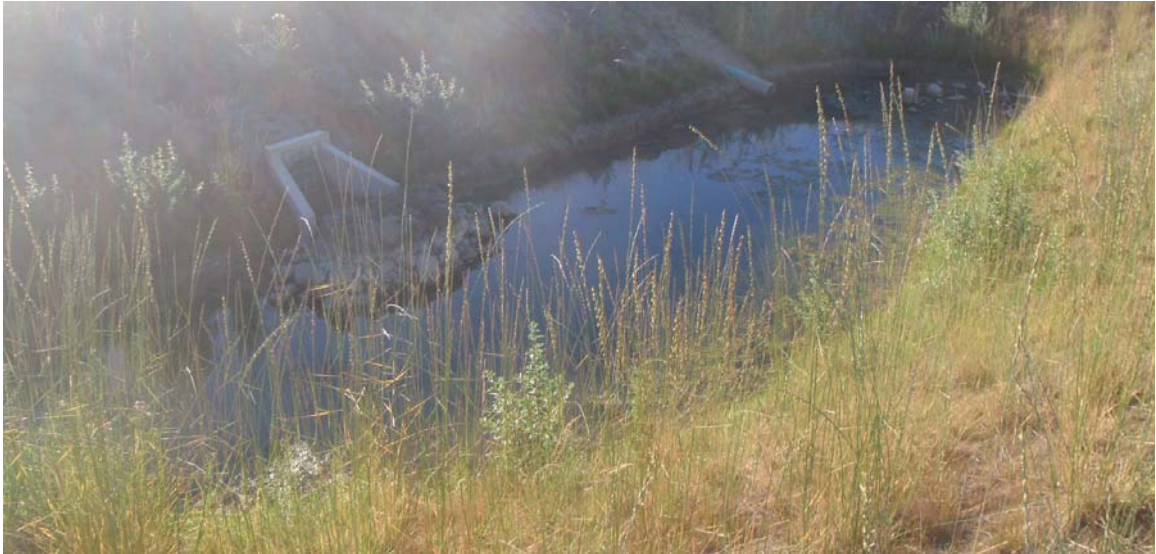
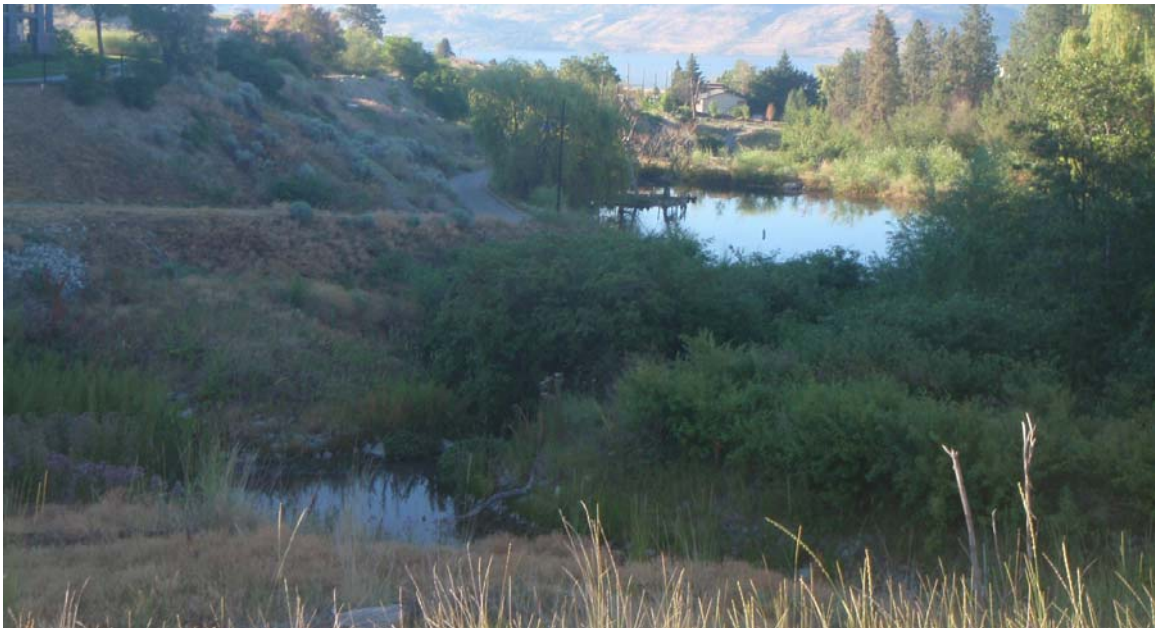
**Figure 13.11: Constructed and Enhanced Stormwater Ponds in DWK**

**Stormwater ponds adjacent to Smith Creek, above Hwy 97**

**Preserved and enhanced ponds on Smith Creek, below Hwy 97**

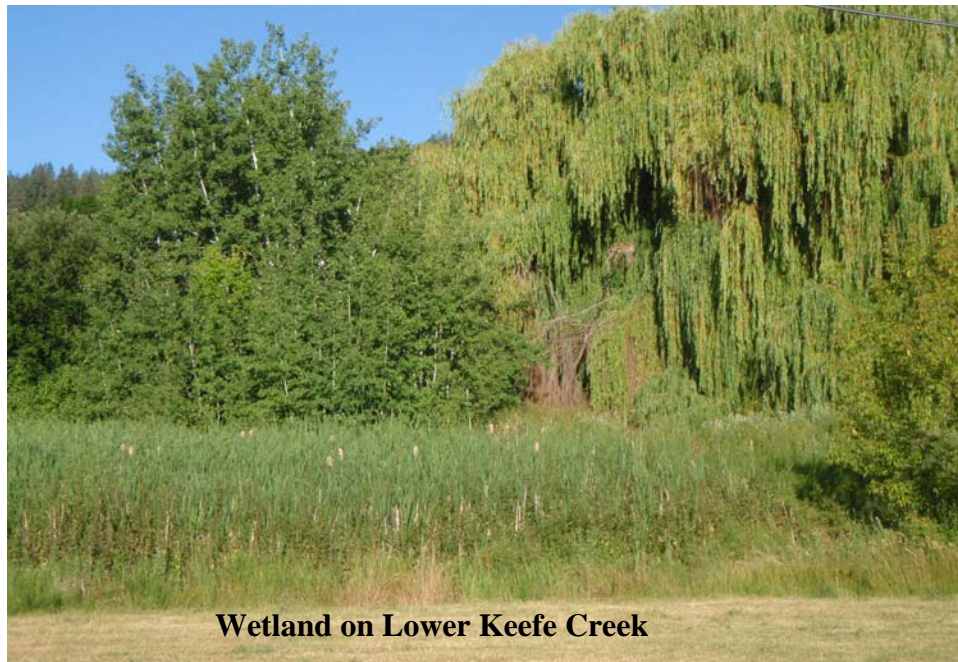
**Figure 13.14: Enhanced Wetland on Lower Keefe Creek**

A good example of a multi-stage wetland is the wetland system on lower Keefe Creek (Figure 13.14). To be functional, multi-stage wetlands must be much larger than stormwater ponds. The Quail’s Gate site would be an excellent choice for a constructed multi-stage wetland. There may be a second opportunity for a multi-stage wetland adjacent to the Medican pond, below Hwy 97 on WFN land. There is an existing depression on the property and management of WFN parking lot flows will be important to Smith Creek.
