Watershed Assessment Report  
for the  
**TREPANIER CREEK WATERSHED**

Prepared for  
GORMAN BROS. LUMBER LTD.

by  
DOBSON ENGINEERING LTD.

June 27, 2001

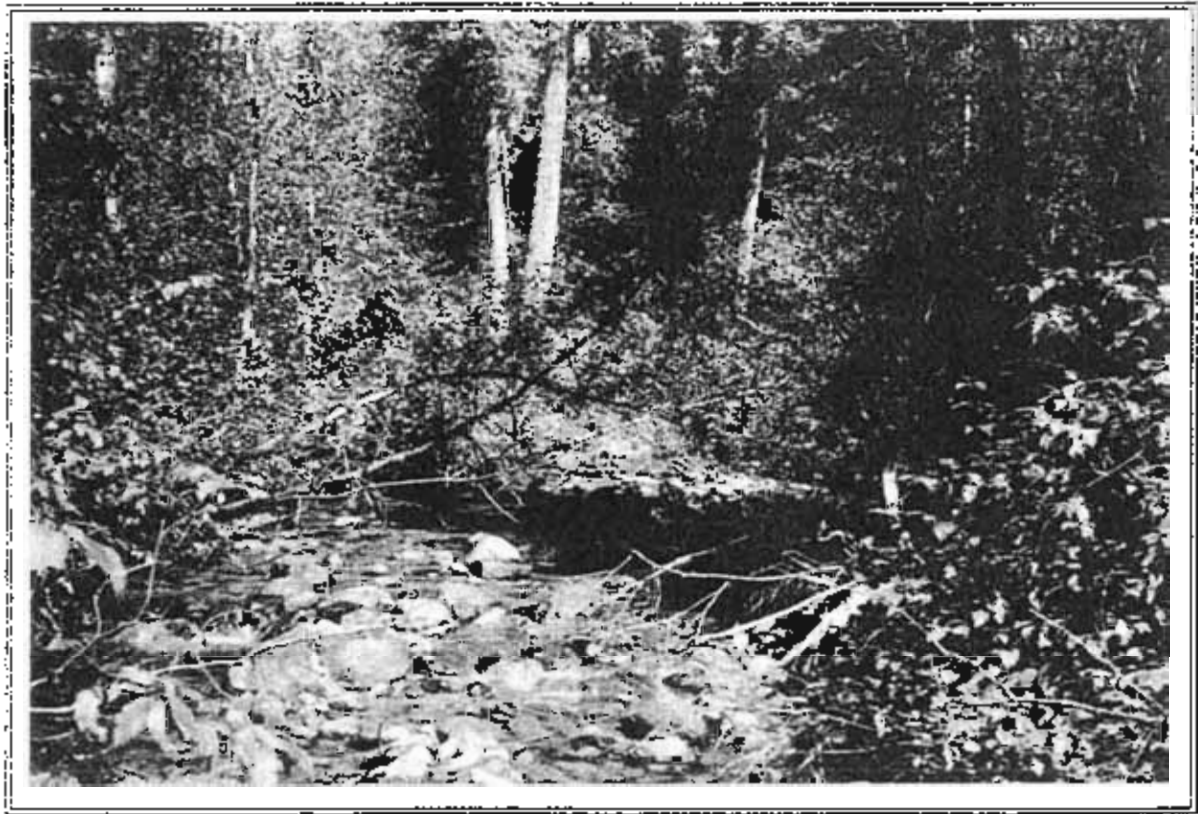
**Comments** 200 m upstream of MacDonald Creek confluence.  
 Bed materials consist of cobbles with some pebbles and boulders.  
 Banks are vegetated with some boulders in fine-textured matrix.  
 Riparian vegetation consists of 5 m alder with tall deciduous and conifers.  
 LWD spanning the channel, small accumulation of SWD.  
 Debris jam below old bridge crossing.

PHOTO TF-1. Upstream view of reach TF on Trepanier Creek.  
*(TR2-3, Aug. 14/98)*

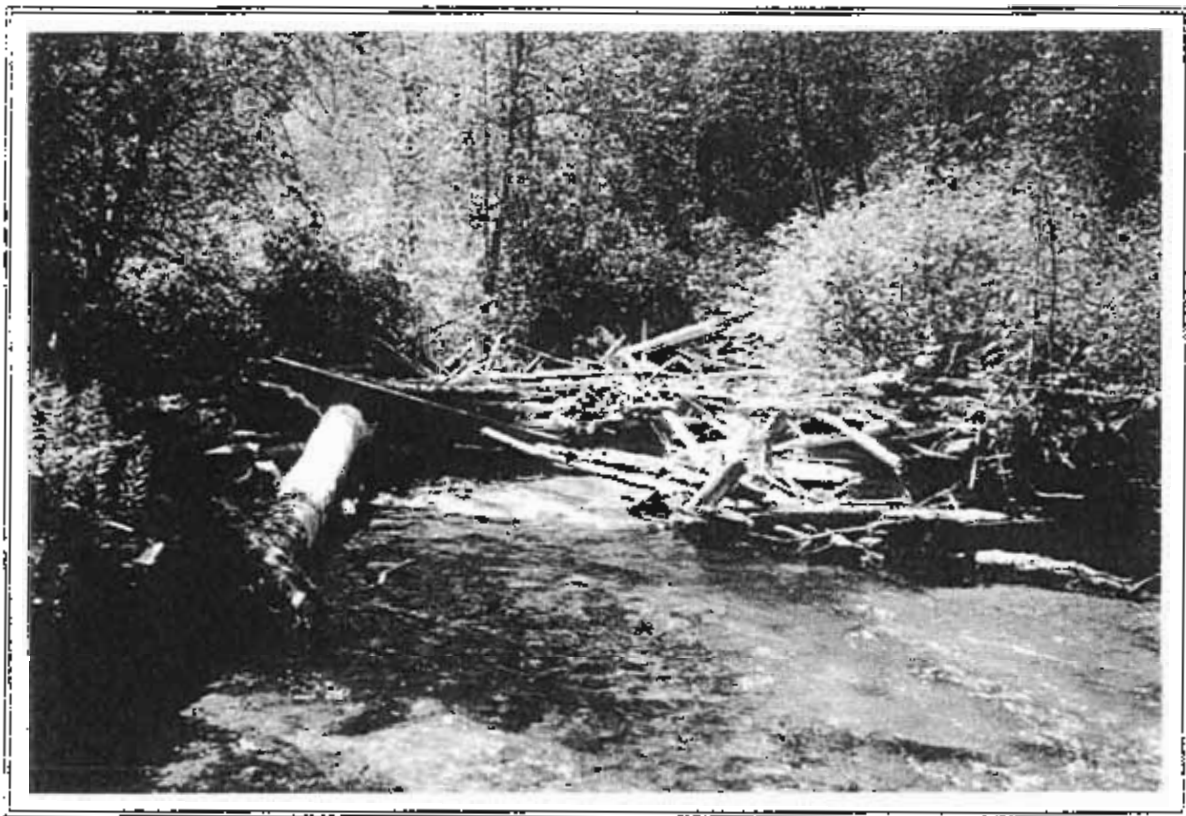
PHOTO TF-3. Debris accumulation at downstream end of reach TF, just upstream of MacDonald Creek. (TR1-25, Aug. 14/98)

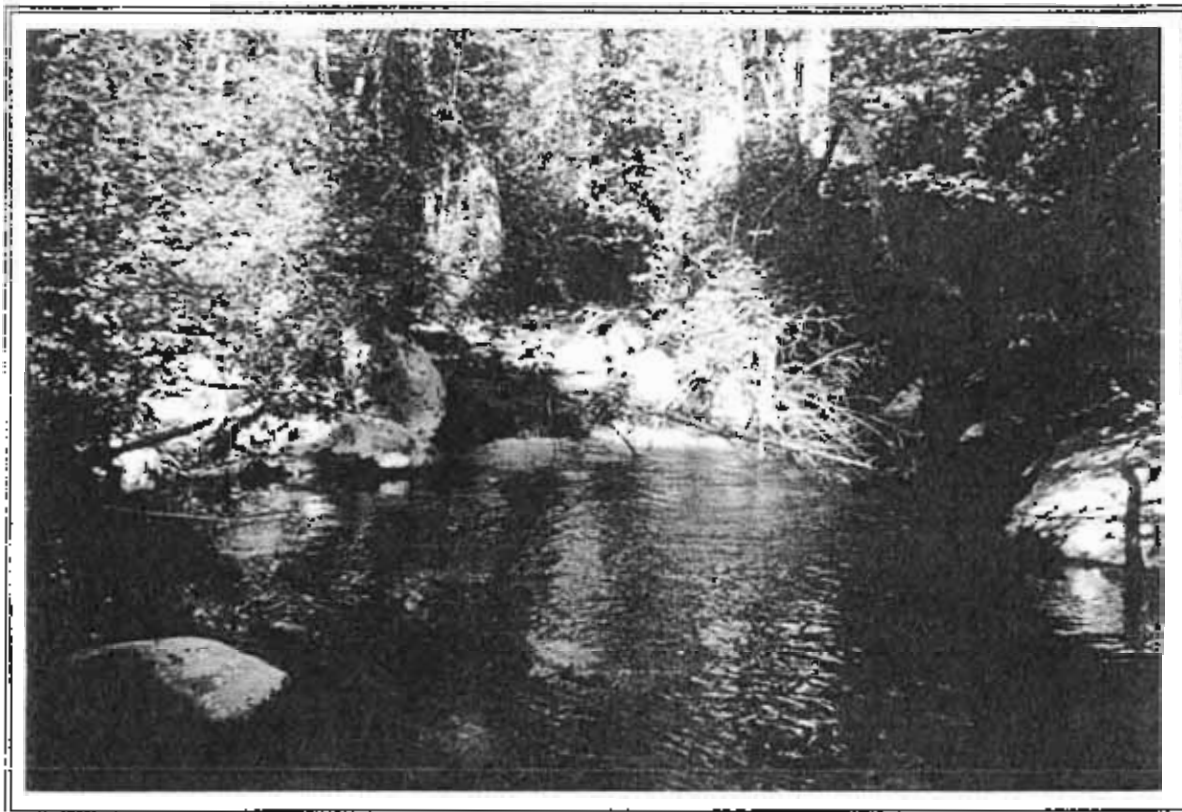
Comments: Bed materials consist of boulders with some deposits of sand and pebbles.  
 Large lag boulders.  
 Banks are cobble/boulder.  
 Riparian vegetation - tall conifers and deciduous trees.  
 Short section with some bedrock control.  
 Sediment accumulation 250 m downstream.

**PHOTO TE-5.** Upstream view of Trepanier Creek below the Clover Creek confluence.  
*(TR2-21, Aug. 17/98)*

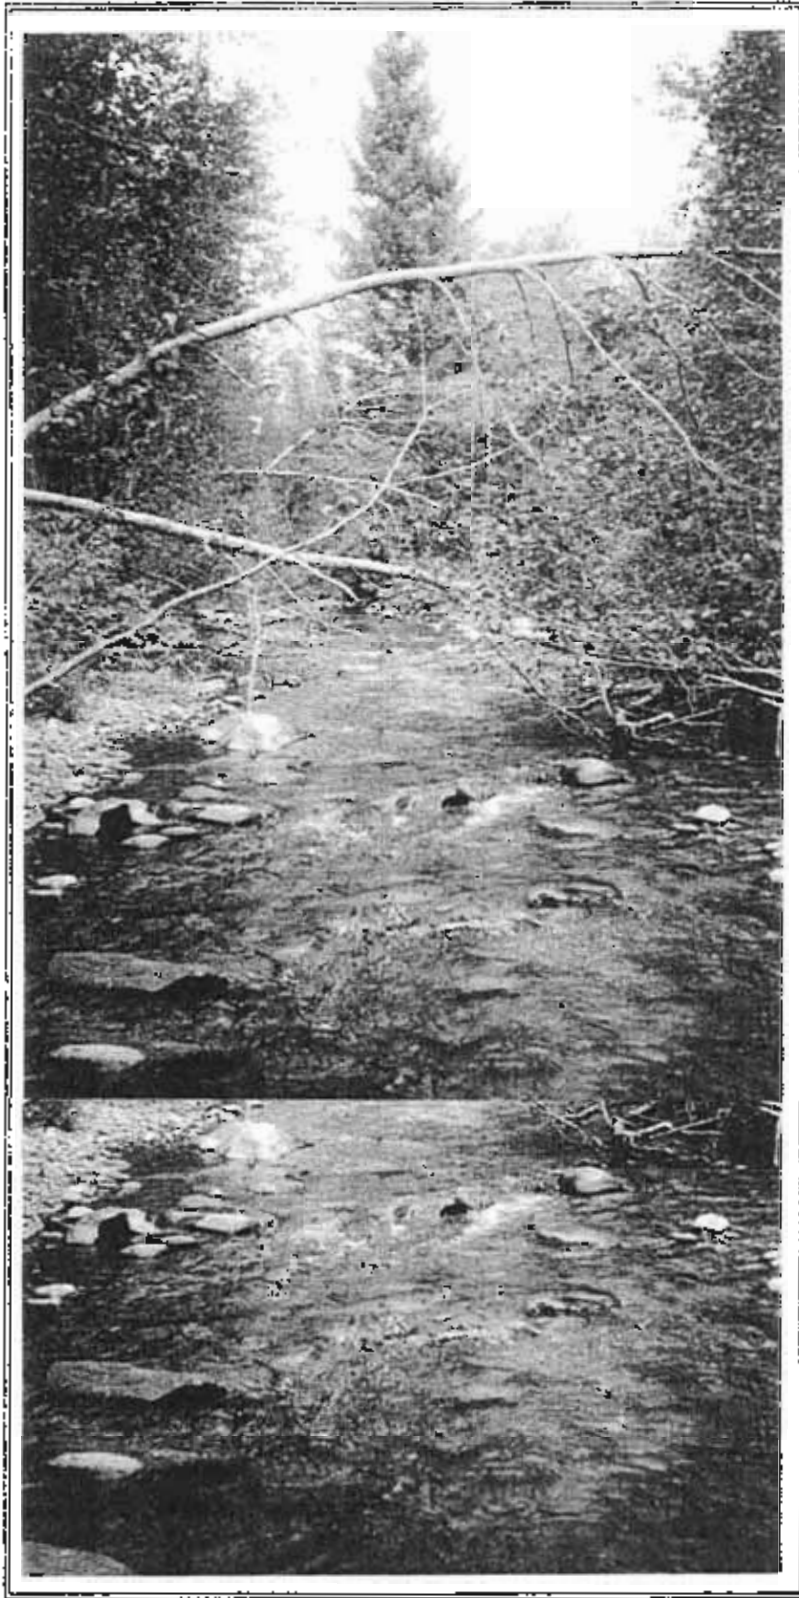
**Comments:** Downstream end of reach, 1.25 km from woods end of road.  
 Bed materials - cobbles, some pebbles and boulders.  
 Banks - fluvial deposits - pebbles to boulders.  
 Riparian vegetation is predominantly 4 m shrubs, some tall deciduous trees, the odd tall conifer.  
 LWD along margins, non-functional.  
 Secondary channel at stations 0+00 and 0+50.

PHOTO TE-7. Upstream view of Trepanier Creek, the lower end of reach TE.  
(TR3-7, Aug. 17/98)

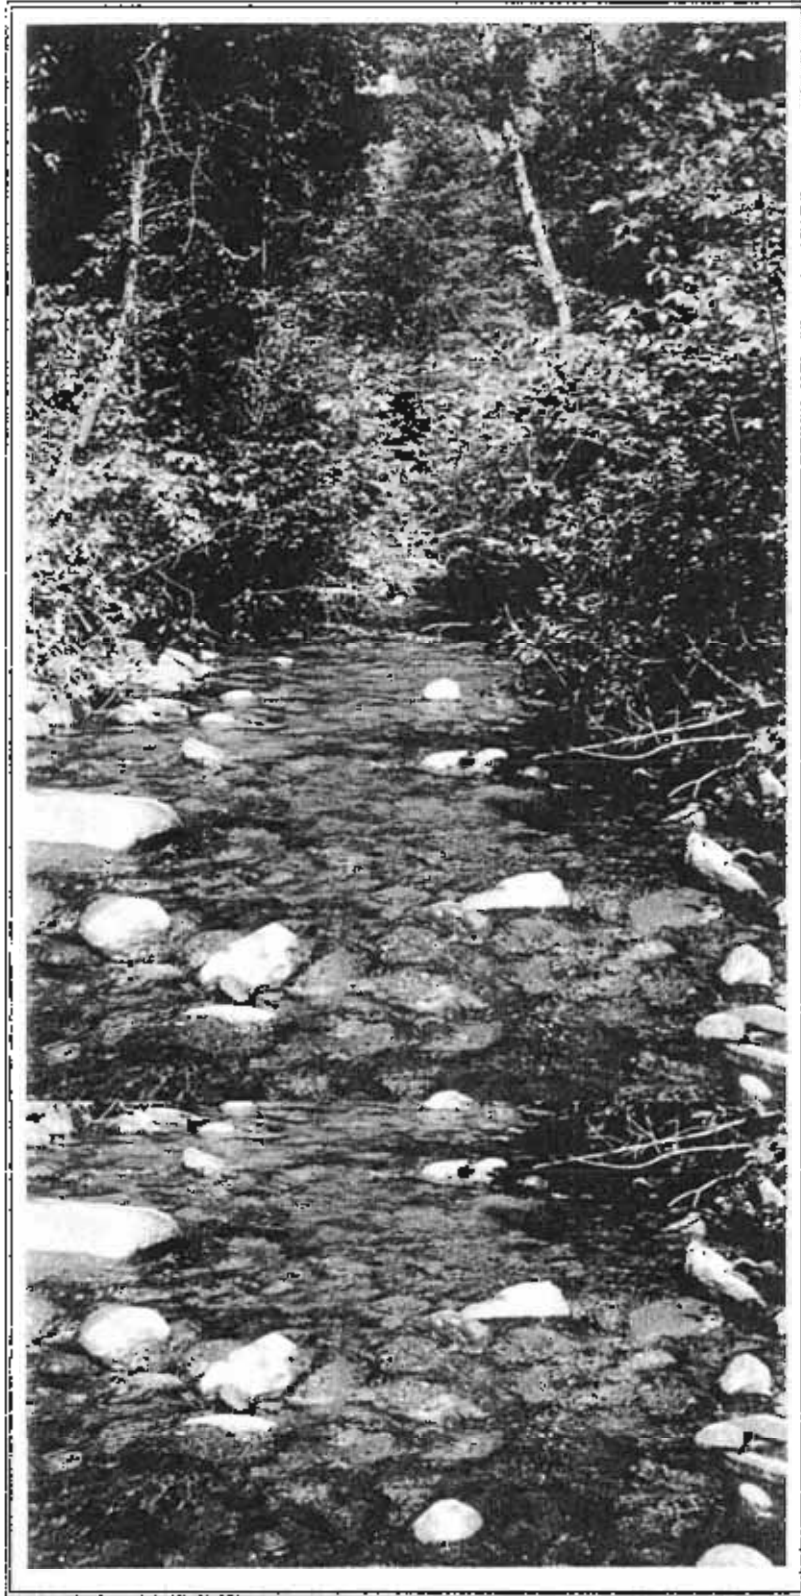
**Comments:** Trepanier Creek 100 m downstream of McDonald Creek confluence.  
 Bed materials consist of cobbles and boulders.  
 Small pockets of sand and pebbles.  
 Constant riffle.  
 Bank materials consist of cobbles and boulders in fine-textured matrix. High root density.  
 Riparian vegetation is tall deciduous trees with the odd conifer.  
 LWD limited to a few pieces parallel to banks.  
 Stable.

PHOTO TE-1. Upstream view of Trepanier Creek below MacDonald Creek.  
(TR1-23 Aug. 14/98)

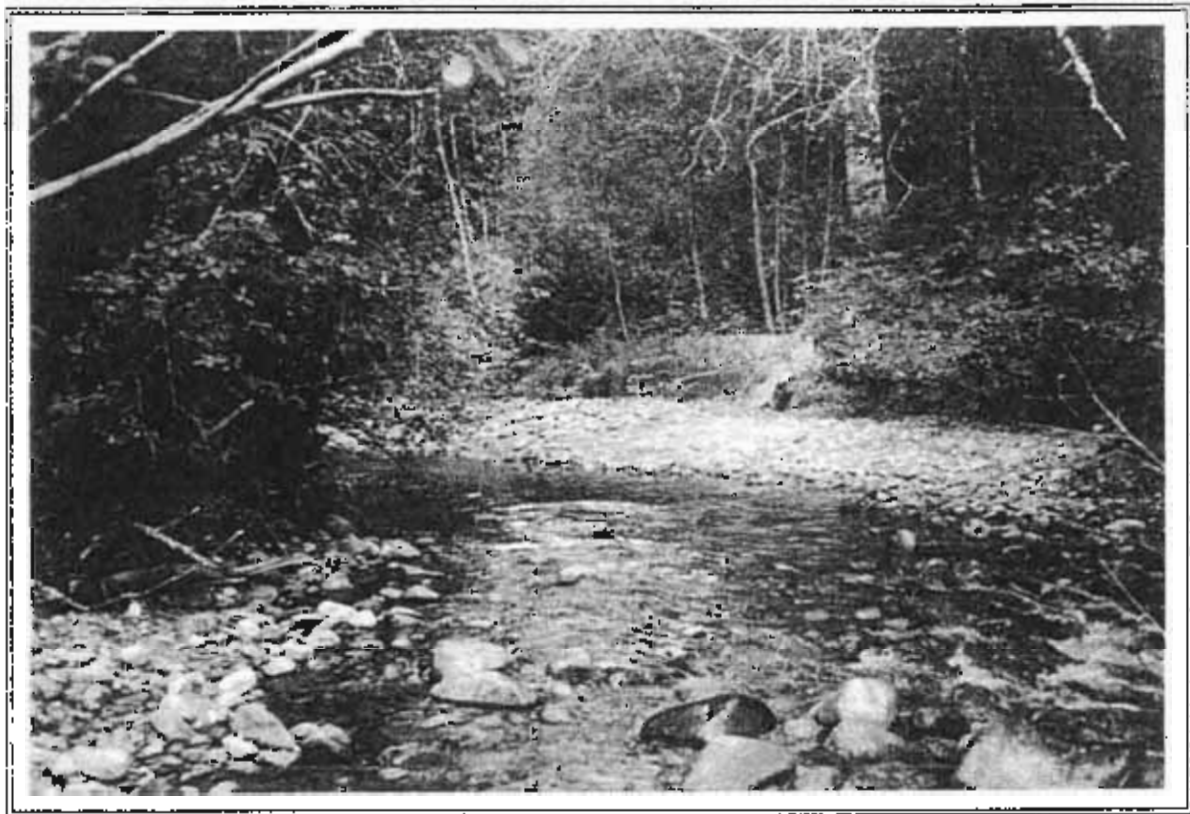
**Comments:** 1.3 km downstream of MacDonald Creek.  
 Bed materials consist of sand to boulders.  
 Bank material consists of sand and cobbles.  
 Riparian vegetation-tall conifers with deciduous trees and shrubs.  
 Woody debris along banks from alders, providing some cover, non-functional.  
 Fluvial sand deposits.  
 Pools 0.5 m deep.  
 150 m downstream large cobble bar.

PHOTO TE-2. Upstream view of Trepanier Creek, 1.3 km below MacDonald Creek. Note sand deposits above the cobble bar. (TR2-15, Aug. 17/98)

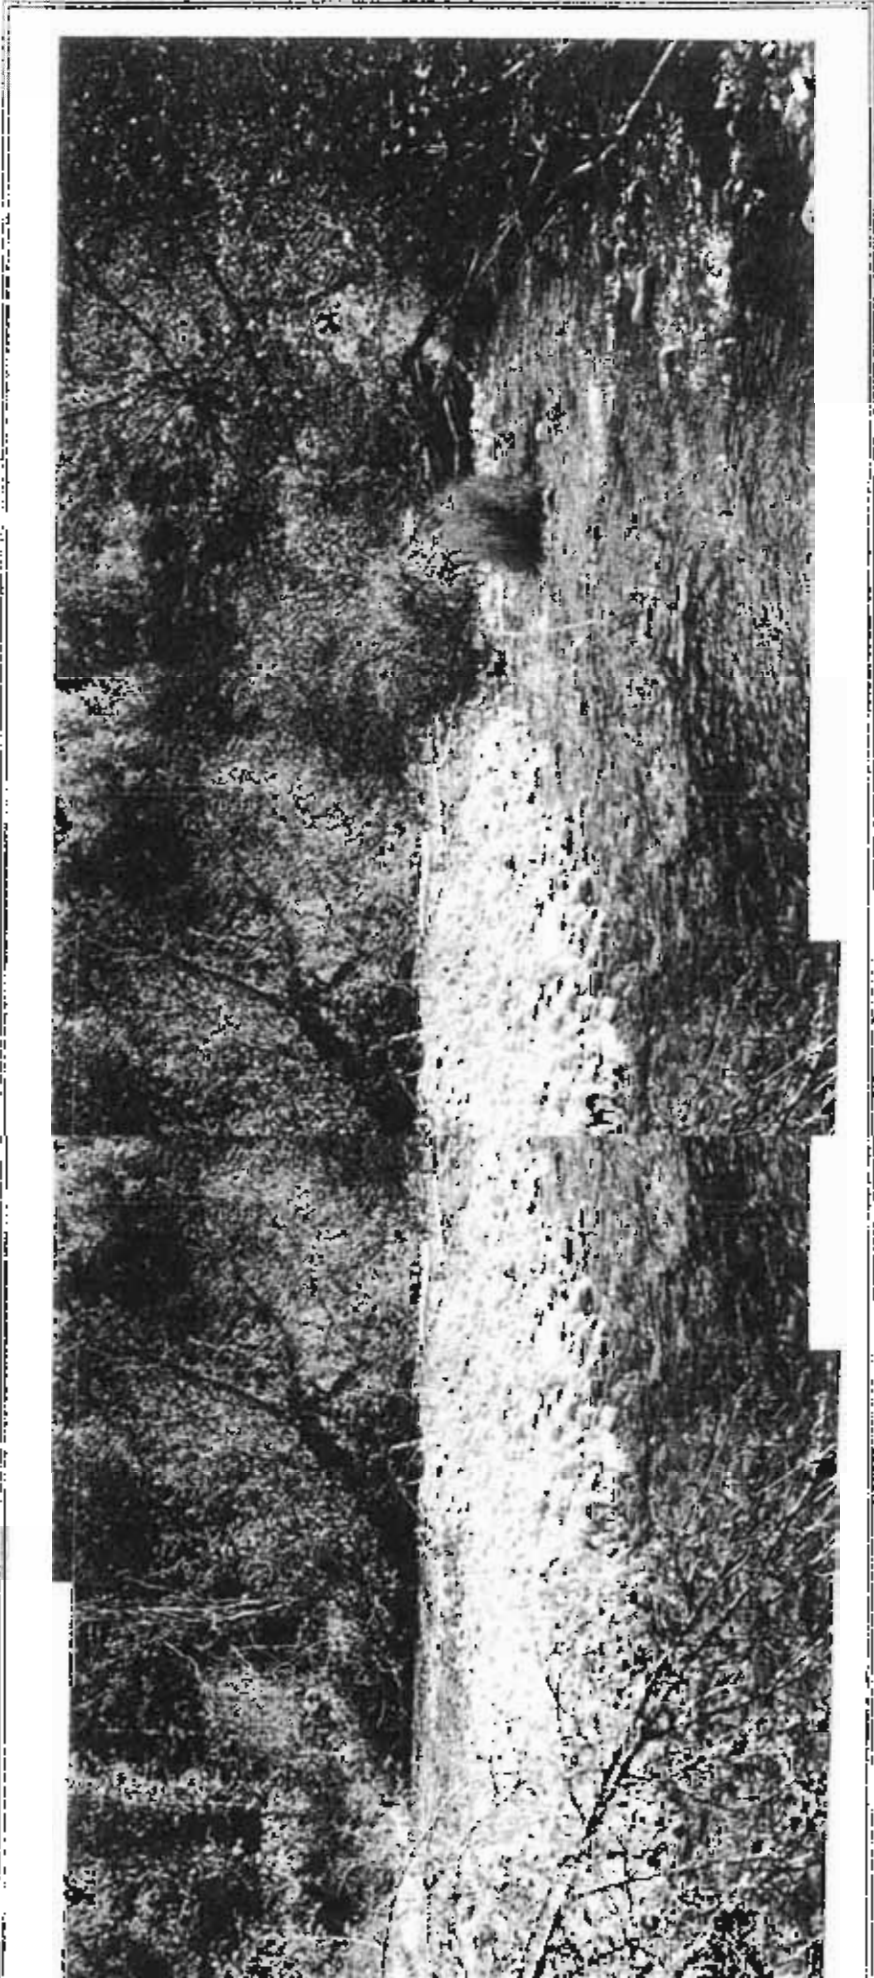
pan view of Trepanier Creek, 700 m upstream from the Clover Creek confluence. (R2-18/19, Aug. 17/98)

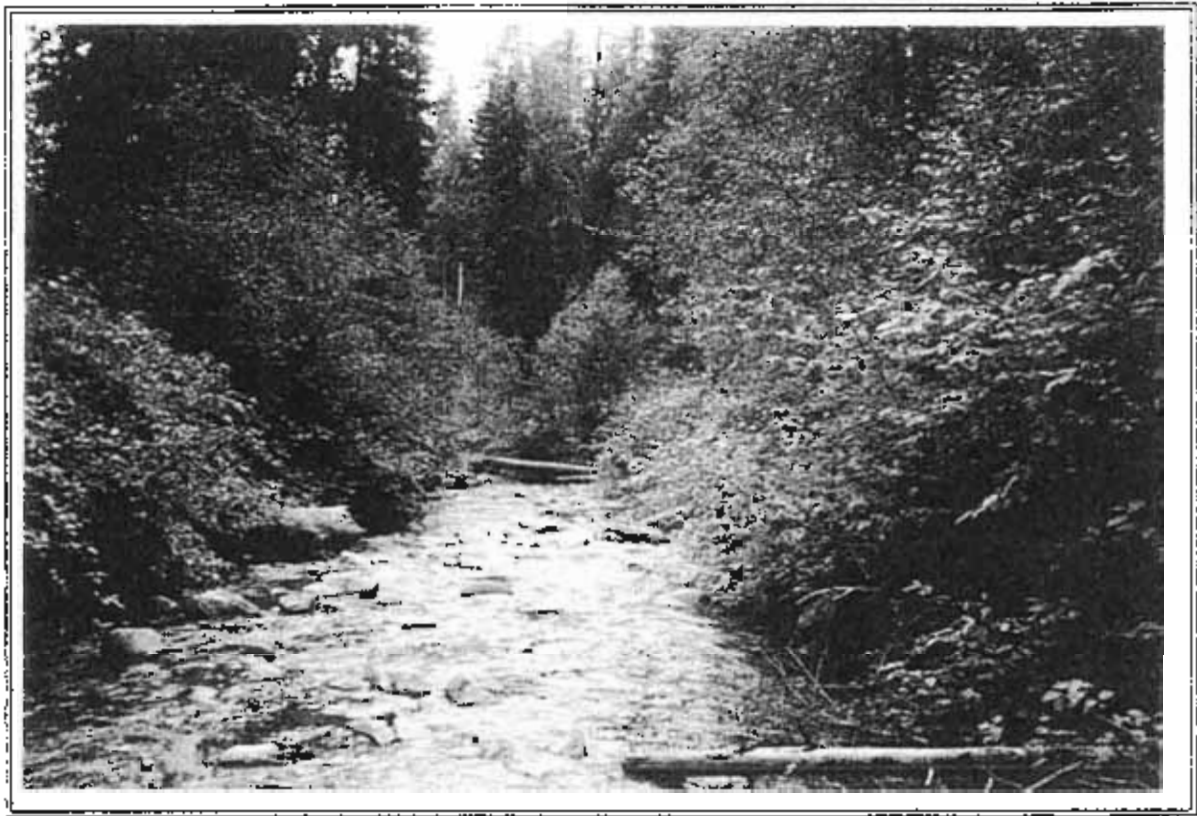
**Comments** 2.0 km from woods end of road.  
 Bed materials boulder with some sand deposits.  
 Banks are cobble/boulder with vegetated cover and organics.  
 Riparian vegetation consists of tall deciduous and conifer trees, 4 to 6 m understory.  
 Old piece of LWD spanning channel.

PHOTO TD-1. Downstream view of Trepanier Creek.  
*(TR3-9, Aug. 17/98)*

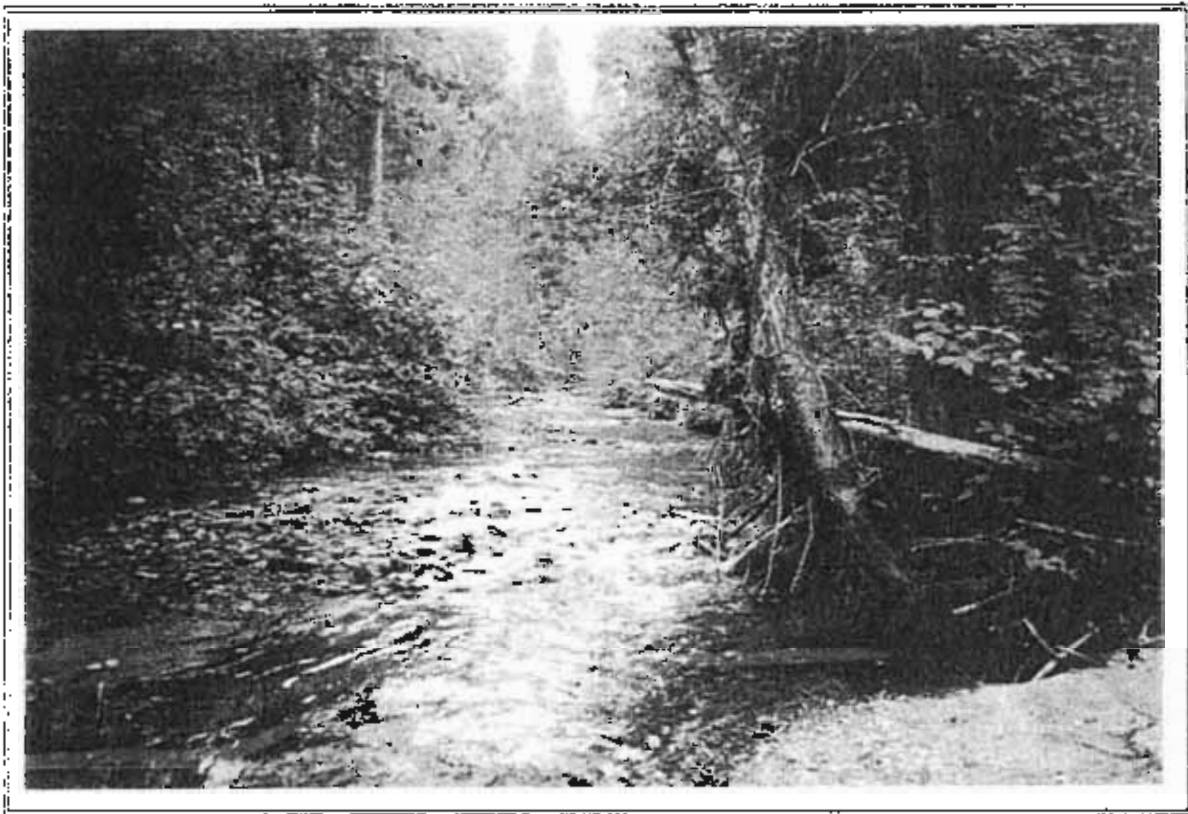
**Comments:** 3.3 km from woods end of road.  
 Bed materials are sand to boulders.  
 Banks consist of fine-textured sediment with organics.  
 Section consists of stable talus slope.  
 Mature riparian forest.  
 Large woody debris accumulation, minor bank erosion.  
 Some overbank sand deposits.

PHOTO TD-3. Upstream view of Trepanier Creek above the debris jam.  
(TR3-10, Aug. 17/98)

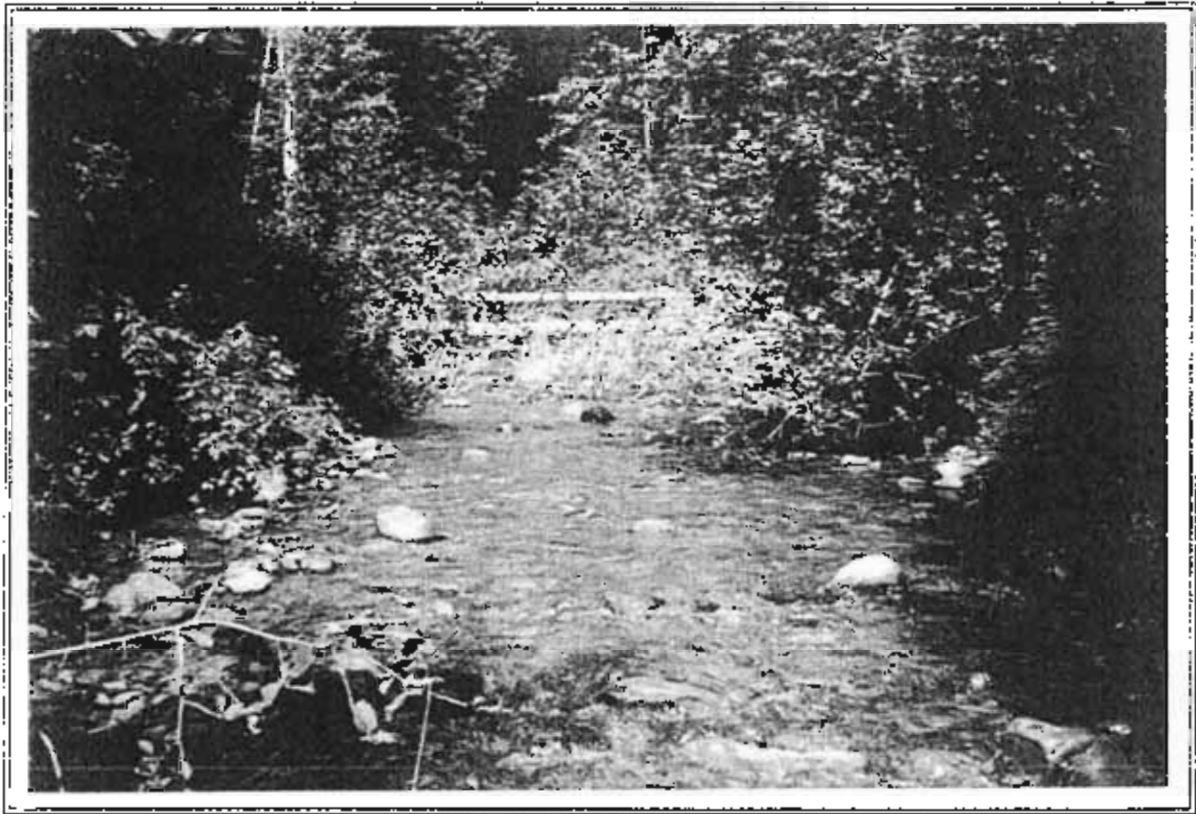
Comments: 4.8 km from woods end of road.  
 Bed materials sand to boulders.  
 Banks consist of fine grained sediment in root matrix with pebbles and cobbles.  
 Minor undercutting of banks.  
 Riparian vegetation is tall conifers with an understory of deciduous trees and shrubs.  
 LWD spanning channel, scattered pieces along banks.

PHOTO TD-4. Upstream view of Frepanier Creek 2.2 km from end of reach.  
*(TR3-12, Aug. 17/98)*

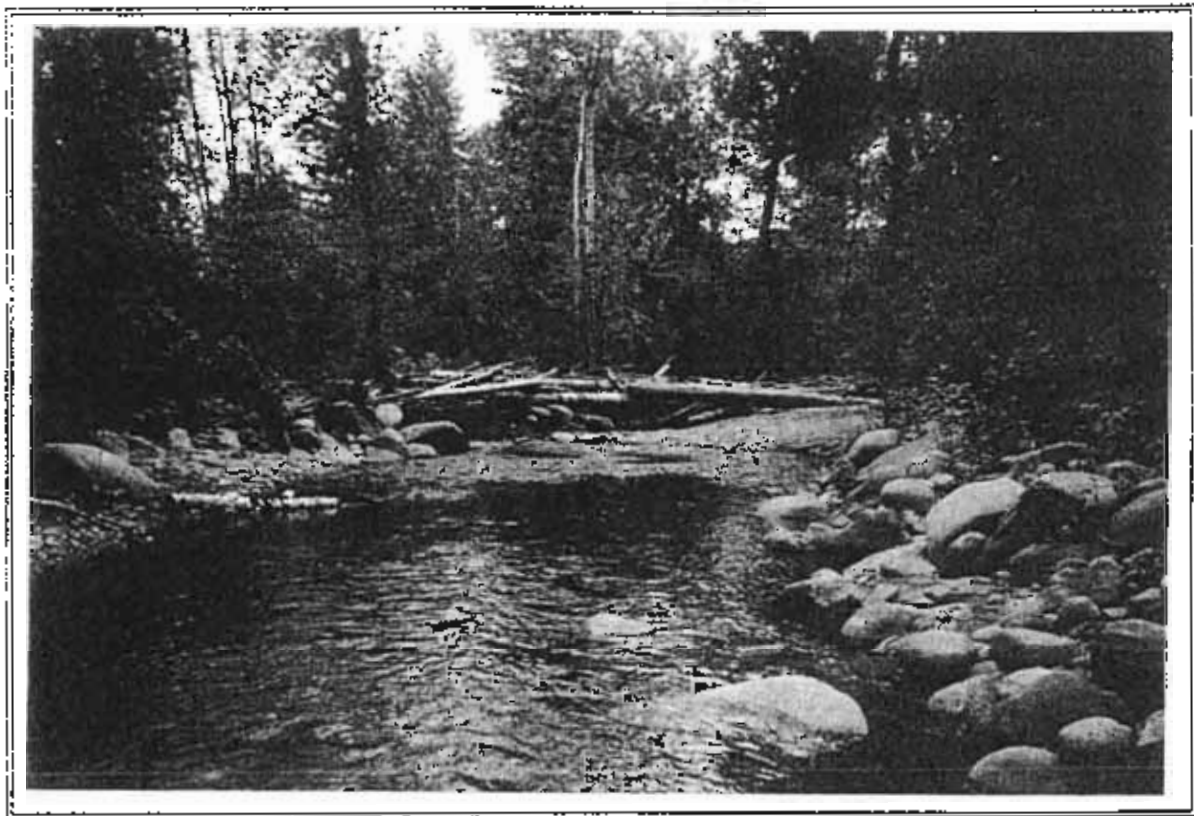
**Comments:** Bed materials cobbles/boulder.  
 Bank materials cobble/boulder, some pockets of sand.  
 Some moss covered boulders in channel.  
 Minimal amounts of LWD.  
 Mature riparian forest.  
 Stable.

PHOTO TD-6. Downstream view of Trepanier Creek, 200 m above the old bridge crossing near the Silver Creek confluence. (TR3-14, Aug. 17/98)

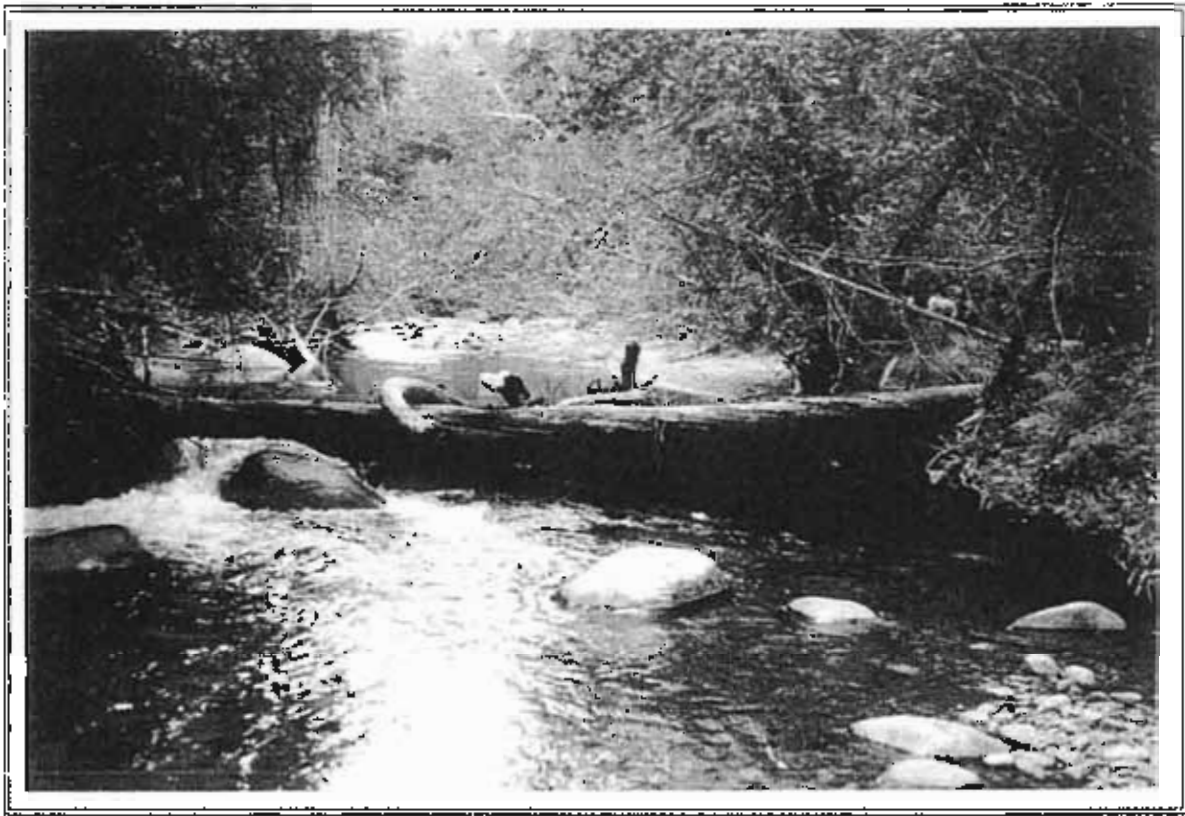
PHOTO TD-8. Upstream view of Trepanier Creek, 100 m upstream from the power line crossing. (TR3-19, Aug. 17/98)

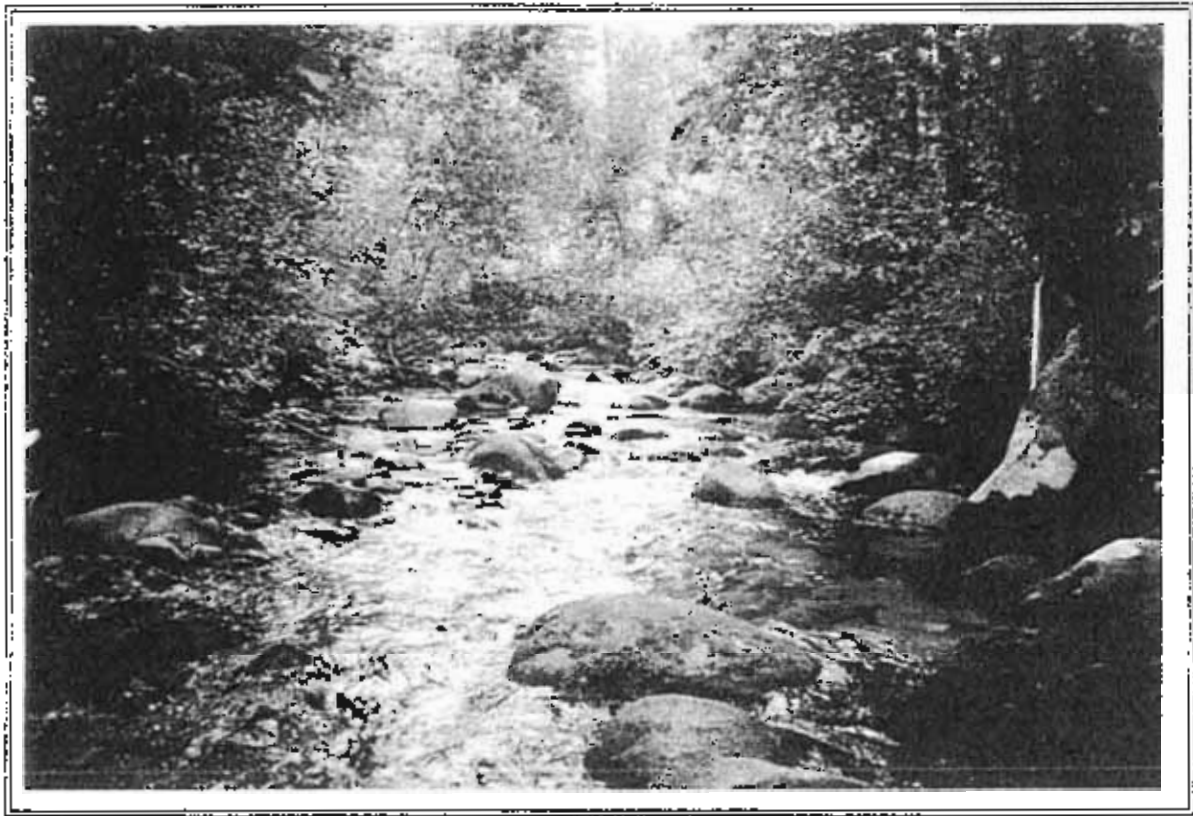
PHOTO TD-9. Upstream view of Trepanier Creek at the WSC gauging station.  
(TR3-20, Aug 17/98)

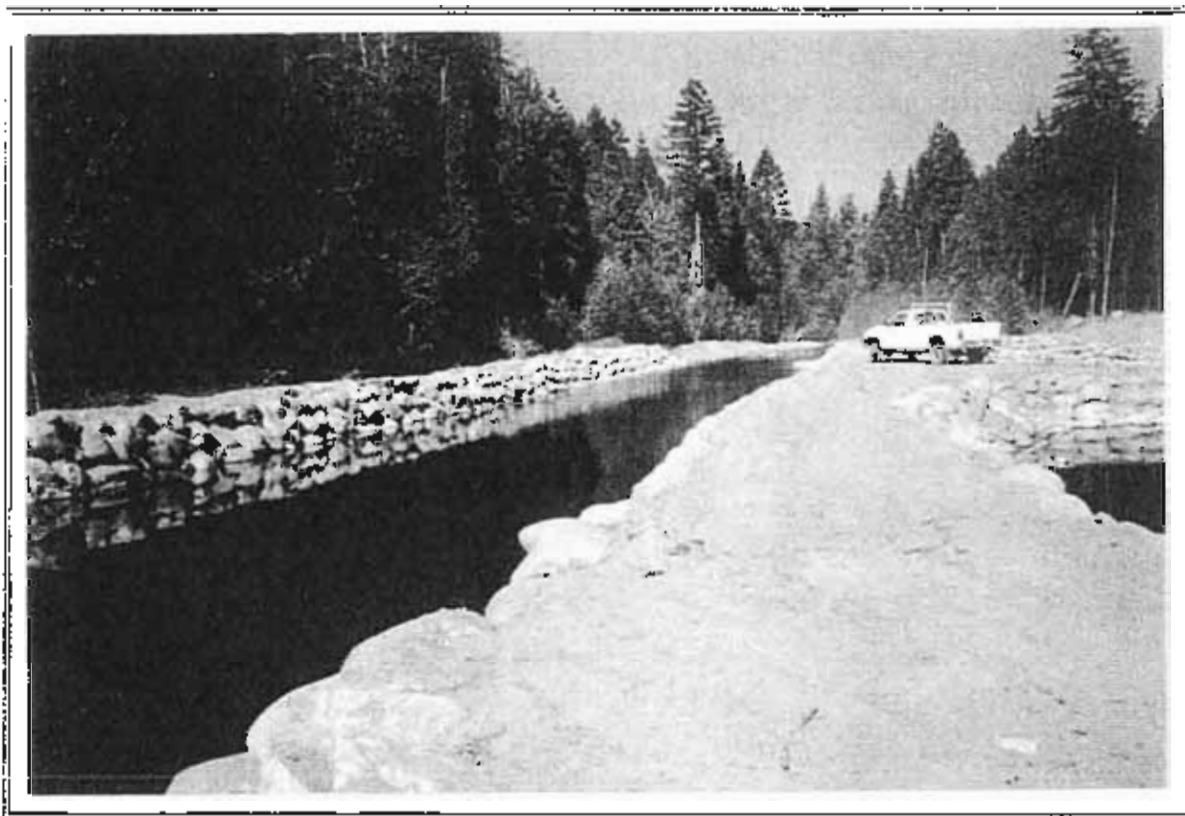
Comments: Moderate amount of disturbance due to water intake, residential development and roads.  
 Most of the mature riparian forest has been removed.  
 Bed materials predominantly cobble/boulder.  
 Bank materials are pebbles to boulders.  
 Minimal amounts of LWD  
 Disturbed stone lines.

PHOTO TC-1. Upstream view of Trepanier Creek at the water intake.  
(TR4-12, Sept. 3/98)

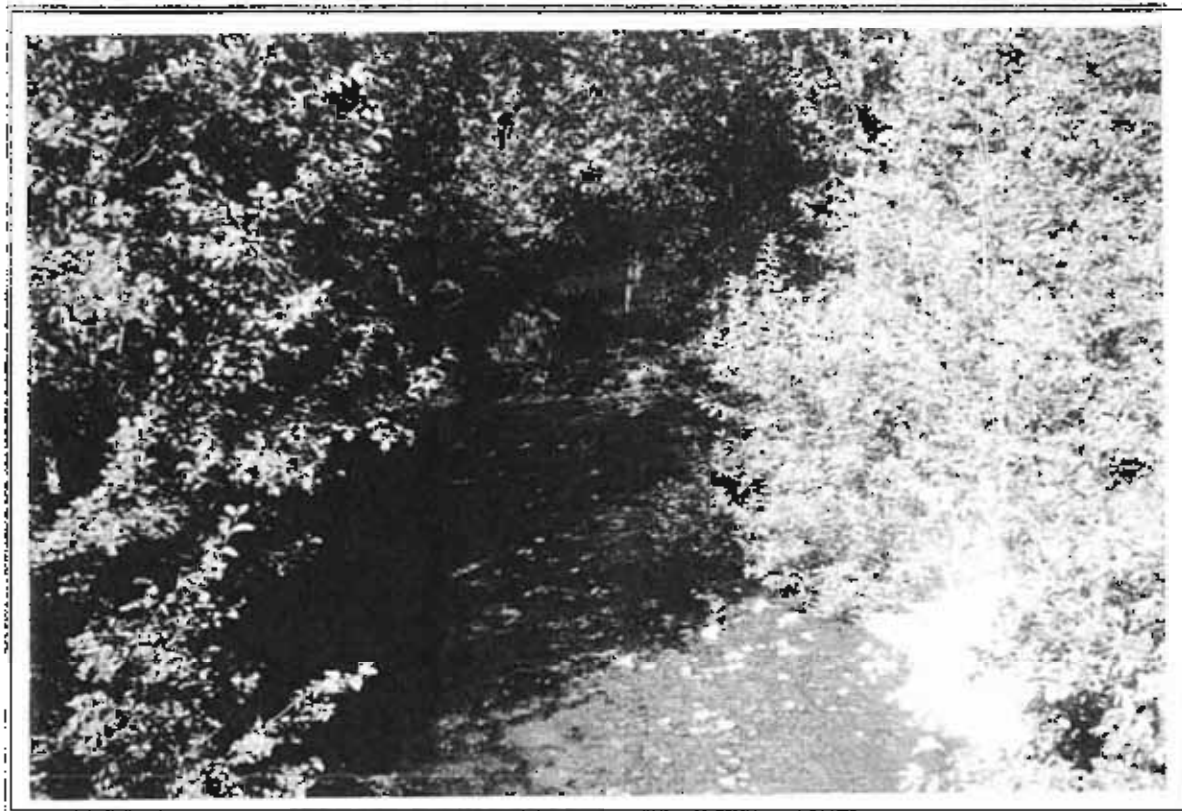
PHOTO TC-3. Upstream view of Trepanier Creek at the Paradise Valley Road bridge  
(TR4-11, Sept. 3/98)

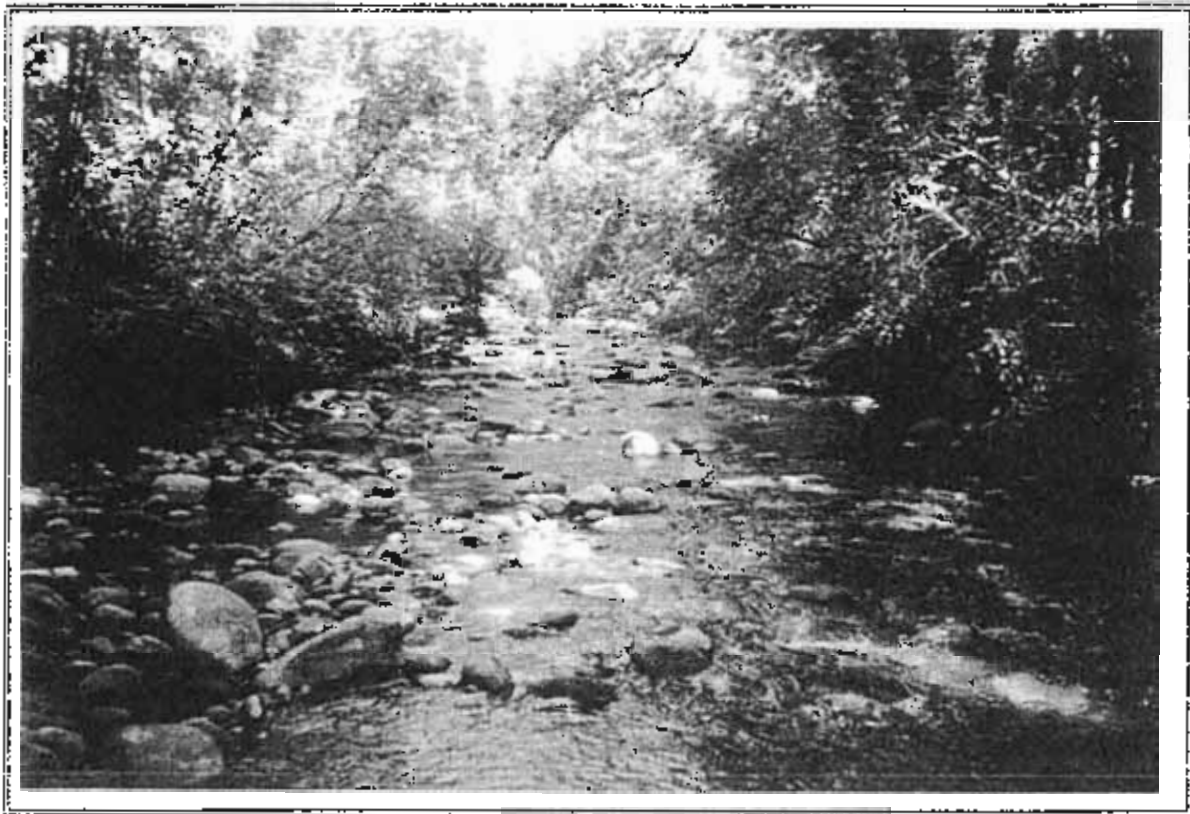
PHOTO TC-5. Lower section of reach TC on Trepanier Creek, downstream of the Coquihalla Highway (TR4-7, Sept. 3/98)

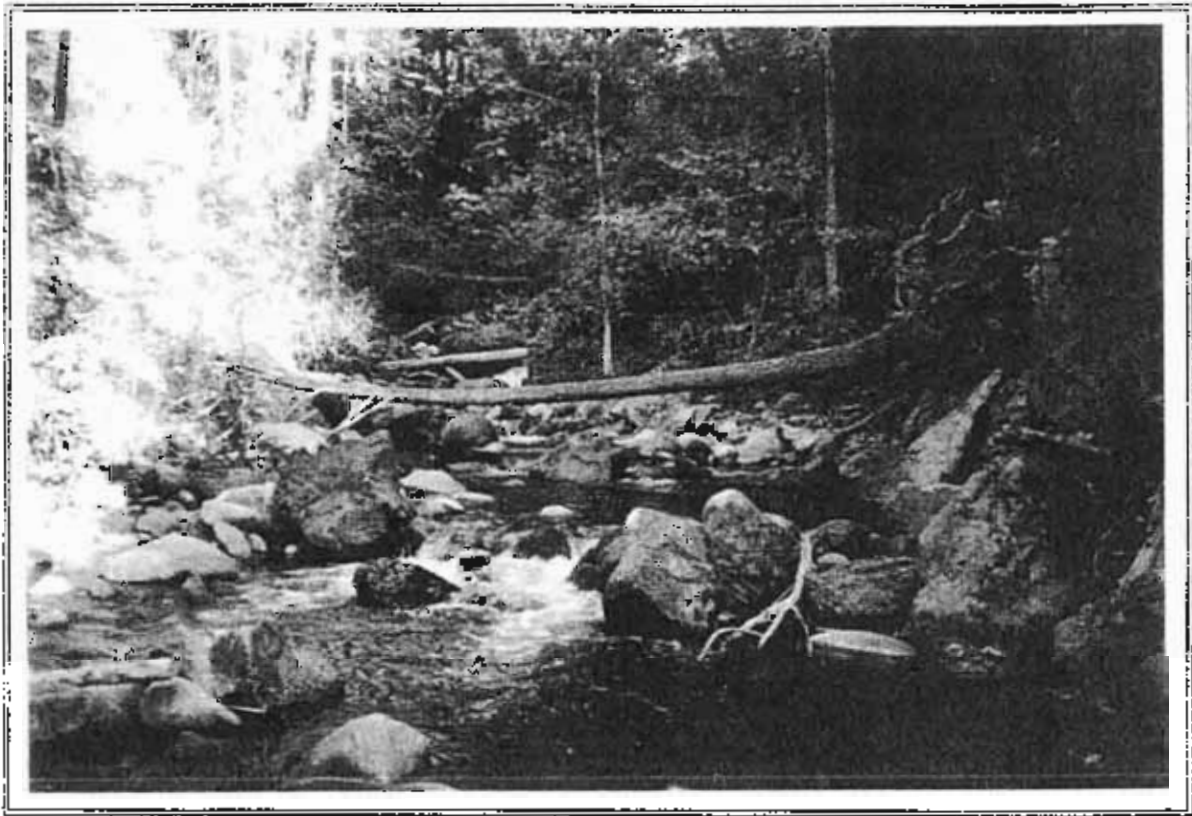
Comments: Lower section is coupled to slopes.  
 Some bedrock control.  
 Bed materials consist of boulders and bedrock.  
 Same for banks.  
 Riparian vegetation consists of tall conifers and deciduous trees  
 LWD spanning channel.

PHOTO TB-1. Upstream view of Trepanier Creek from the Law Creek confluence  
(TR4-4, Sept. 4/98)

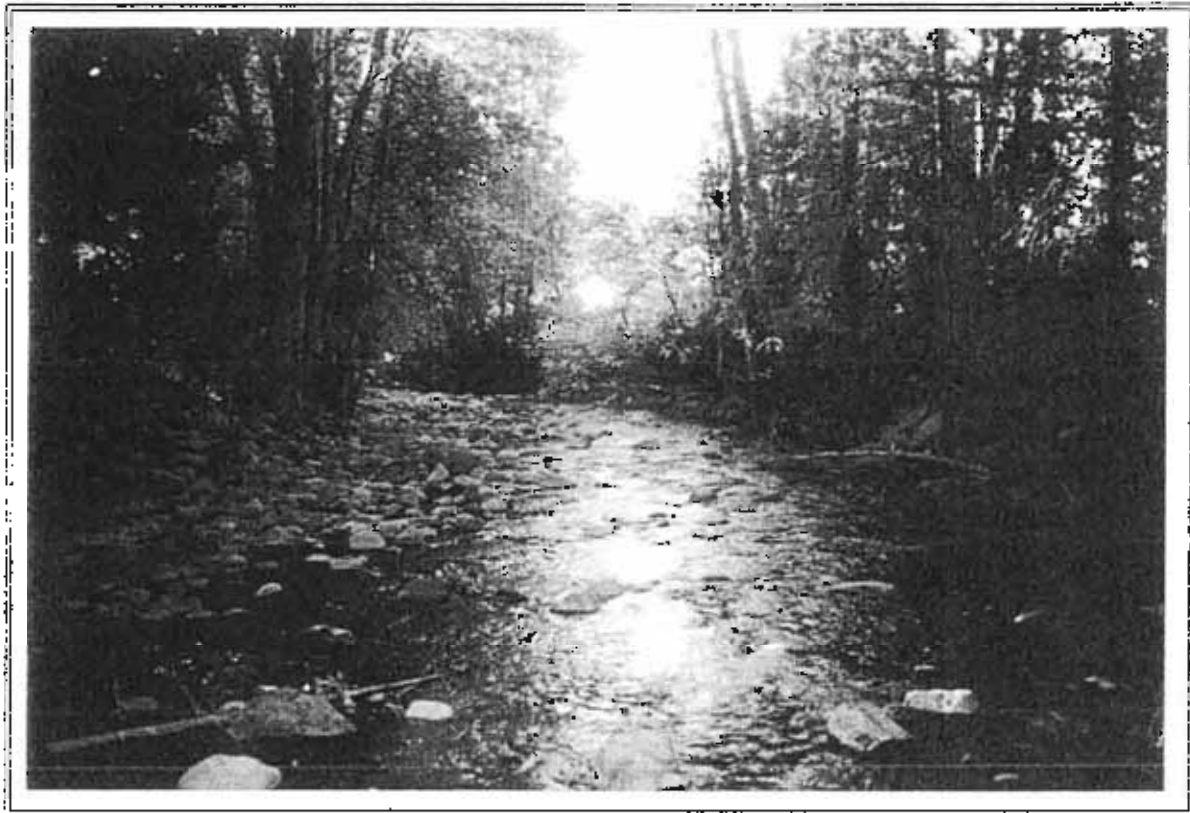
Comments: Bed materials consist of cobbles and boulders.  
 Banks for the most part are constructed levees.  
 Riparian vegetation primarily deciduous trees and shrubs.  
 Some planting has taken place to stabilize banks.  
 Reach appears degraded.

PHOTO TA-1. Downstream view of the lower section of reach TA on Trepanier Creek.  
*(TR4-3, Sept. 3/98)*

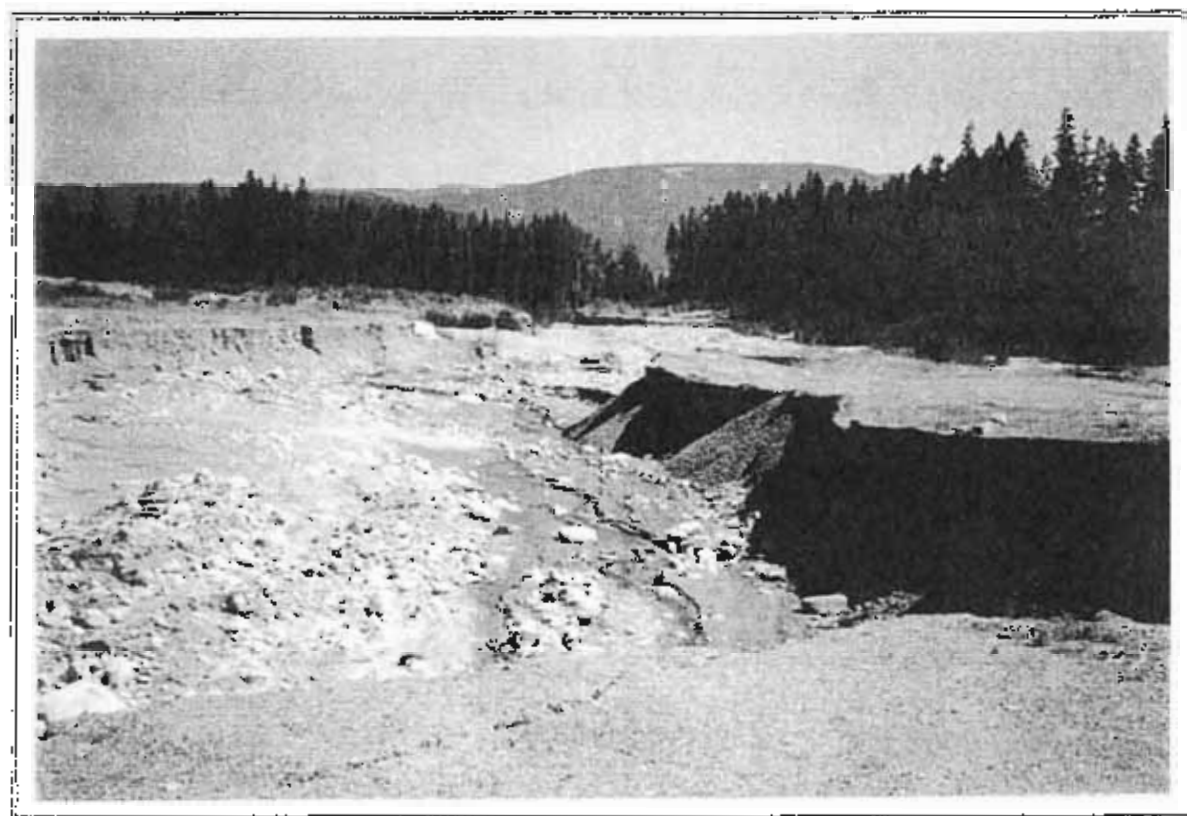
PHOTO MC-1. Downstream view of tributary channel in upper section of reach MC on MacDonald Creek. (TR4-22, Sept. 3/98)

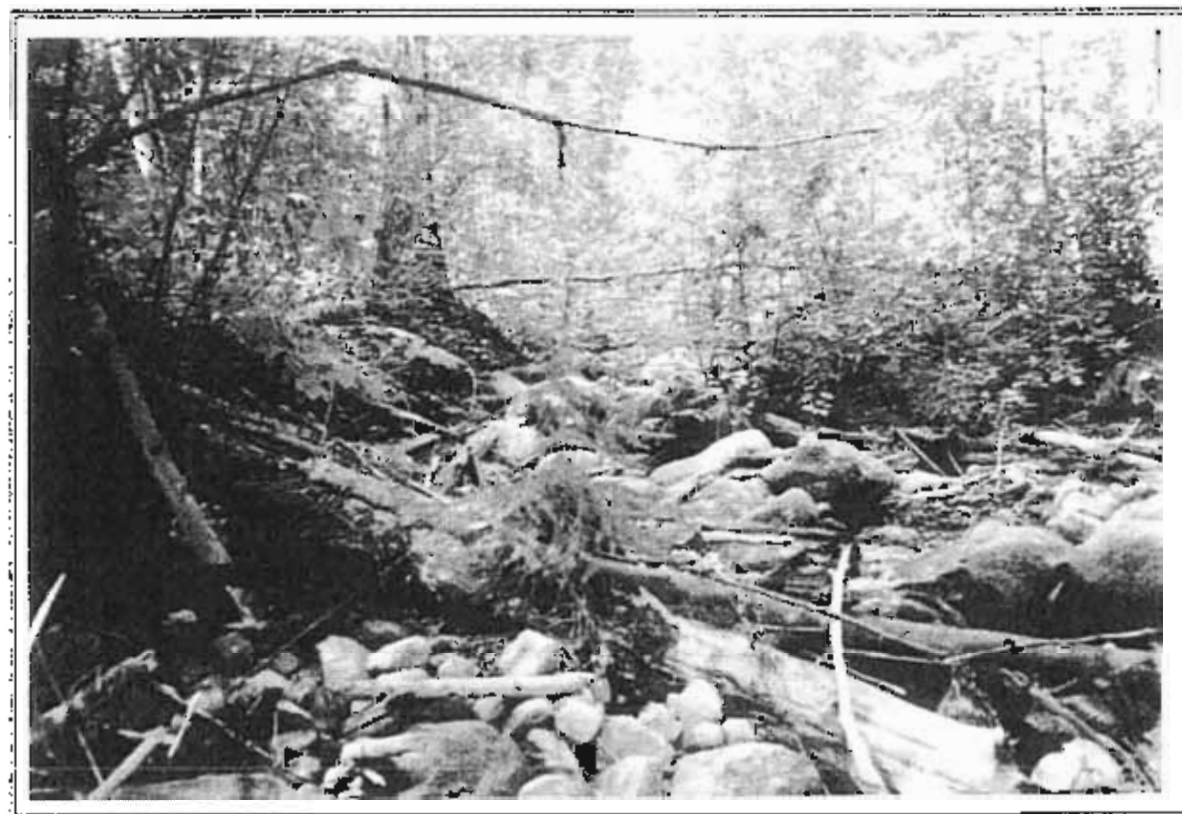
Reach MB has a moderately degraded step-pool channel morphology. The channel has been torrented, as evident by the exposed culvert at an old stream crossing.

**Comments:** Bed materials consist of sand to boulders.  
 Banks are cobble/boulder intermixed with fine-textured material.  
 Some overbank sand deposits present.  
 Minor undercutting of banks.  
 Scattered LWD in channel, remnants of old debris jam.  
 Riparian vegetation tall deciduous and conifers, and shrubs.  
 Disorganized stone lines.  
 Washed out stream crossing upstream.

PHOTO MB-1. Upstream view of reach MB on MacDonald Creek.  
(TRI-17, Aug. 14/98)
