Watershed Assessment Report  
for the  
**TREPANIER CREEK WATERSHED**

Prepared for  
GORMAN BROS. LUMBER LTD.

by  
DOBSON ENGINEERING LTD.

June 27, 2001

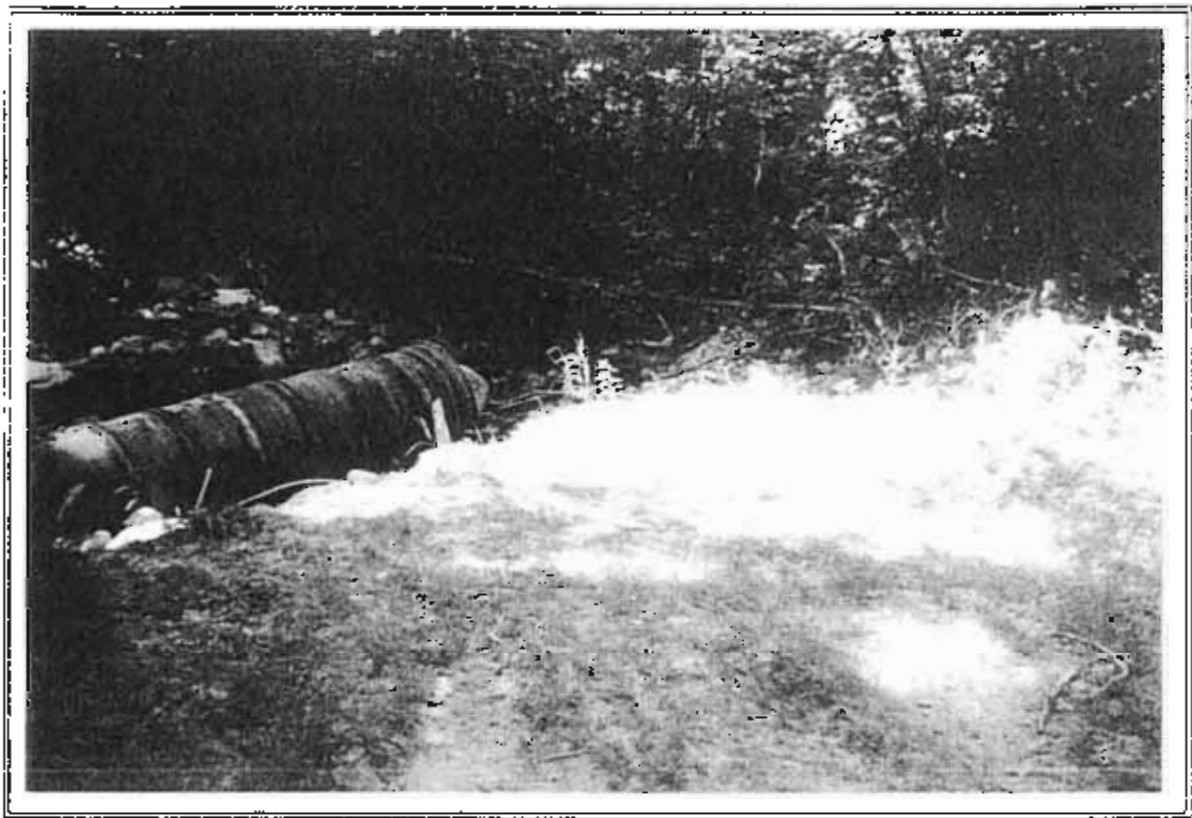
PHOTO MB-3. View of lower stream crossing in reach MB of MacDonald Creek  
(TRI-16, Aug. 14/98)

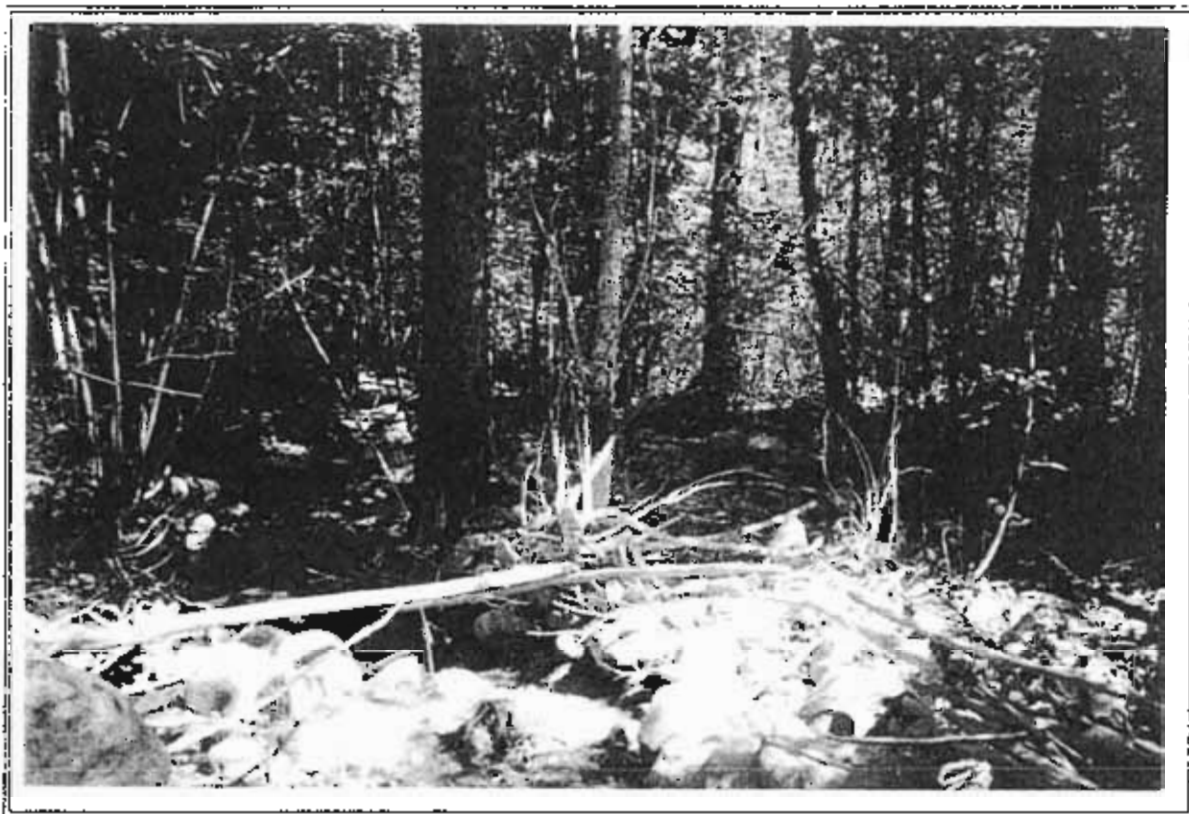
Comments: Reach break between MA and MB.  
 Laterally unstable fan.  
 Multiple channels.  
 Layered sand deposits on flood plain.  
 Eroding banks.  
 Overbank deposits

PHOTO MA-1. Downstream view of reach MA on MacDonald Creek.  
*(TRI-20, Aug. 14/98)*

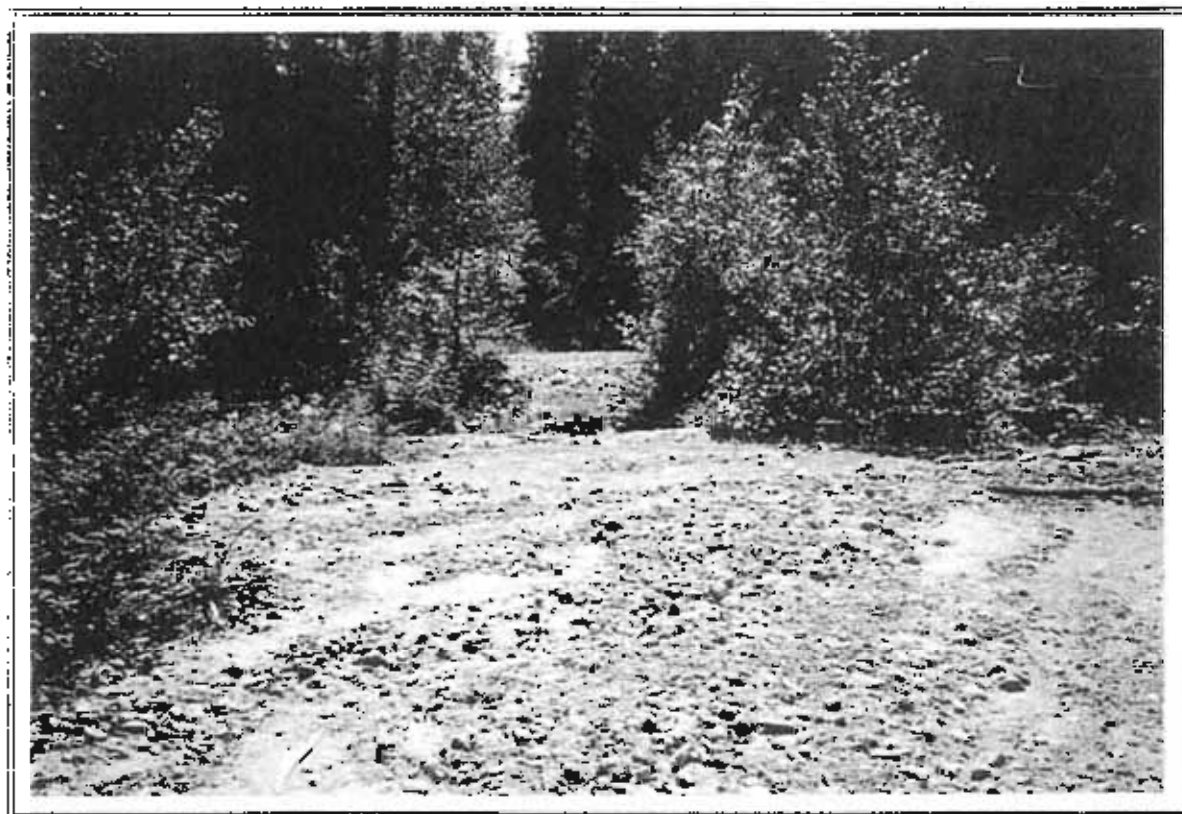
PHOTO MA-3. View southeast along road, MacDonald Creek in middle of photo.  
(TRI 21, Aug. 14/98)

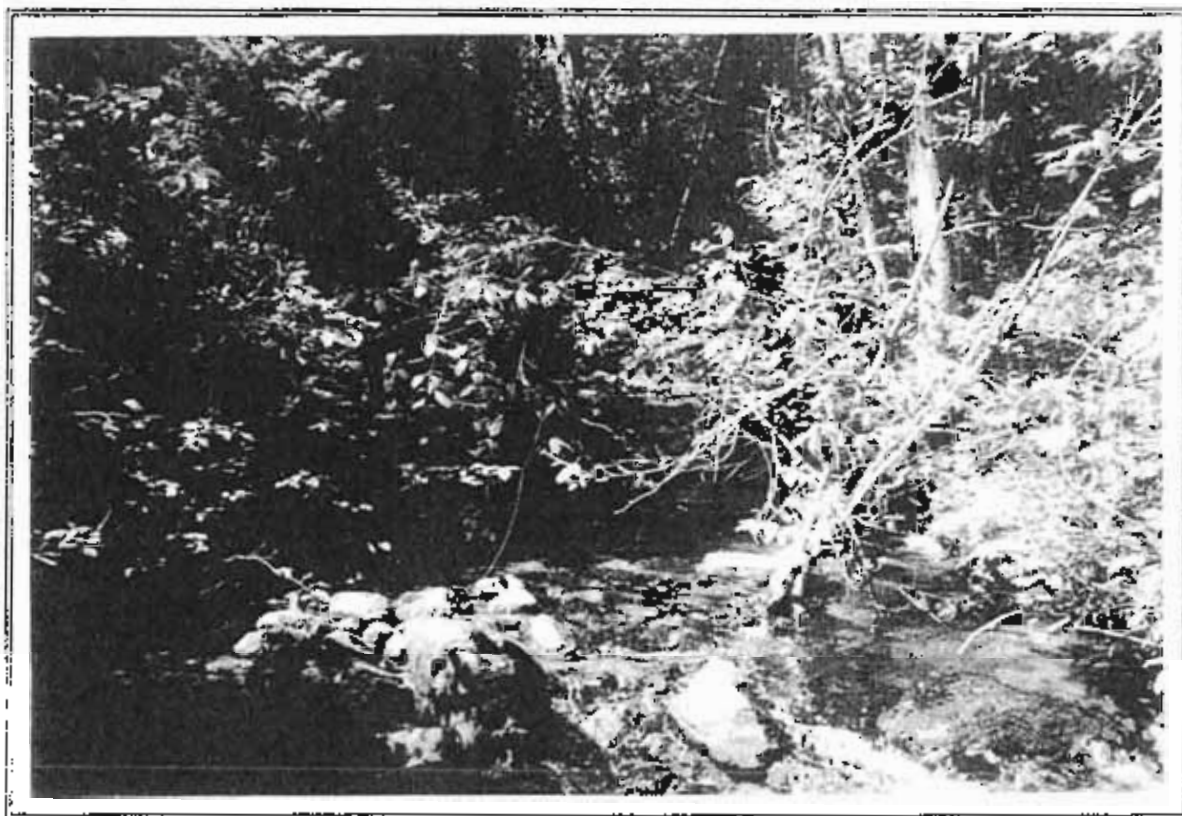
**Comments:** Bed materials-boulder with some sand, pebbles and cobbles.  
 Banks are moss-covered boulders and fines.  
 Complex morphology with pools, mid-channel vegetation.  
 Small woody debris scattered along margins.  
 Appears stable.

**PHOTO UTA-1.** Upstream view of Upper Trepanier Creek, 50 m from the Lacina Creek confluence. (TR2-5, Aug. 14/98)

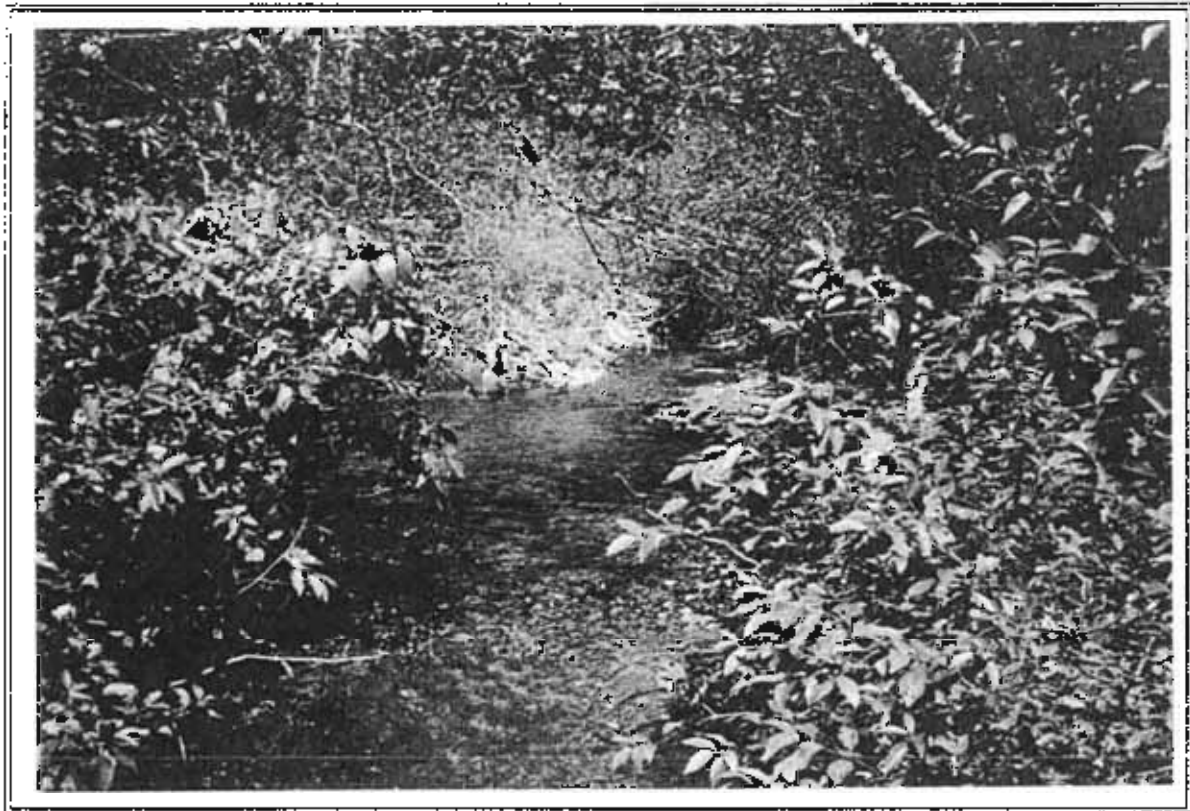
Comments: Bed materials pebble and cobble.  
 Banks fine textured matrix with organics.  
 Riparian vegetation 10 m to 20 m deciduous trees.  
 No woody debris apparent.  
 Multiple channels with vegetated islands.  
 No elevated bar surfaces.  
 Some mobile sand deposits present on bed and along channel margins.  
 Channel confined between two talus slope, partially coupled.

**PHOTO LB-1.** Upstream view of lower Lacombe Creek.  
*(TR2-7, Aug. 14/98)*

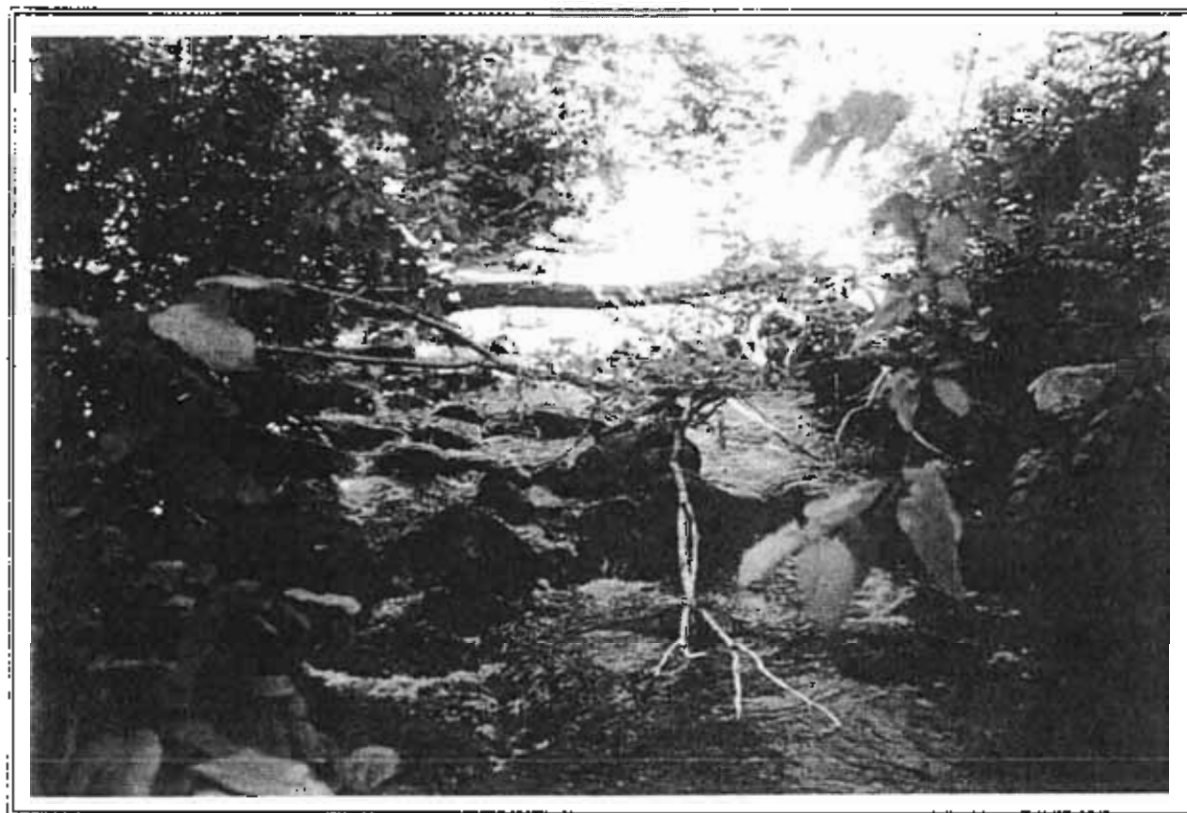
Comments: Bed materials boulders.  
 Banks consist of pebbles to boulders, trace fines.  
 Some sections with LWD along banks.  
 Minor undercutting.  
 Moss-covered.  
 Minimal woody debris in channel, non-functioning.  
 Well formed stone lines with plunge pools.  
 Riparian buffer of tall deciduous trees with the odd conifer.

PHOTO LA-1. Upstream view of lower Lacoma Creek.  
(TR2-10, Aug. 14/98)

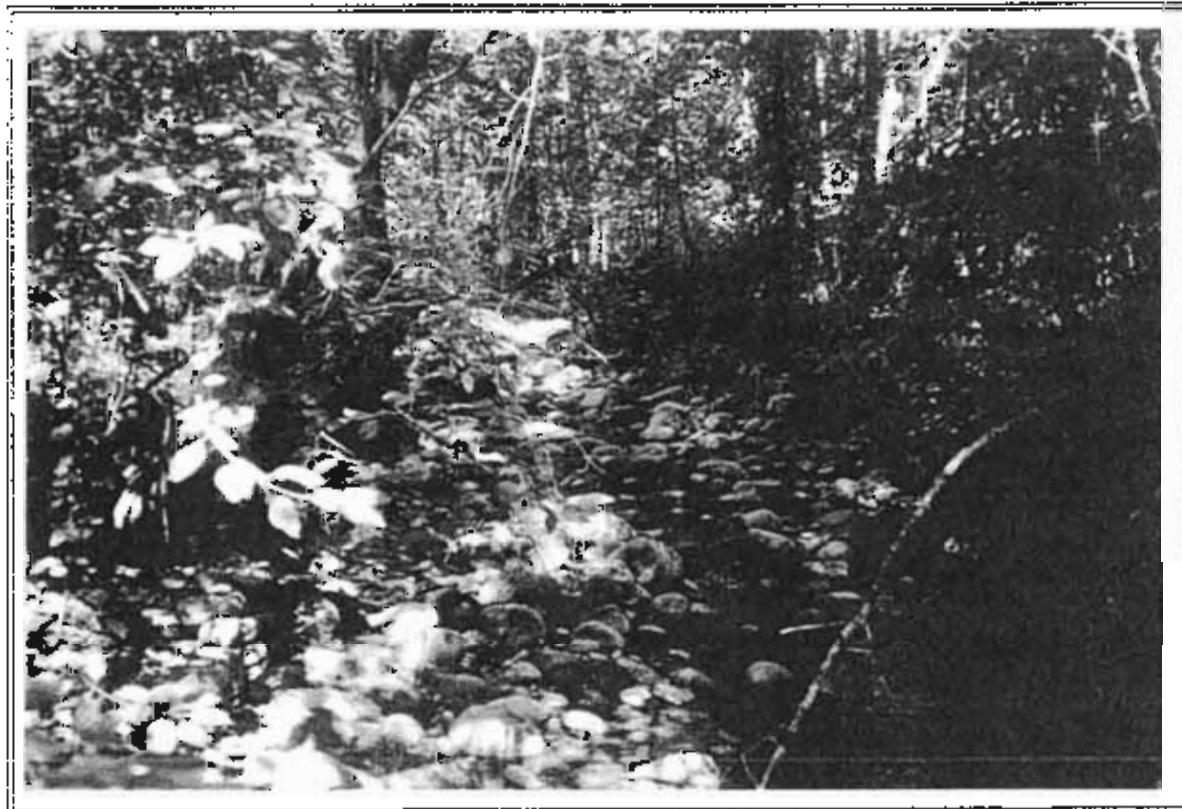
**Comments** Bed materials are pebble to boulder.  
 Some sediment storage.  
 Infilled pools.  
 Banks are pebbles to boulders, some bedrock.  
 Riparian vegetation is young conifers and deciduous trees.  
 Woody debris parallel to banks

PHOTO JA-1. Upstream view of Jack Creek, above the Trepanier Bench Road.  
(TR-15, Sept. 3/98)

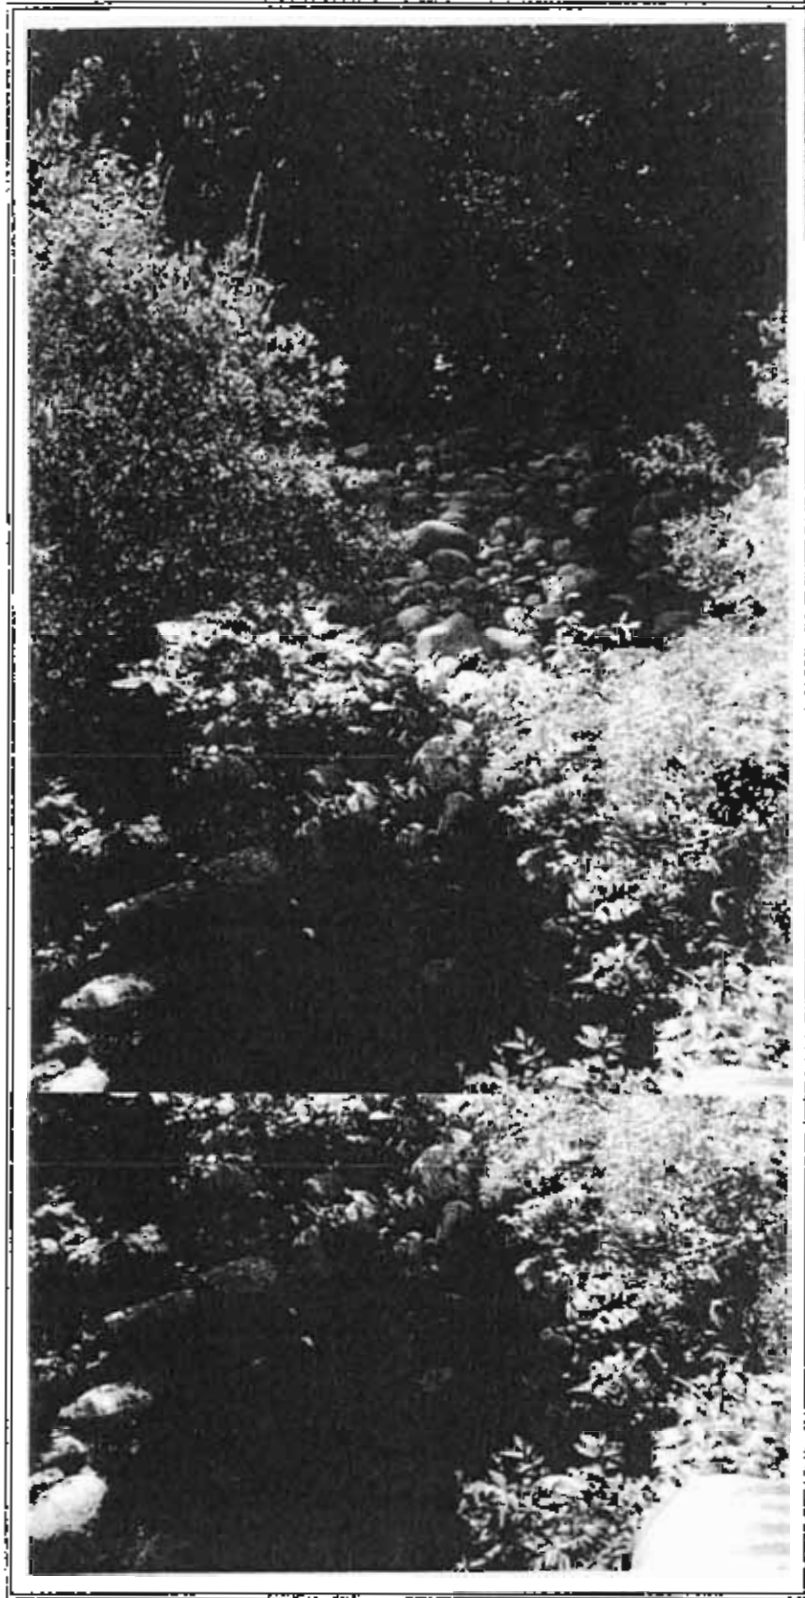
PHOTO JA-2. Downstream view of Jack Creek from the Trepanier Bench Road.  
(TR4-17, Sept. 3/98)
