CITY OF ARMSTRONG FLOOD MAPPING AND RISK ASSESSMENT REPORT

Issue Date: Project No. January 21, 2019 2018-001 (0130.05)

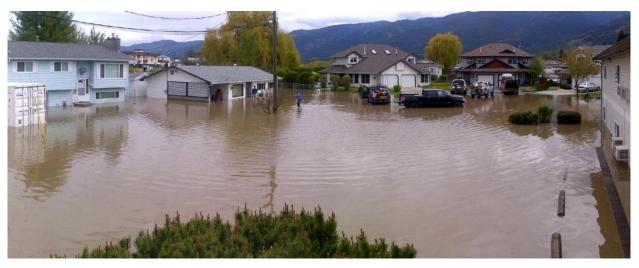
Figure 1-1: Willowdale Drive - May 5, 2017 (looking east) (Adapted from Global, 2017)

On May 5 of 2017, high streamflows were generated by rapidly warming temperatures and intense rainfall⁴ following a sustained cold winter with above normal snow accumulation. The high streamflows caused extensive flooding to numerous properties along Meighan Creek and Deep Creek. A community care facility on Willowdale Drive was impacted by Meighan Creek (Figure 1-1) and Deep Creek threatened to breach its banks near the City's Sanitary Sewer Headworks building. As a result, the City declared a local emergency (City of Armstrong, 2018).

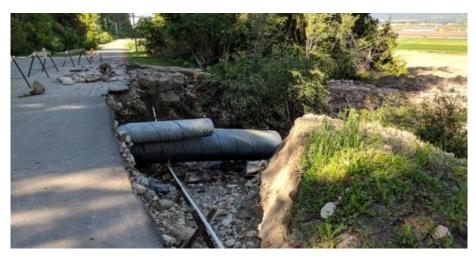
Figure 1-2: Powerhouse Road following May, 9, 2018 freshet

On May 9, 2018, the Meighan Creek freshet peaked following a short-duration high-intensity rainfall⁷. Quickly rising water overwhelmed culverts and caused overtopping at Powerhouse Road and flooding throughout Armstrong (Figure 1-2). An Interior Dams stream gauge measured the peak instantaneous streamflow to be 1.32 cubic metres per second (m³/s) at the Highway 97A crossing immediately downstream of Powerhouse Road.

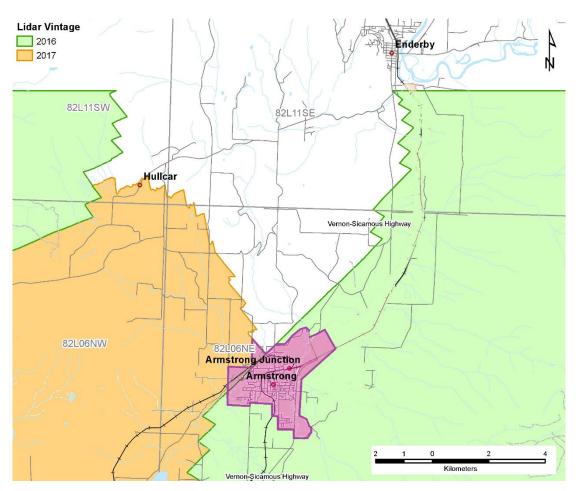
Figure 2-2: LiDAR data (purple area acquired and used in flood model)

Careful inspection of the digital elevation model (DEM) was conducted prior to importation to the flood model. As the data collection did not take place during "leaf-off" conditions, the generated surface contained some cropping of densely vegetated areas. All identified cropping and inaccurate elevations in critical flood areas were corrected using field survey data. See Figure 2.2 for an illustration of the area collected.

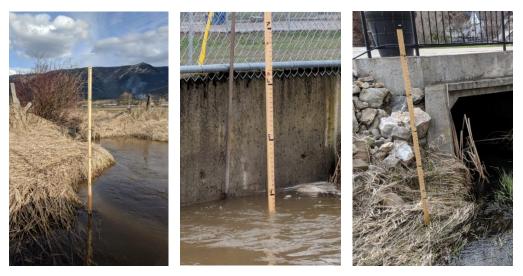
Figure 2-4: Typical temporary staff gauges installed

Fifteen (15) temporary staff gauges were installed throughout the Meighan Creek and Deep Creek study area. These were installed upstream and downstream of critical cross sections and manually monitored from March 19, 2018 to May 31, 2018. The date, time, and local water depth were recorded and used for model calibration and flow estimation. Figure 2-4 illustrates some of these temporary staff gauges.

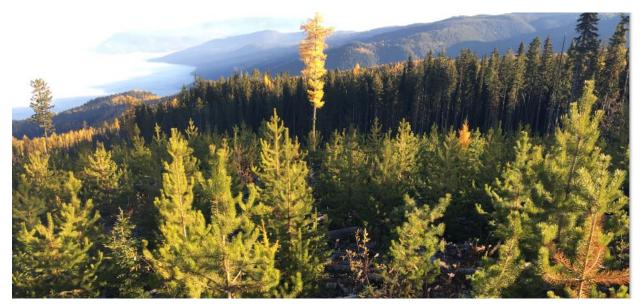
Figure 2-5: Typical timber harvesting in the Meighan Creek Watershed (2018)

Based on input data described in previous sections, the watershed is predominantly forested and periodic timber harvesting is common. No clearcutting was observed in historical air photos; however, approximately 30% of the watershed had been selectively harvested in the 1930s and 1940s (Dobson Engineering Ltd., 1998). In 2013, approximately 12% was selectively harvested totalling approximately 140-150 hectares (ha) (Figure 2-5). Based on a watershed assessment conducted in 2015, this harvesting significantly increased the equivalent clearcut area (ECA) above the H40-line¹³, and therefore, increased the potential for higher peak flows in the short-

term¹⁴ (Tolko Industries Ltd., 2015). Although impacts to peak flows due to increased ECA levels may contribute to short-term elevated peak flows, the current ECA levels identified in the Meighan Creek sub-catchment is consistent with historical norms for the period of record reviewed.

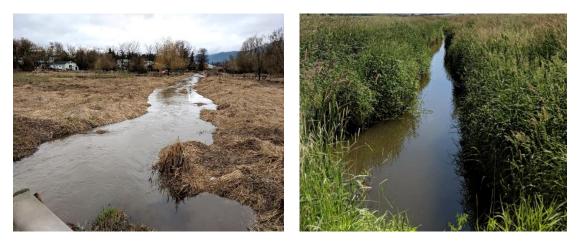
The City of Armstrong is located within the catchment area below the upper sub-basins. This area consists of a broad valley bottom with a relatively low gradient. Both the Meighan Creek and Deep Creek reaches through this area have average gradients of less than 1.5% with distinct low-lying wetland areas. Figure 2-6 illustrates a typical Deep Creek riparian and wetland area.

Note variation in vegetation between mid-April to mid-June Figure 2-6: Typical riparian and wetland area through Armstrong, BC - Deep Creek (2018)

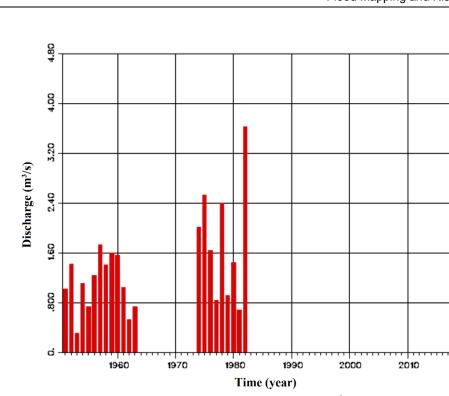
*Note: Figure includes a datapoint of 3.18 m³/s for 2018. Figure 2-9: Peak Annual Discharge vs. Year – Deep Creek at Armstrong (Station ID 08NM119)

In order for the statistical frequency analysis to be valid, the hydrometric dataset must meet statistical criteria. The initial review of the identified no errors or outliers. Following this, the Run Test for General Randomness, Spearman Test for Independence, Mann-Whitney Split Sample Test for Homogeneity, and Spearman Test for Trend (stationarity) was used to test the dataset. Based on the results, the dataset was confirmed to be significantly random, independent, homogeneous and stationary and was determined to be valid. Appendix I includes a summary of the CFA-3 statistical test results. Figure 2-9 provides an illustrated summary of the dataset used in the analysis.

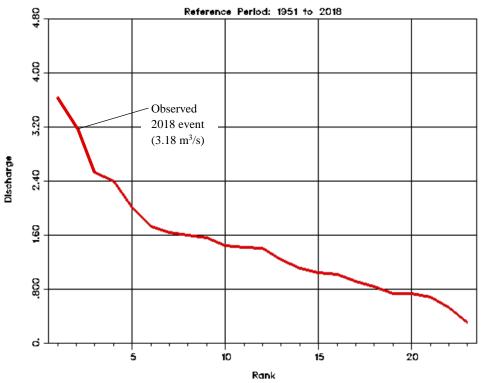
Figure 2-10: Discharge vs. Rank Plot – Deep Creek at Armstrong Station ID 08NM119

Since the absence of other large flood events during the years of missing data could not be definitively ascertained, the inclusion of a 2017 historical flood event estimate could cause the HSFA to underestimate the 1/200-year flood regardless of the selected historical threshold²². As such, the inclusion of historical floods of record were not included in the HSFA. For more information refer to Appendix I Table AI-1.

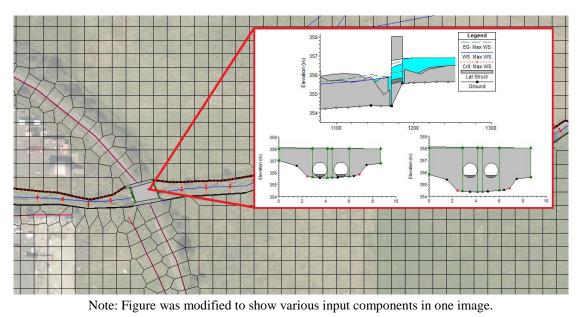
Figure 2-13: Typical 1D and 2D geometry component showing culverts, sediment buildup, ineffective flow areas, lateral structures, and breaklines

Other 1D geometry, such as channels, culverts, and bridges, was constructed using available records and collected field data described in Section 2.2. If sediment deposits were identified, these were also included. All components were constructed as per USACE guidelines and later calibrated. Figures 2-13 graphically illustrates these features as they appear in the hydraulic model (See CN railroad crossing on Deep Creek below).

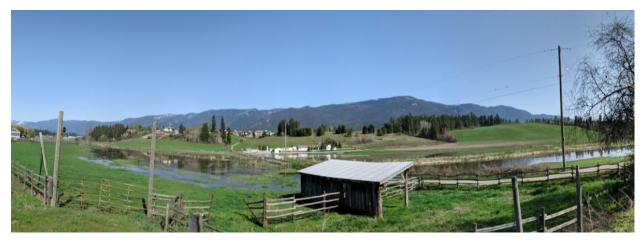
Figure 2-14: Downstream boundary control section at 2615 Otter Lake Road (April 27, 2018)²⁵

²⁵ A panoramic photograph of the downstream control section taken during the City's local state of emergency 13 days prior to Meighan peak flow of 2018. For reference, the photo is taken looking southeast and Armstrong is upstream is to the left of the photo. The photo depicts the residential access at near-overtopping conditions with deep ponded flooding both upstream and downstream.

The assumed depths of debris buildup in culverts relied on measured field observations and calibration limited to 10% of the total depth. Downstream boundary conditions were carefully adjusted based on field survey and flooding observations under the 2018 flood conditions at 2615 Otter Lake Road residential crossing. Figure 2-14 shows a panoramic photograph of this section.

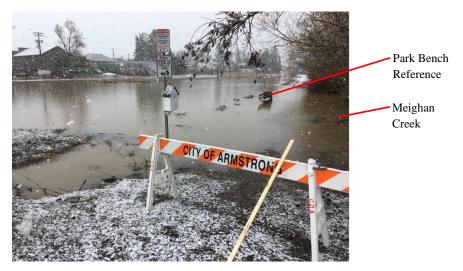
Figure 2-15: Just upstream of Okanagan Road on Meighan Creek – flood flow conditions (March 23, 2018)

As a result, Deep Creek required minor modification and typical channel manning coefficients were in the range of 0.030 and 0.040 as expected; however, Meighan Creek required a substantial increase. Typical channel manning coefficients were in the range of 0.080 to 0.140 with a short portion between downstream of Meadow Creek Lane to just beyond Okanagan Road requiring coefficients even higher as this portion was heavily impacted by sediment deposition and vegetation growth. This portion used the maximum recommended value of 0.200 representing dense willows. Figure 2-15 and 2-16 depicts a section of this reach under flood and low flow conditions.

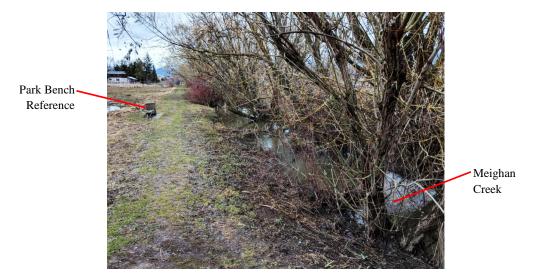
Figure 2-16: Sediment deposition and heavy vegetation growth in thalweg just upstream of Okanagan Road on Meighan – low flow conditions (April 7, 2018)

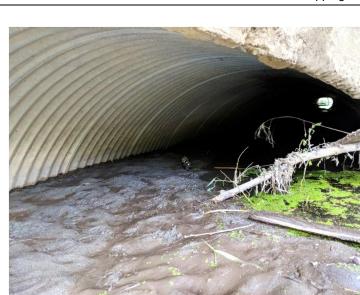
Figure 2-17: Sediment deposition in culvert – Wood Avenue right culvert shown

Culvert crossings required little adjustment to the friction and entrance loss coefficients. Some required minor modification to the depth of sediment deposition at most crossings but these were considered minimal and similar to field observations. All modifications to sediment deposition were limited to 10% of the total depth measured in the field. Figure 2-17 illustrates some typical sediment deposition identified in the field.

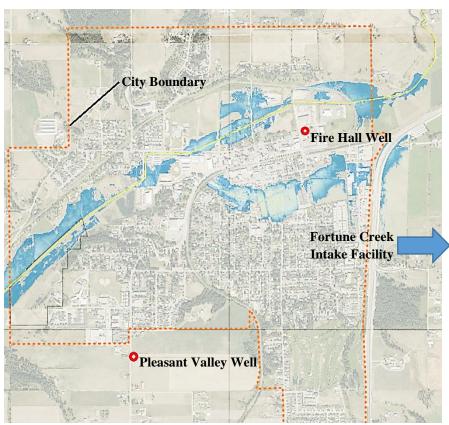
Note: Fortune Creek Intake Facility is approximately 330 m above and 2700 m east of the flood.

Figure 3-1: Potable water source locations relative to flood (City of Armstrong, 2016)

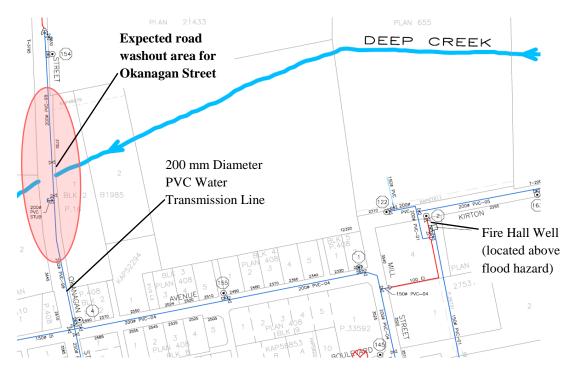
Figure 3-2: Water Composite Map compared to an expected Okanagan Street washout location

Comparing estimates of road washouts covered in Section 3.1.2, it was assumed that transmission mains existing within any expected washout location would be damaged and functionality would be compromised. As such, the location of washout roads was compared to the City's Water Composite Maps and two vulnerable transmission mains were identified: 1) Meighan Creek Crossing at Okanagan Street, and 2) Deep Creek crossing at Okanagan Street. Since a 50% probability of failure was assumed, only one (1) washout having a watermain pipeline was assumed to be impacted. Figure 3-2 illustrates one of these crossings.

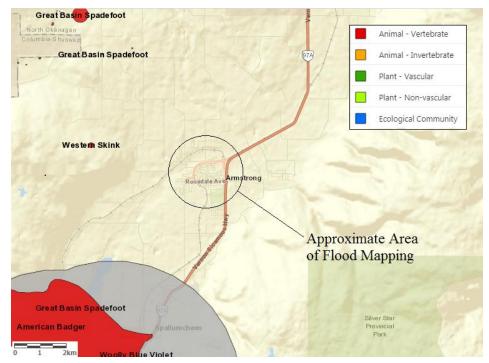
Figure 3-3: BC CDC map of red- and blue-listed species and ecosystems (BC CDC, 2018)

According to the BC guidelines for assessing environmental flood consequence in relation to dam breaches, if red- or blue-listed species are impacted, the consequence is considered $high^{35}$ (FLNRORD, 2016). The Dam Safety Regulation defines a high environmental consequence as a "significant loss or deterioration of important fisheries habitat or important wildlife habitat, rare or endangered species, or unique landscapes" where "restoration or compensation in kind is highly possible" (BC, 2016). Although a monetary value is not attributed to the environmental losses described above, significant pollution of water quality and potential impact to species at risk are identified; however, there are no expectations of permanent environmental loss

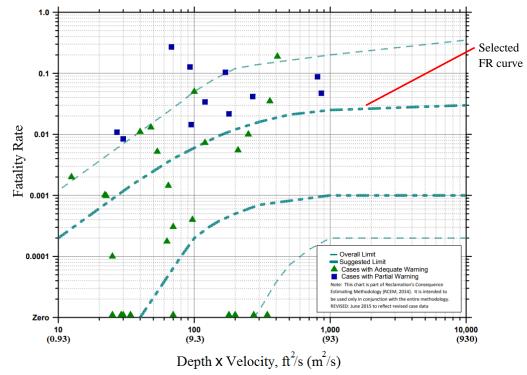
Figure 3-4: Loss of Life Fatality Rates for No Warning (USBR, 2015)

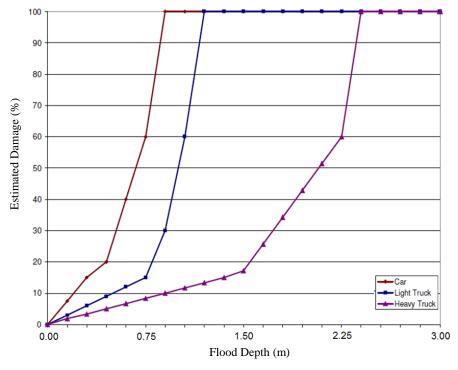
Figure 3-5: Vehicle Depth vs. Damage Curves

According to NRC guidelines, loss to automobiles can be estimated based on the depth of flooding. Figure 3-5 illustrates some typical loss functions illustrating the potential damage expected to various vehicle types.

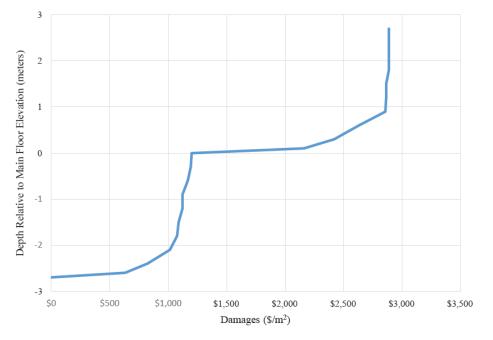
Figure 3-6: Residential One-Storey Class A – Damage Function

Impact to residential structures and content was estimated using available NRC damage functions. An example damage function used in this analysis is illustrated by Figure 3-6. For all other damage functions used, refer to Appendix IV.

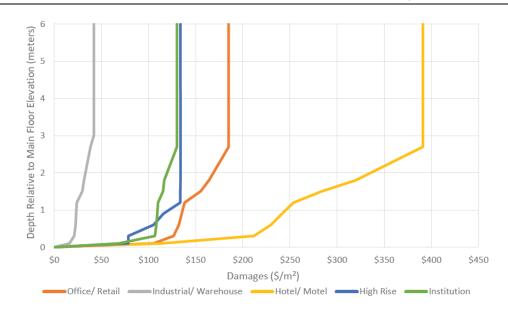
Figure 3-7: Non-Residential Structural Damage Function

To account for economic losses related to non-residential structural and content damage, the impact was estimated using available NRC damage functions. Damage functions used in this analysis for structural and content damage for all industry categories are illustrated in Figure 3-7 and Figure 3-8.

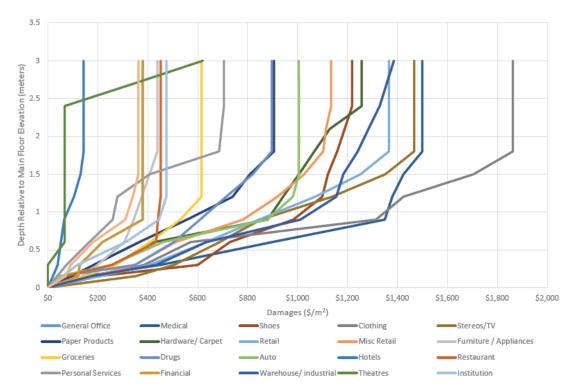
Figure 3-8: Non-Residential Content Damage Function

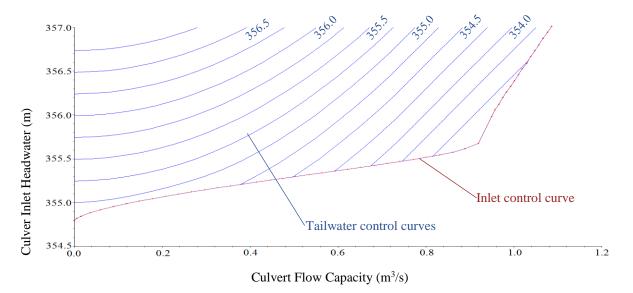
*Note: Tailwater could not be calibrated as all field data collected was under headwater control⁵²

Figure 4-3: Meighan Creek with and without sediment management and new headwall

This crossing was identified as the largest contributor to flood impact. The crossing consists of a long 1200 mm diameter corrugated steel pipe (CSP) with an approximate length of 365 m. Under most flow conditions in Deep Creek and Meighan Creek, this pipe capacity is dictated by the geometry of the culvert's inlet (referred to as inlet controlled). However, under high flow conditions in Deep Creek – such as from obstructions in Deep Creek in the vicinity of Adair Street, or a combination of both – the water elevations at the downstream end of the pipe limit the flow capacity (referred to as tailwater controlled). Streamflow in Meighan Creek that cannot be managed by this simply backs up causing significant impacts to upstream flood risk. Figure 4-3 illustrates the estimated rating curves showing flow capacity under inlet control and tailwater control conditions.

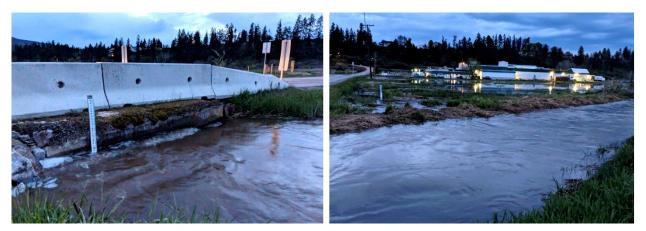
Figure 4-5: Okanagan Street Crossing on Deep Creek (2018)

The Deep Creek crossing at Okanagan Street was identified in Section 3.1.2 as being undersized and at risk of washout. In addition to the possible impact on local transportation and potable water systems, the crossing also increases the floodwater upstream of Okanagan Street. Figure 4-5 illustrates this crossing under moderately high flood flows.

The structures shown in Figure 4-5 were identified as being large contributors to the local economy, and indirectly, to individuals who are employed by this business. As such, improvement of this crossing may significantly reduce the total risk to the individuals and organizations within the community of Armstrong⁵³.

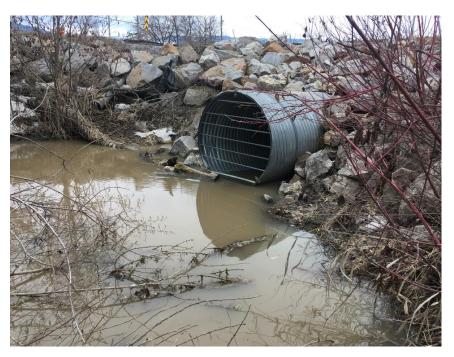
Note: Parallel 600 mm diameter CSP culvert partially blocked and submerged (not shown) Figure AI-6-5: Meighan Creek – Rosedale Road East near Hwy 97A – Station 1+258 (2018)

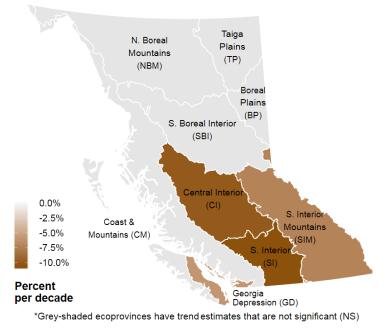
Note: There is a trend of -11% snow water equivalent per decade for the Southern Interior.

Figure AI-6-19: Observed change in Snow Water Equivalents for 1950-2014 (Province of BC, 2018)

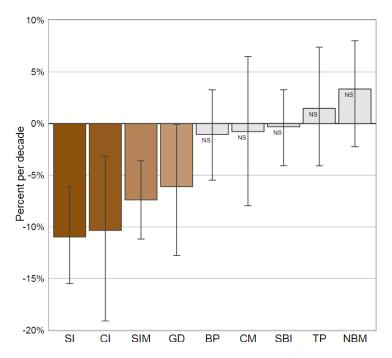
Note: There is a trend of -11% snow water equivalent per decade for the Southern Interior.

Figure AI-6-20: Observed change in Snow Depth for 1950-2014 - Graph (Province of BC, 2018)

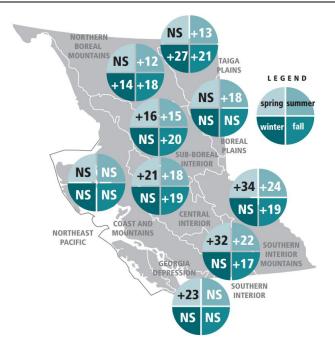
Note: The springtime average precipitation increase for the Southern Interior is +32% per century (year-round average increase of +17% per century).

Figure AI-6-21: Observed change in annual temperature for 1900-2013 (Province of BC, 2016)

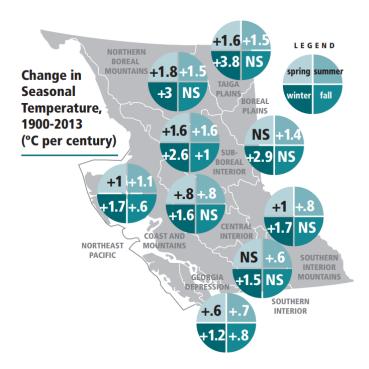
Note: The springtime average temperature increase for the Southern Interior is +1.2°C per century (year-round average increase of +0.9°C per century).

Figure AI-6-22: Observed change in annual temperature for 1900-2013 (Province of BC, 2016)

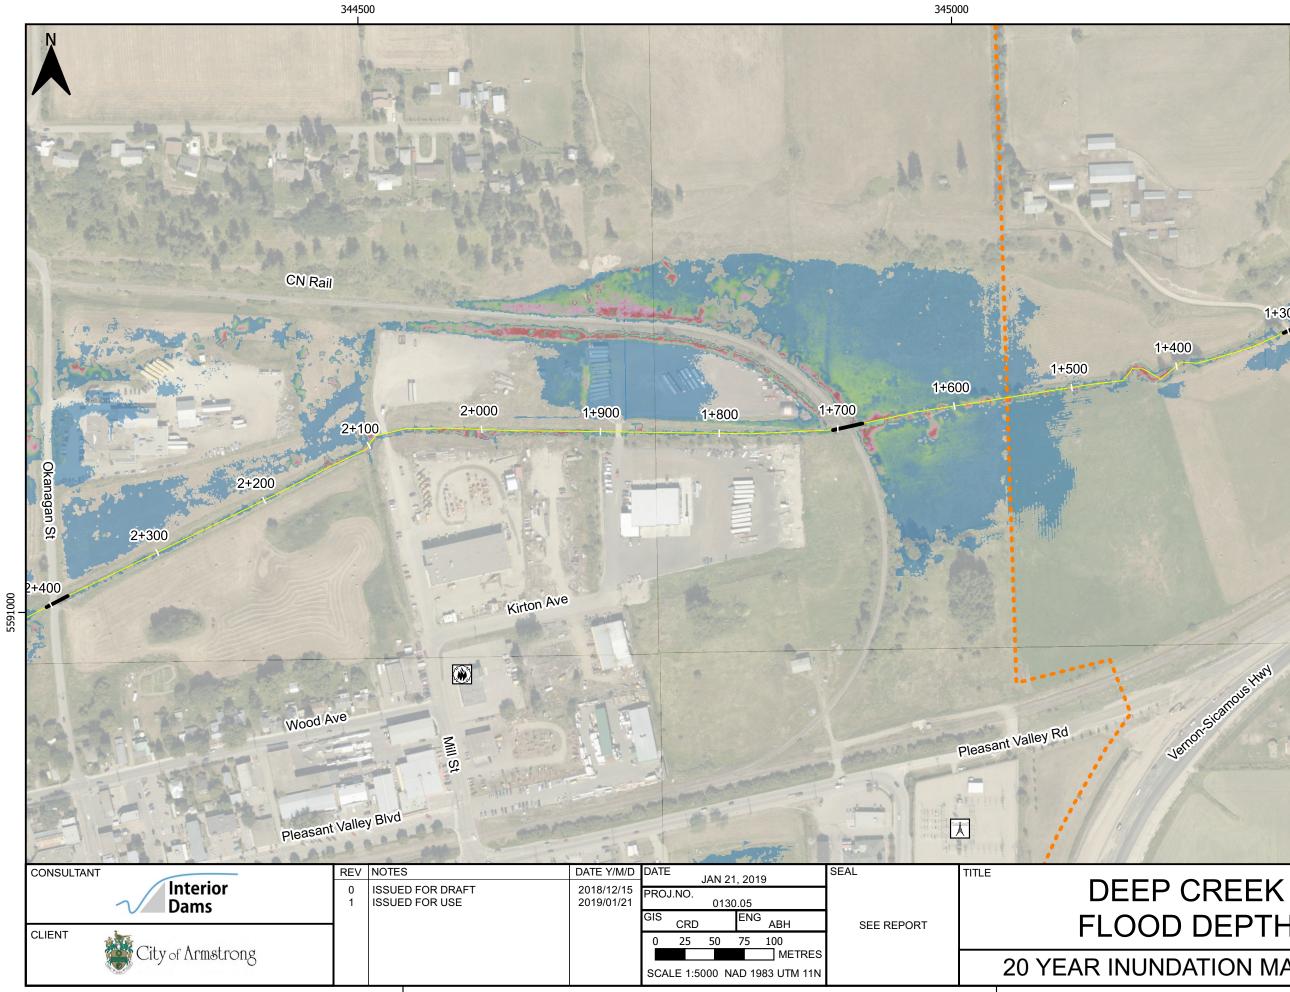
FLOOD DEPTH 20 YEAR INUNDATION MAPPING

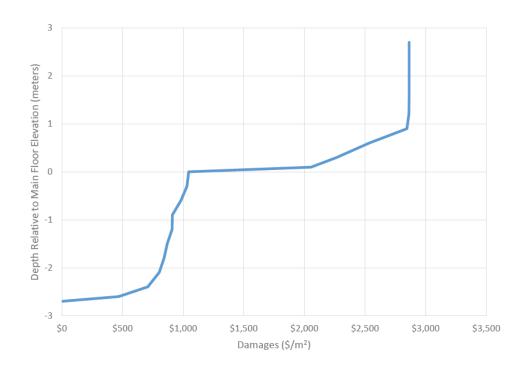
Residential Damage Function for Class A Two-Storey (NRC, 2017):

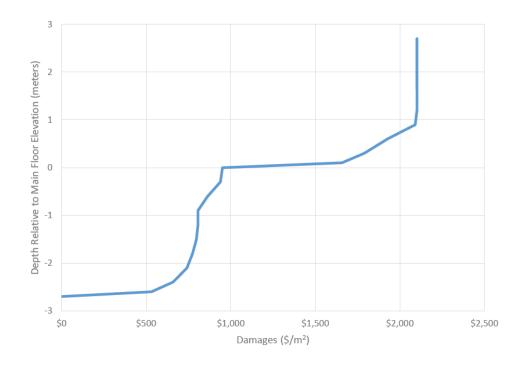
Residential Damage Function for Class C One-Storey (NRC, 2017):

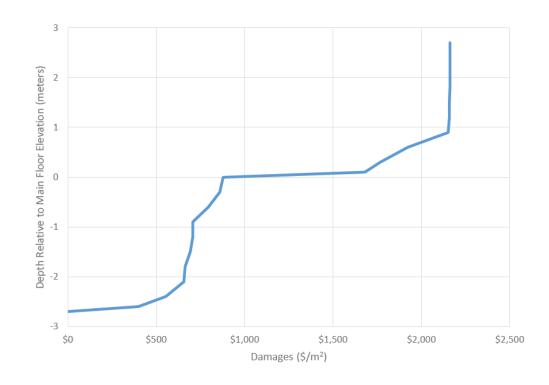
Residential Damage Function for Class C Two-Storey (NRC, 2017):

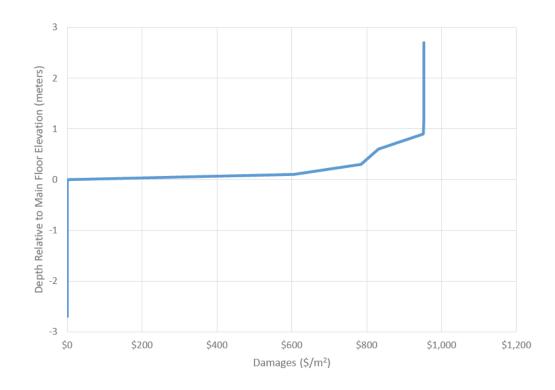
Residential Damage Function for One-Storey Mobile Homes (NRC, 2017):
