Vaseux Lake Milfoil Study Interim Report

Prepared for Regional District Okanagan Similkameen
March 2018

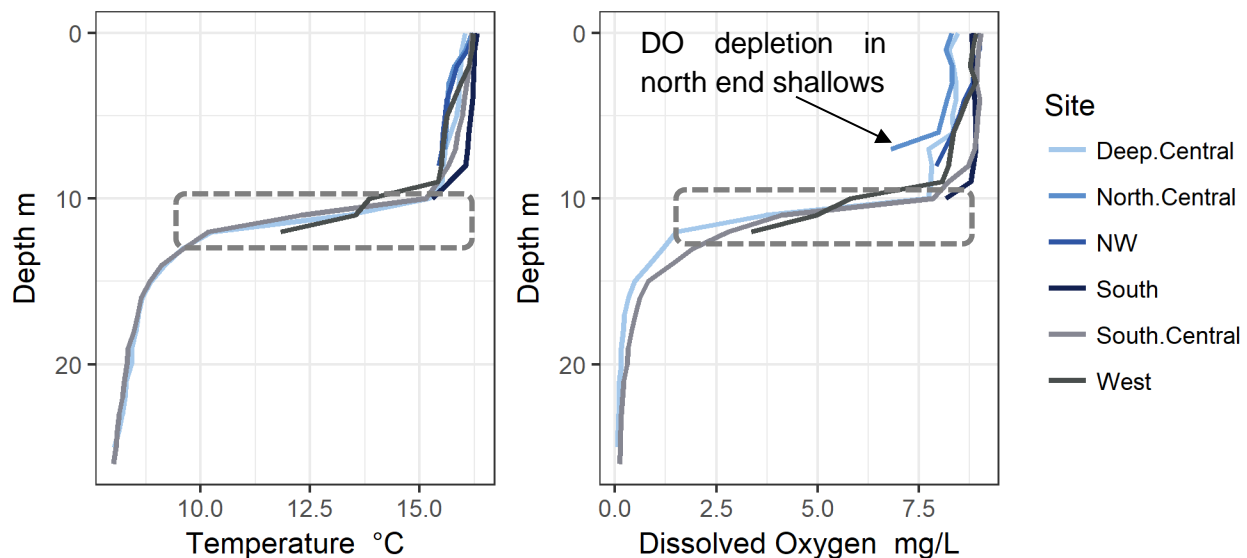
The multimeter profiles collected in September 2017 showed a consistent thermocline at 10-11m throughout the main basin of the lake (Figure 3.2-3). Temperature ranged from 16 °C at the surface to only 8 °C at 25 m in the deep central basin. Dissolved oxygen was high at the surface and became anaerobic just below the thermocline at sites that were deeper than 10 m. In the north end shallows (North.Central in Figure 3.2-3) there was oxygen depletion within the deepest meter of the water column even though it was shallower than the thermocline. This confirms that there is intense oxygen demand in Vaseux sediments.

Figure 3.2-3: Temperature and dissolved oxygen profiles from Vaseux Lake in September 2017

Note: Dashed box highlights thermocline

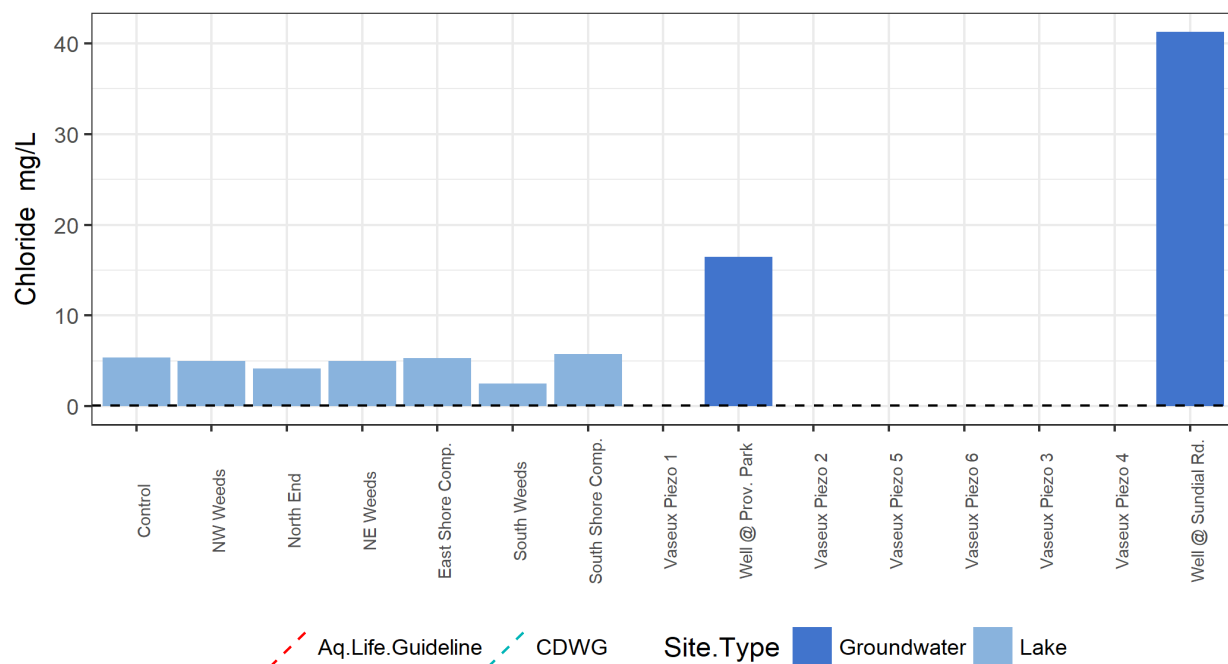
Chloride is a conservative parameter that indicates human impact. Chloride concentrations in Vaseux Lake ranged from 2.48 mg/L in the south end plant beds to 5.77 mg/L in the south shore composite sample. There was no statistically significant North to South gradient (KW-Test, $p=0.48$) indicating significant loading within Vaseux Lake. Groundwater contained higher chloride and ranged from 16.5 mg/L at the provincial park campground to 41.3 mg/L in a well on Sundial Rd. at the south end of the lake. These results are all far below guidelines, but the groundwater samples from the Sundial well do indicate human impact, likely through septic field influence.

Figure 3.3-1: Chloride concentrations at Vaseux Lake sample sites, September 2017

Note: Dashed line indicates lab reportable detection limit (sites are presented in North (left) to south (right) and split by surface and groundwater.

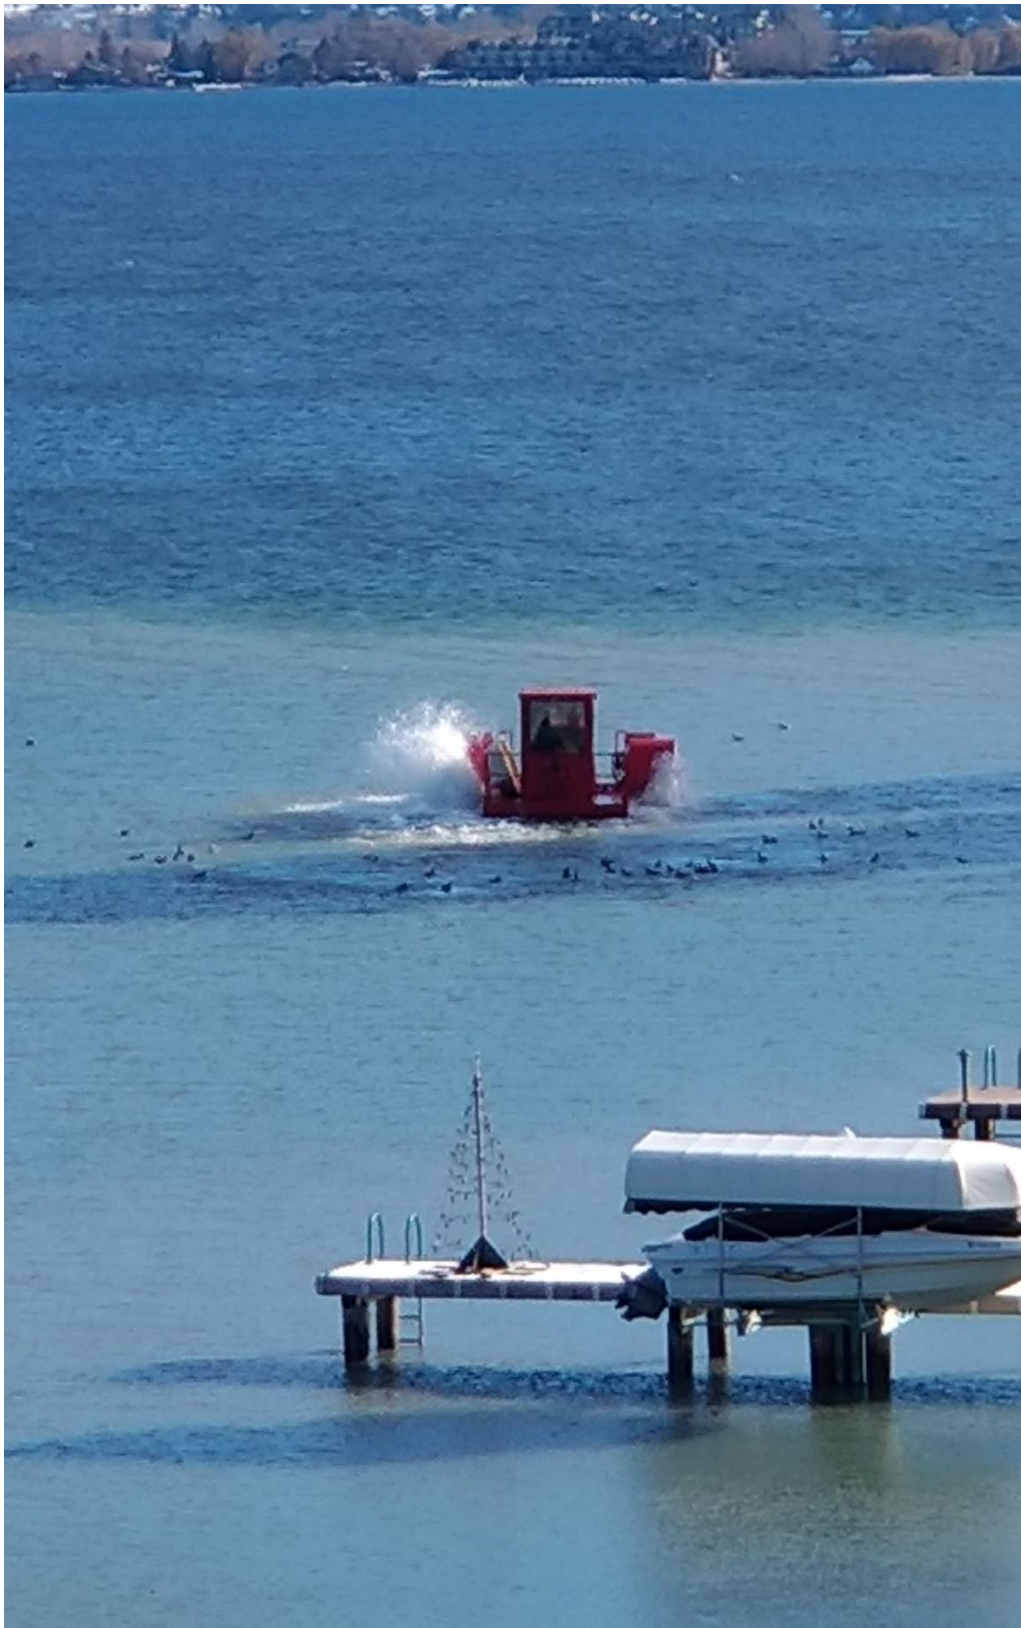
Figure 3.4-1: Plume of suspended sediment from milfoil rototilling in Okanagan Lake at Casa Loma

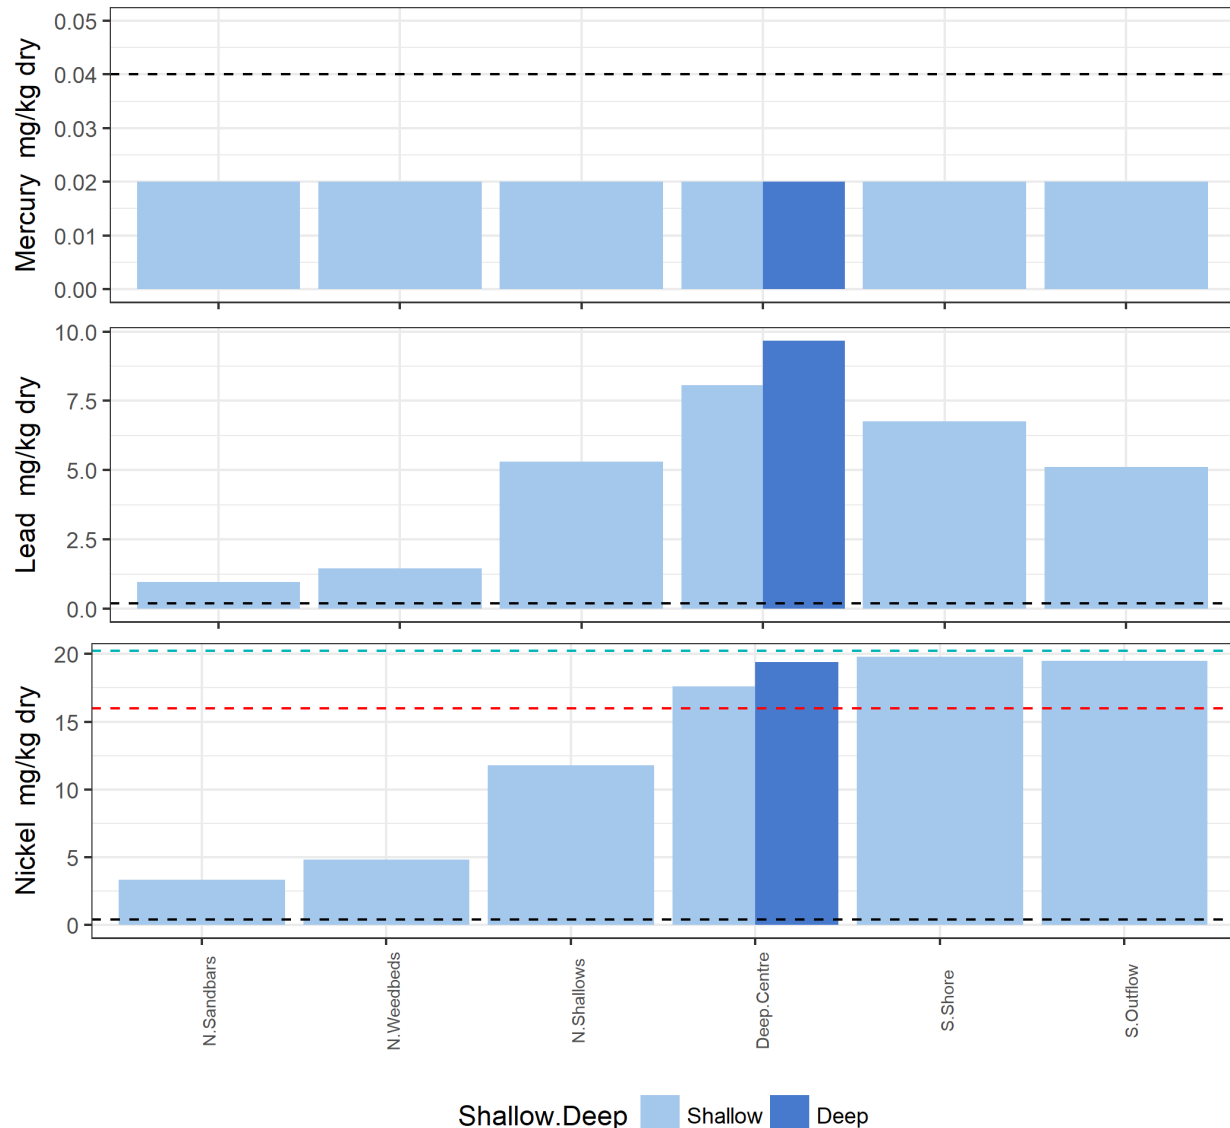
The composite sediment cores collected from Vaseux Lake in 2017 showed that for most metals, the highest concentrations were found in the sediments from the deep central basin (Figure 3.4-2). This suggests that many metals are being sequestered in anaerobic sediment, likely through biological pathways such as sulphate reducing bacteria (SRB). The sediment from the main

Figure 3.4-2: Mercury, lead, and nickel in Vaseux Lake sediments, September 2017

Note: Black dashed line = RDL; Red dashed line = guideline; cyan dashed line = BC Average

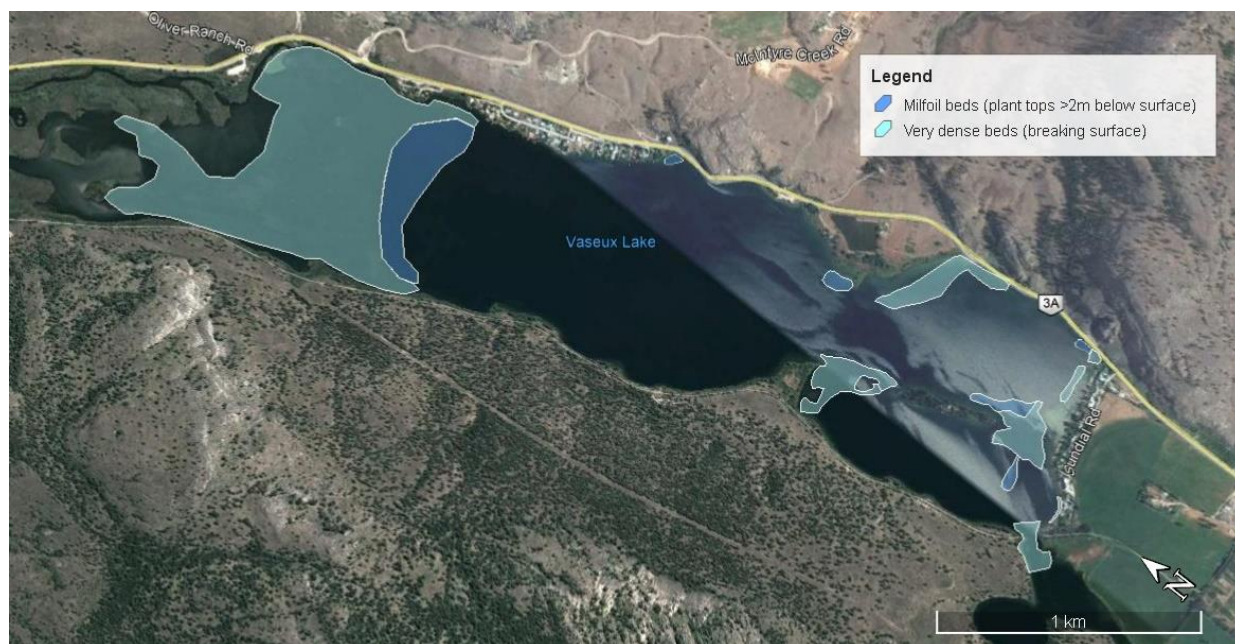
Aquatic plant beds occurred throughout much of the lake but were most densely concentrated in shallow areas such as the north and south ends (Figure 3.5-2).

Figure 3.5-2: Plant beds in Vaseux Lake during September 2017

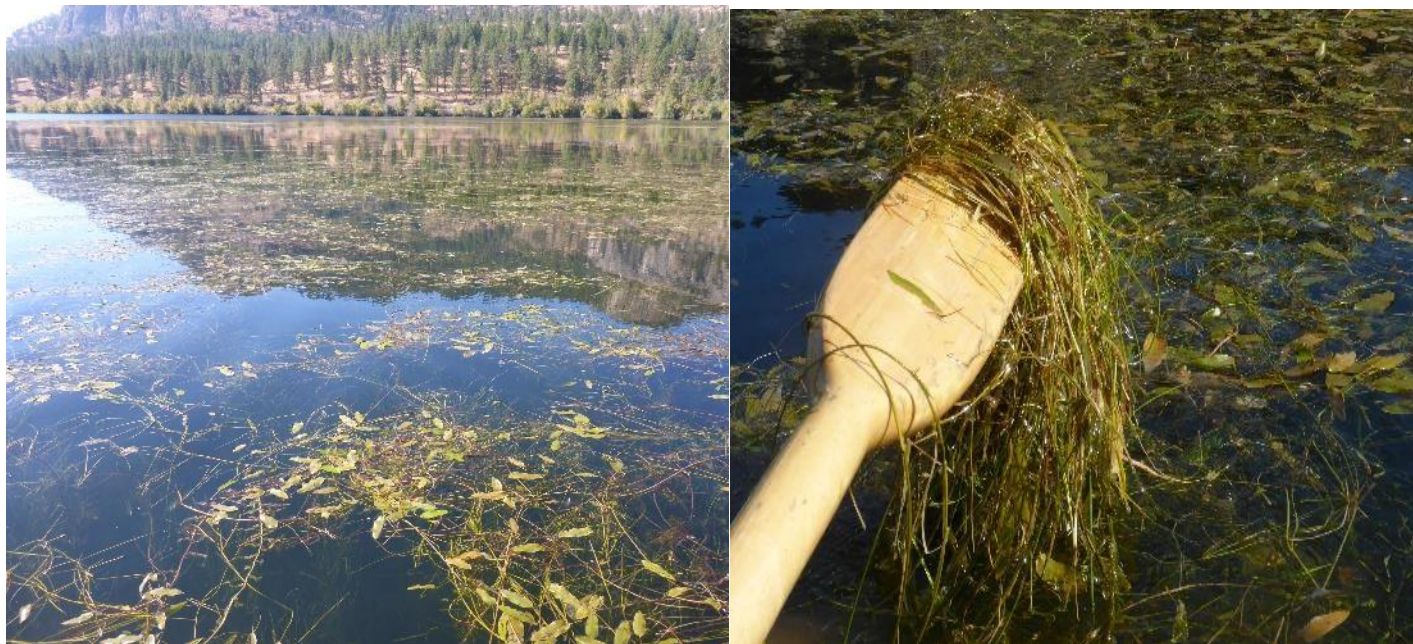
Common species included several native species (*Potamogeton natans*, *Potamogeton pectinatus*, *Potamogeton crispus*, and native milfoil), and in some places invasive milfoil (*Myriophyllum spicatum*). *Potamogeton natans* was by far the dominant species in September 2017 (Figure 3.5-3).

Figure 3.5-3: *Potamogeton natans* beds in Vaseux Lake during September 2017

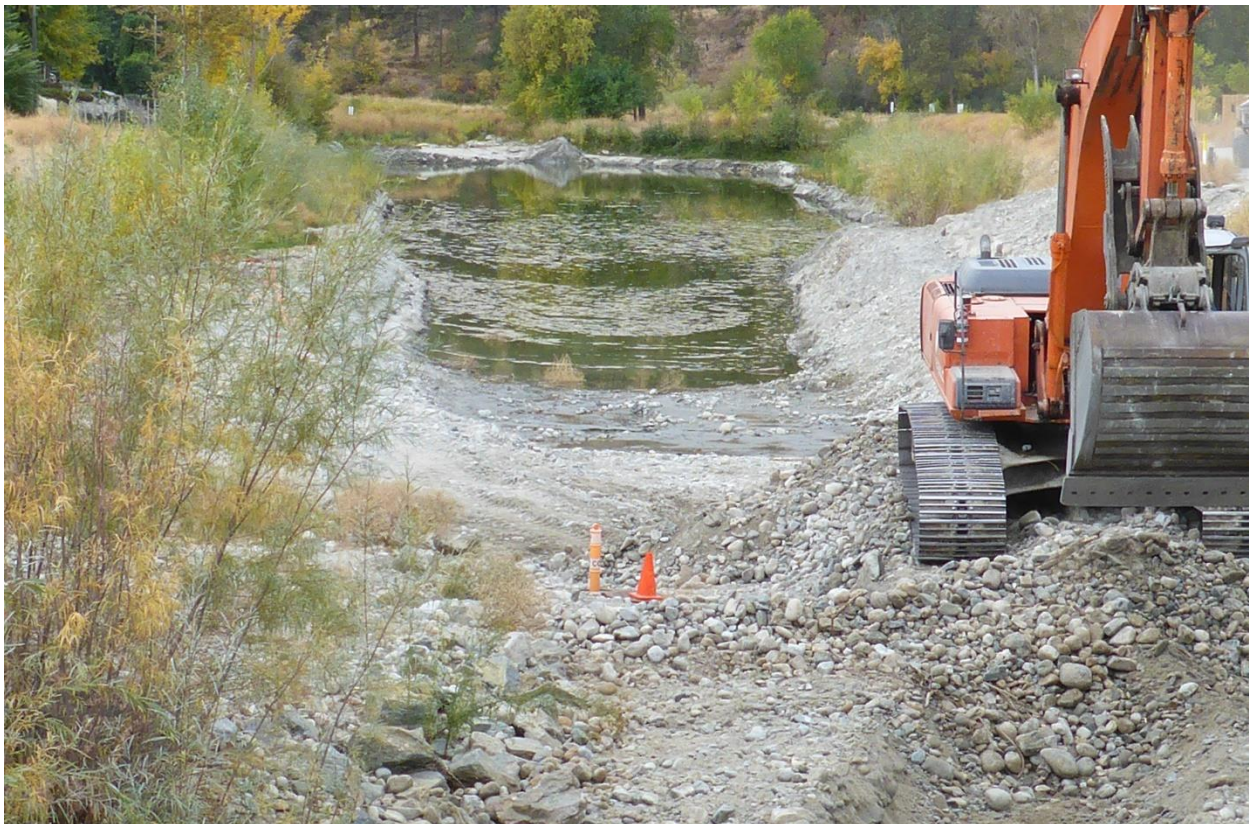
A lower reach of Shuttleworth Creek was modified into a sediment trap, and this collects huge volumes of sand/cobble substrate (Figure 3.6-2). In fall 2017, the sediment trap was dredged. Instability in the Shuttleworth Creek drainage area is will be worsened during extreme flow events such as those that occurred in May 2017. As the climate changes, the frequency of extreme flow events is expected to increase.

Figure 3.6-2: Shuttleworth Creek sediment catch basin being cleaned in October 2017
