Vaseux Lake Land Use and Water Quality Assessment—
Sedimentation, Nutrient Loading and Invasive Milfoil Study
Year 2 Report
FINAL

Prepared for Regional District Okanagan Similkameen

Report prepared by: Larratt Aquatic Consulting Ltd.

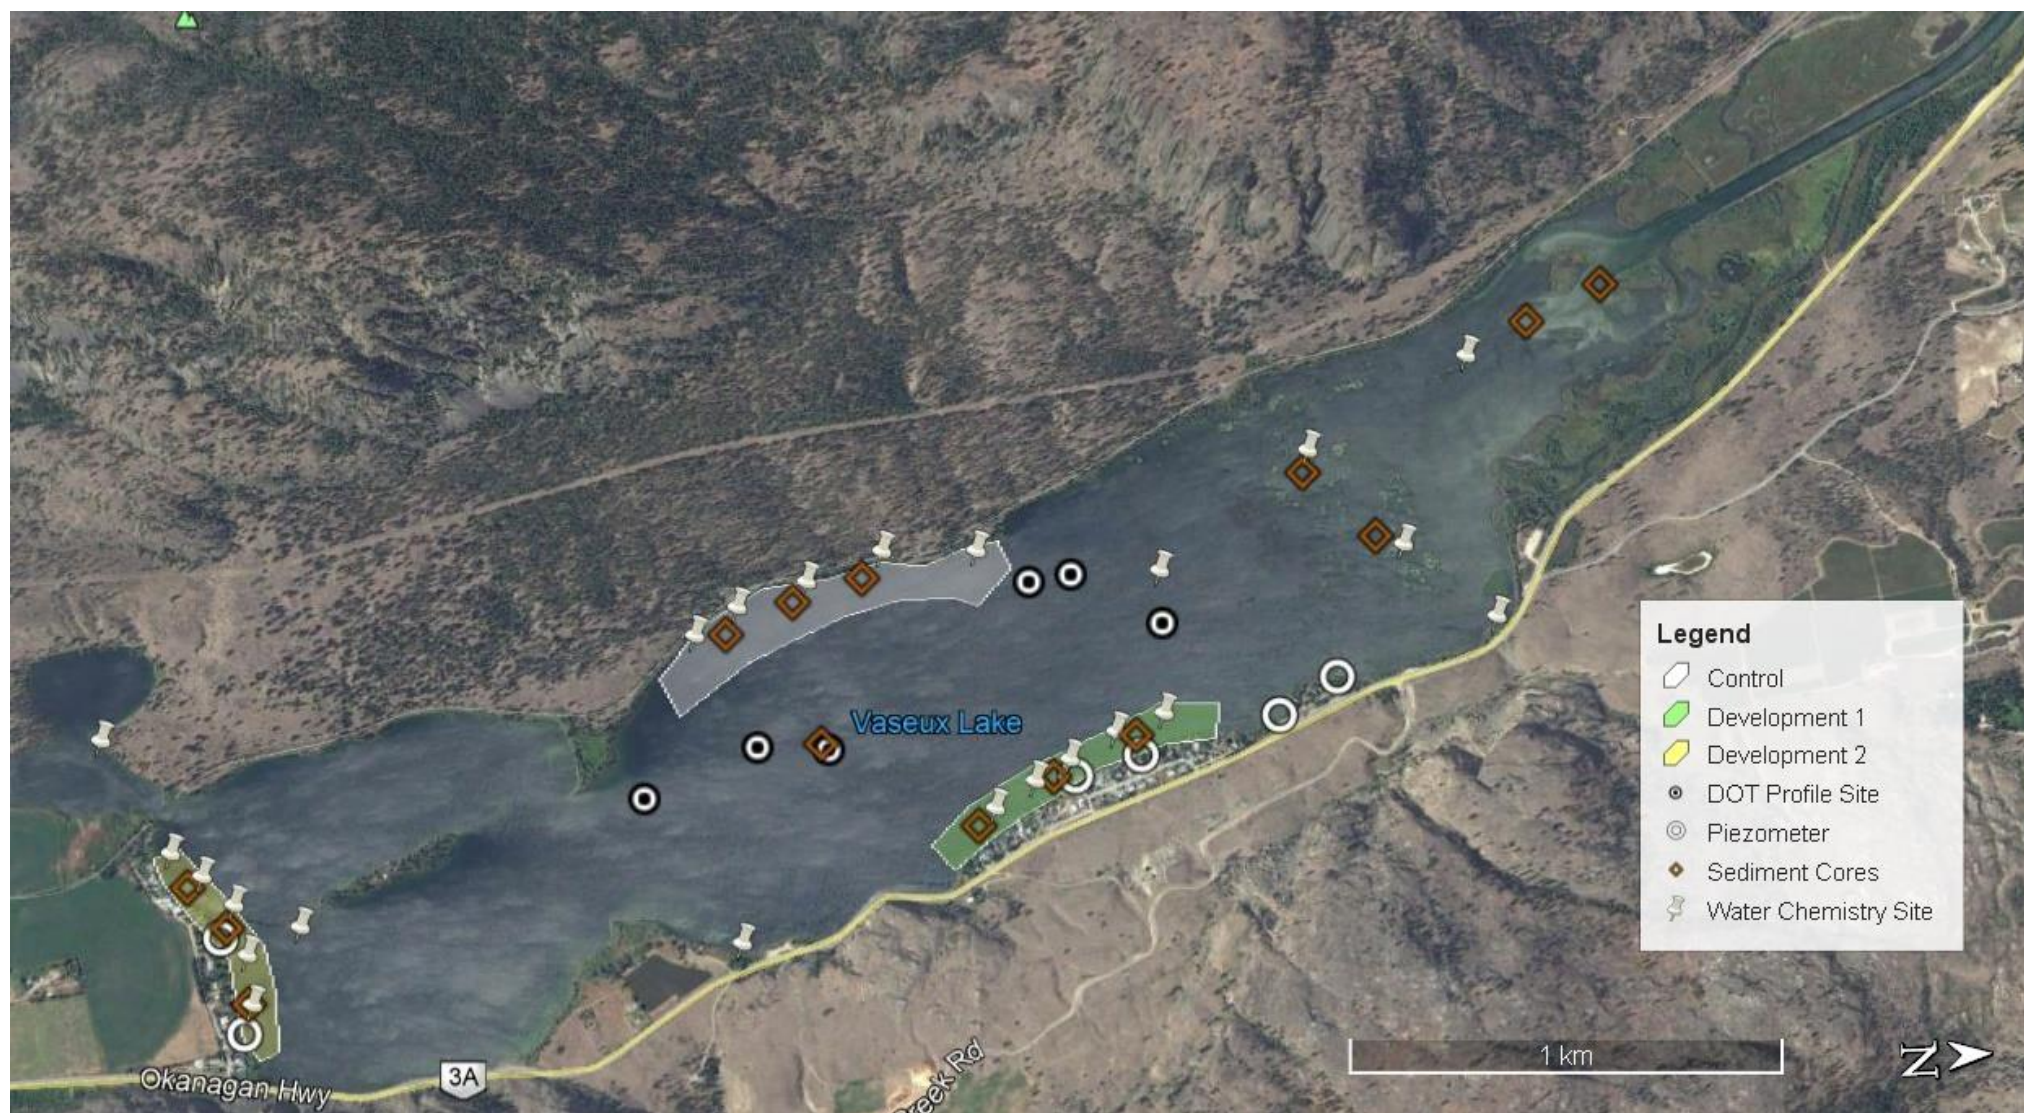
Figure 2-1: Map of Vaseux Lake with sample sites

In September 2017, a Hannah multi-meter with GPS was used at 50 – 60 perimeter sites to identify potential sample sites for piezometers (shallow groundwater) and lake sample sites, shown in Figure 2-1. The multi-meter parameters include: pH, temperature, dissolved oxygen, conductivity and total dissolved solids. This was used to determine areas of interest for more intensive sampling.

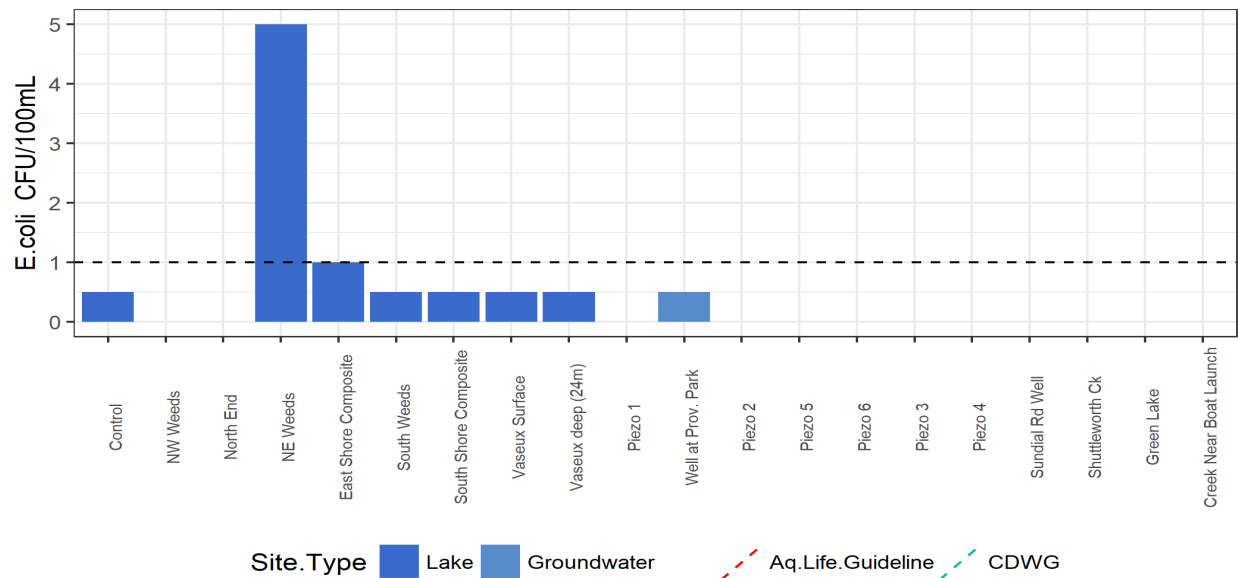
Figure 3-4: E. coli results from sample sites during 2017

Fecal and coliform bacteria were measured in the lake samples during 2017 and the results were encouraging. While most strains of *E. coli* are harmless, their presence in a sample correlates to fecal pathogens. *E. coli* was below detection in 4 of 6 samples with a maximum measured value of 5 CFU/100mL in the NE plant beds, likely due to waterfowl (Figure 3-4). The other detectable *E. coli* sample was the east-shore composite at 1 CFU/100mL. These results are very low and would not be considered a problem from a drinking water source (before disinfection) or recreational perspective.

Note: Reportable detection limit indicated with dashed black line

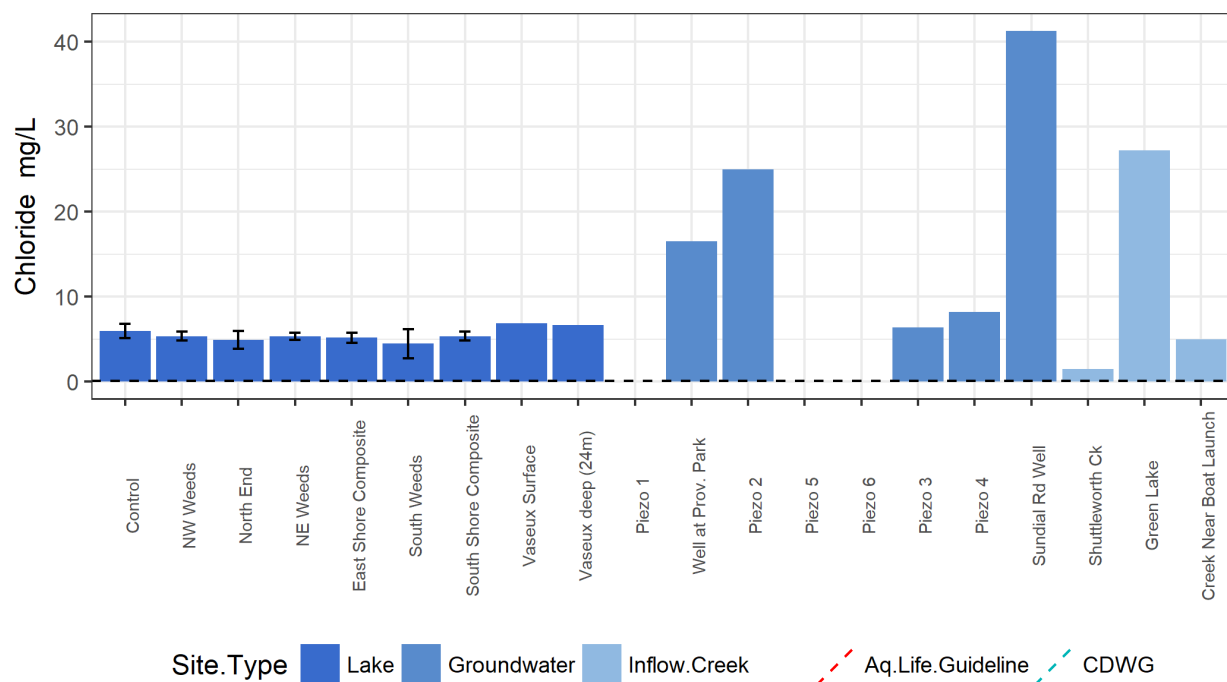
Figure 3-6: Chloride concentrations at Vaseux Lake sample sites, September 2017-2018

Chloride is a conservative parameter that indicates human impact. There was no statistically significant North to South gradient in lake samples (KW-Test, $p=1.0$). This was likely because of the rapid flushing rate of Vaseux Lake and the dominance of Okanagan River on the water chemistry of Vaseux Lake epilimnion. Groundwater contained elevated chloride concentrations and ranged from 16.5 mg/L at the provincial park campground to 41.3 mg/L in a well on Sundial Rd. at the south end of the lake. These results are all far below guidelines. The groundwater samples from the Sundial well indicate human impact, likely through septic/agricultural influence, and the provincial park piezometer was probably affected by highway salt residuals. There has been an increasing trend in chloride values throughout the Okanagan, including discharges from Vaseux Lake (Dessouki, 2009).

Note: Dashed line indicates lab reportable detection limit (sites are presented in North (left) to south (right) and split by surface, groundwater, and inflow sites).

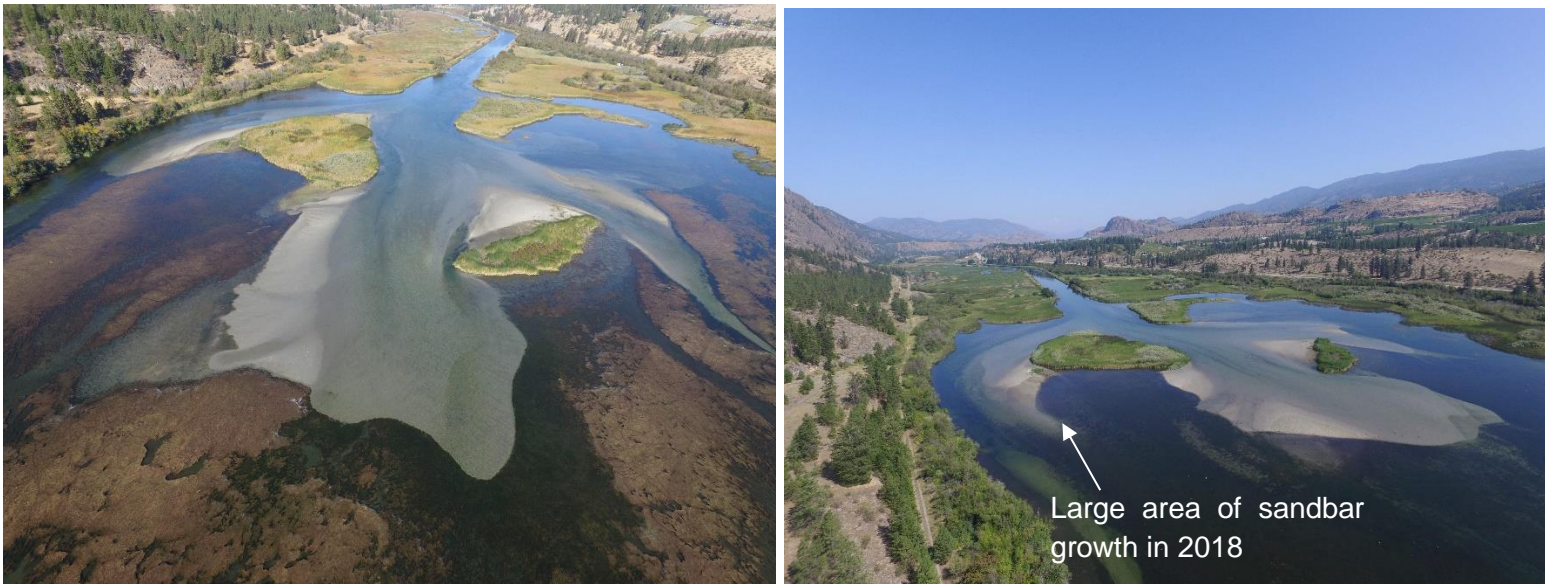
Figure 3-8: Sand and gravel accumulation at north end of Vaseux Lake in 2017 (left) and 2018 (right)

Sediment accumulation in the north shallows of Vaseux Lake was a major concern expressed by residents and was a focus of this study. Sediment naturally accumulates where flowing water meets still water and this process forms deltas and alluvial fans. The plantbeds themselves do not play a meaningful role in the accumulation of coarse sediment in Vaseux Lake because most sediment arrives during freshet before the plants have put on much growth. However, they will colonize shallow areas and freshly deposited sediment is typically rich in nutrients. A large shallow (<1 m) sand and gravel bar is visible where the Okanagan River enters Vaseux Lake (Figure 3-8). Sediment accumulation within this area is currently faster than can be colonized by plants and so it appears as bare gravel in Figure 3-9.

Sand and gravel drop out of suspension rapidly explaining why the north end shows expanding sandbars. Silts and clays travel further into Vaseux Lake because of their slower fall velocities (~20m/day for silt; 1m/day for clay). Most silt should deposit in the lake, while clay-sized particles should be discharged in outflowing water.

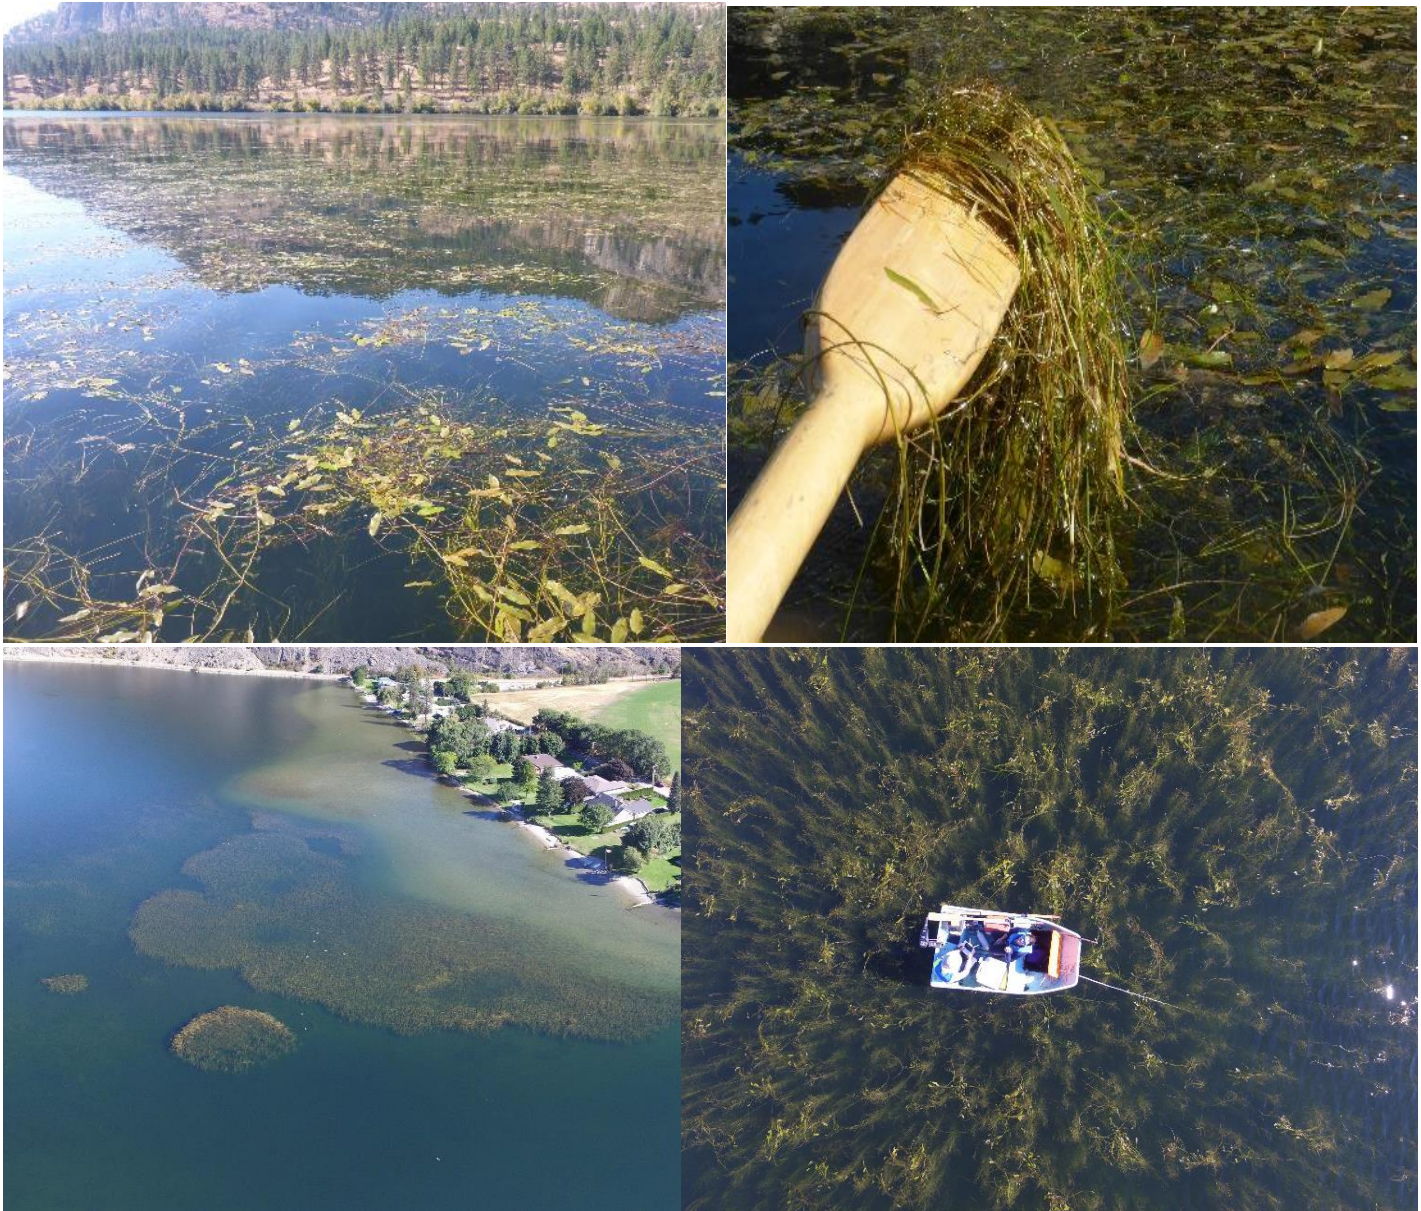
Figure 3-14: *Potamogeton natans* beds in Vaseux Lake, 2017

Common species included several native species (*Potamogeton natans*, *Potamogeton pectinatus*, *Potamogeton crispus*, and native milfoil), and invasive milfoil (*Myriophyllum spicatum*). *Potamogeton natans* was by far the dominant species in September 2017 while *Myriophyllum spicatum* was the overall dominant in 2018 (Figure 3-14).

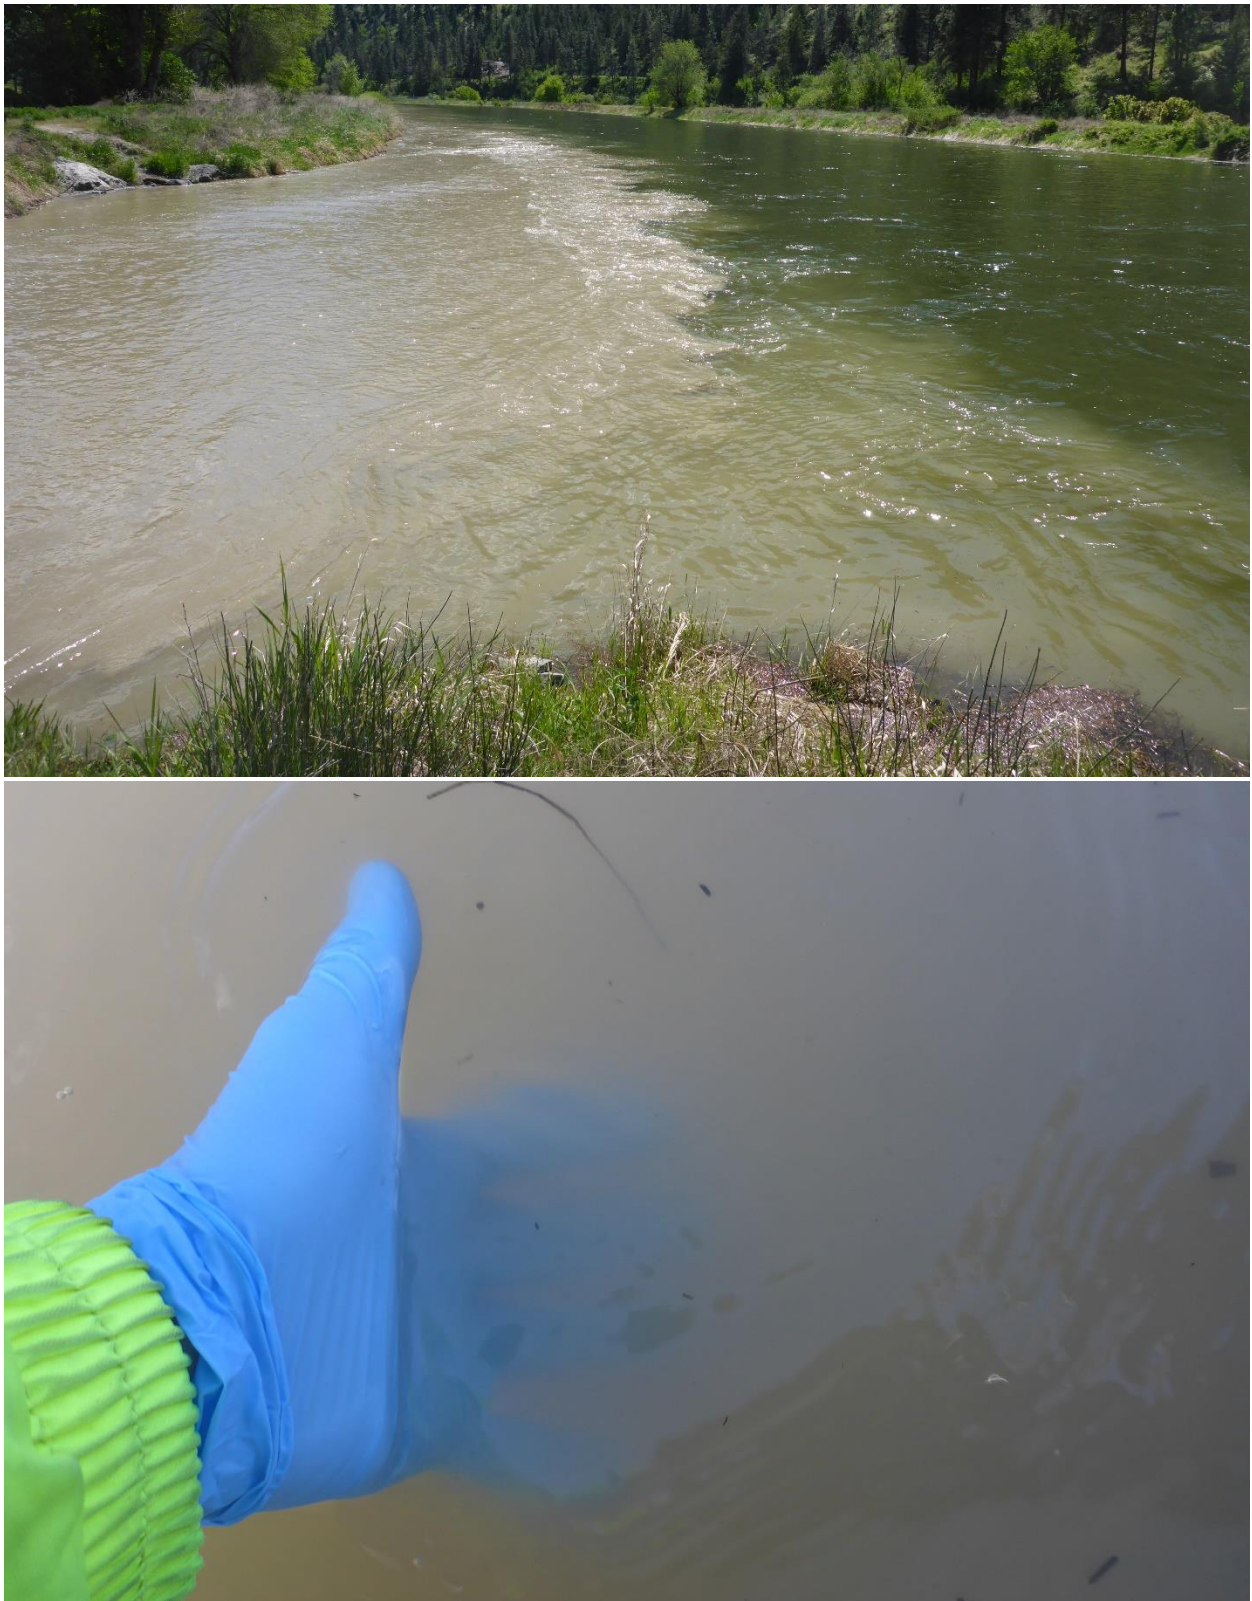
Figure 3-18: Shuttleworth Creek plume entering Okanagan River (top) and extreme turbidity in Vaseux Lake on May 11, 2018 (bottom)

The source of increasing sedimentation in Vaseux Lake was quickly determined to be the Shuttleworth Creek watershed. A major washout in May 2018 carried enough sediment into Vaseux Lake to cloud the entire lake and reduce water clarity to near zero. The large sandbar at the north end of Vaseux Lake changes shape with each freshet but has grown significantly within the past 10 years forming a new island in the process. Control of the plantbeds will not affect the sedimentation rate in the north end of Vaseux Lake because most sediment is deposited during freshet before active growth commences. Rather, reducing sedimentation will benefit macrophyte control efforts because fresh sediment is often nutrient-rich and provides a new growth substrate for macrophytes. Restoration of Shuttleworth Creek is essential if continued rapid expansion of the sandbars in Vaseux Lake is to be minimized.
