# Vulnerability of the Okanagan Watershed Infrastructure to Dreissenid Mussel Infestation

Renata Claudi RNT Consulting Inc.

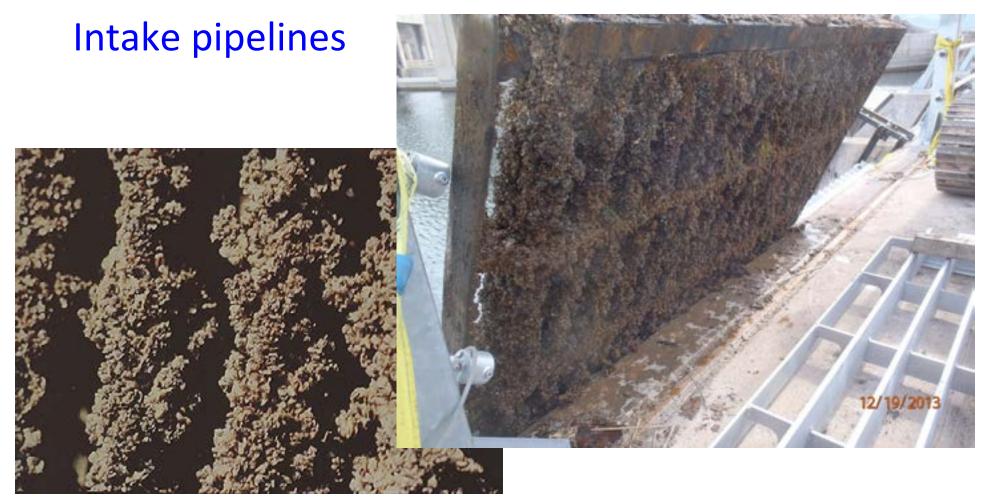
Fouling of fixed screens

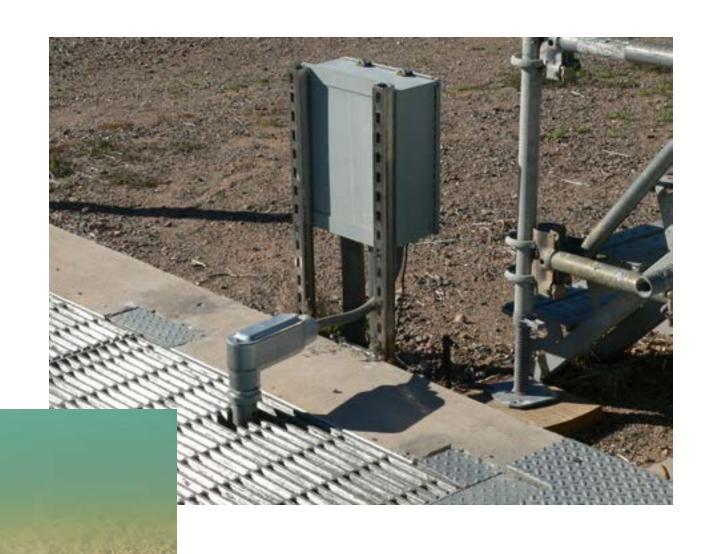
Level gauges

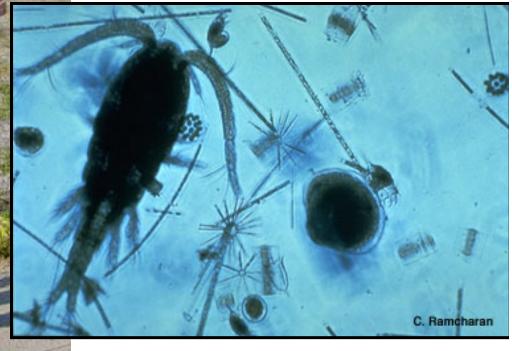
### Plankton Tows

- Quick and easy way to establish presence or absence of veligers at the beginning and end of the breeding season. Take large samples, process by "density separation" using sugar solution method
- Can be used to do actual veliger counts in the incoming water, tedious and offers limited information for the plant

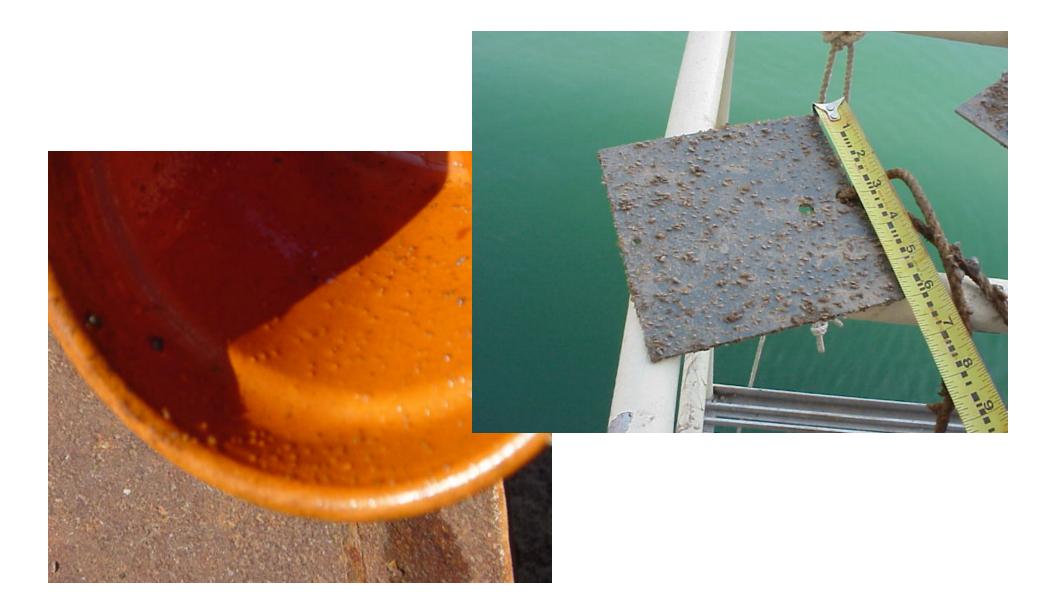
### Settlement monitoring

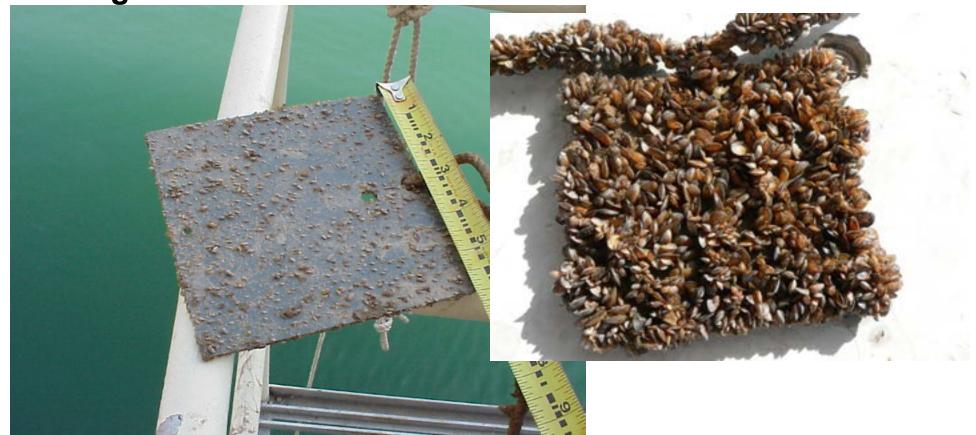
### Fast increase in population density – Lower Colorado River

August/07 November/07
