District of Lake Country

Water Conservation and Quality Improvement Grant Program Progress Report

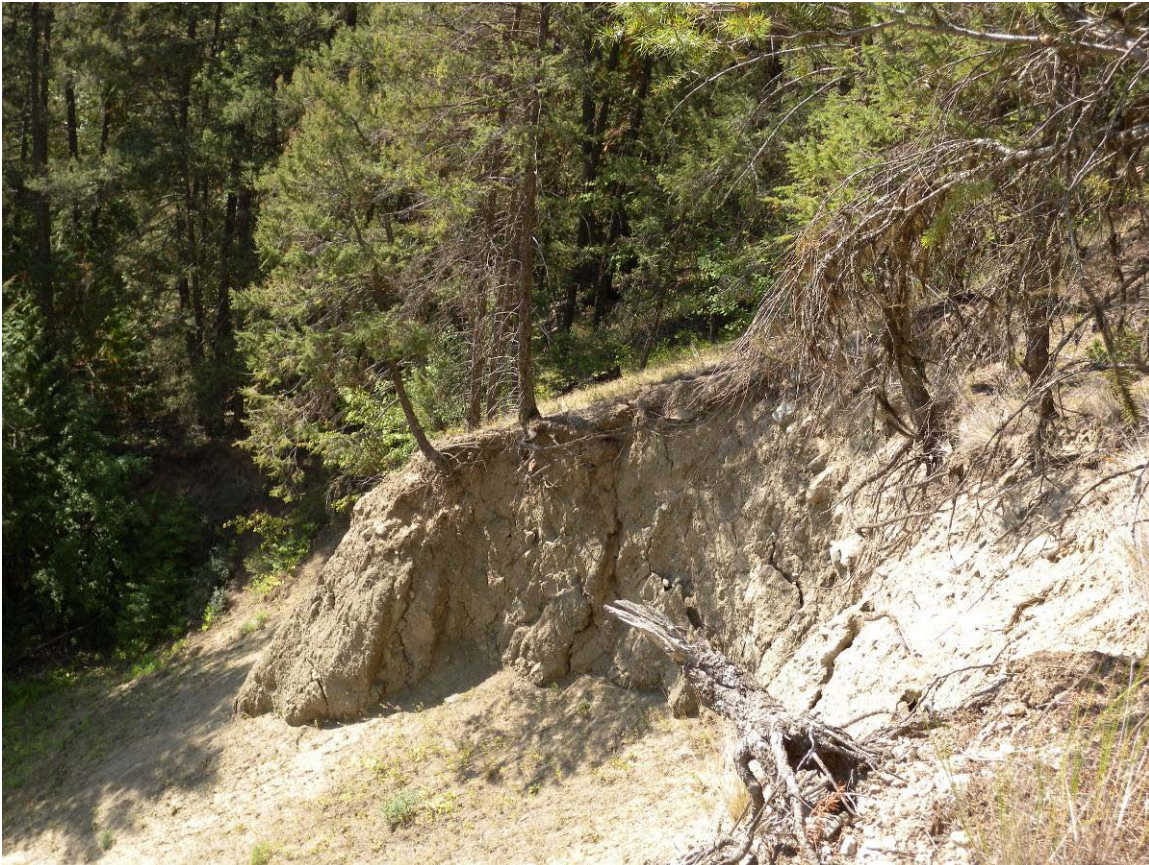
Photo 1: Illustrates one of several natural landslides that occur upstream of the source water intake in the Beaver Lake watershed.

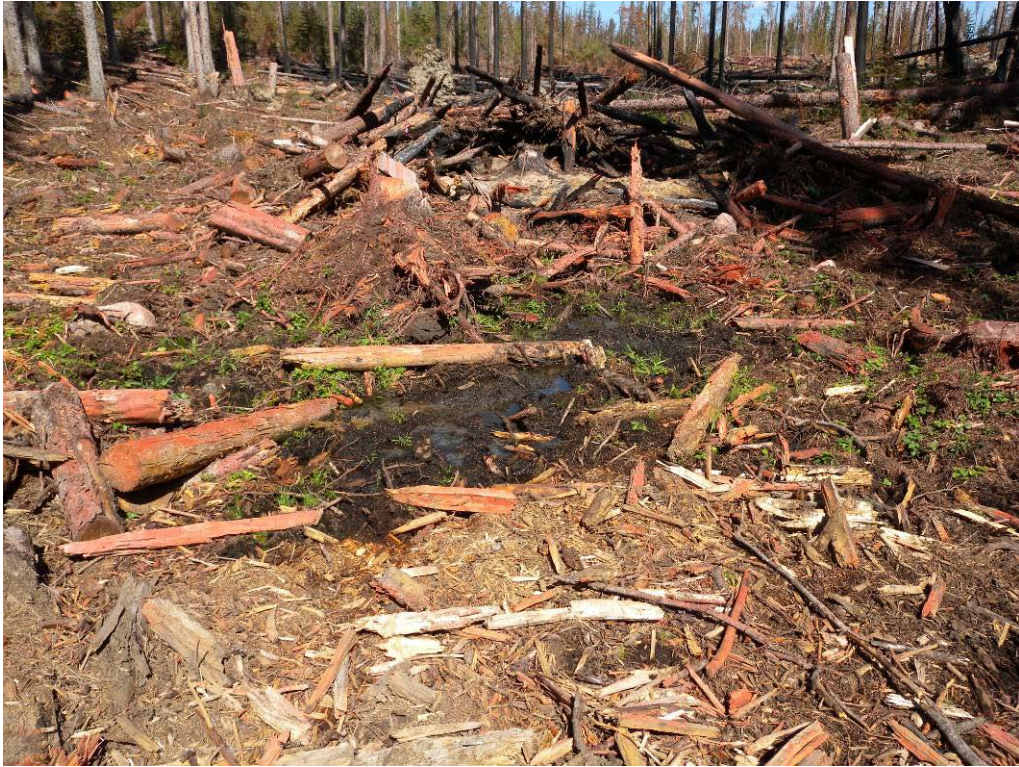
Photo 2: Depicts the remnants of a recent forest fire in the Oyama watershed. Potential impacts from the fire include large scale vegetation disturbance, ground water seepage from the fire site to the adjacent reservoir and the chemical-based fire retardant that is visible above.

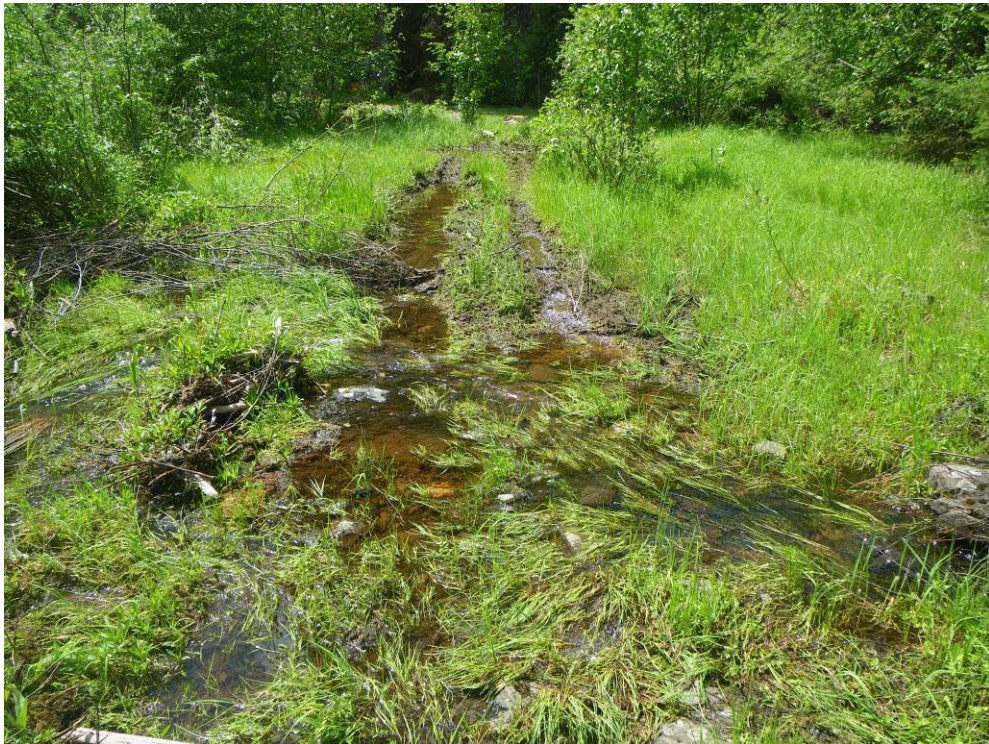
Photo 3: Shows the tracks of an all terrain vehicle which has disturbed sediment below the high water level of Vernon Creek.

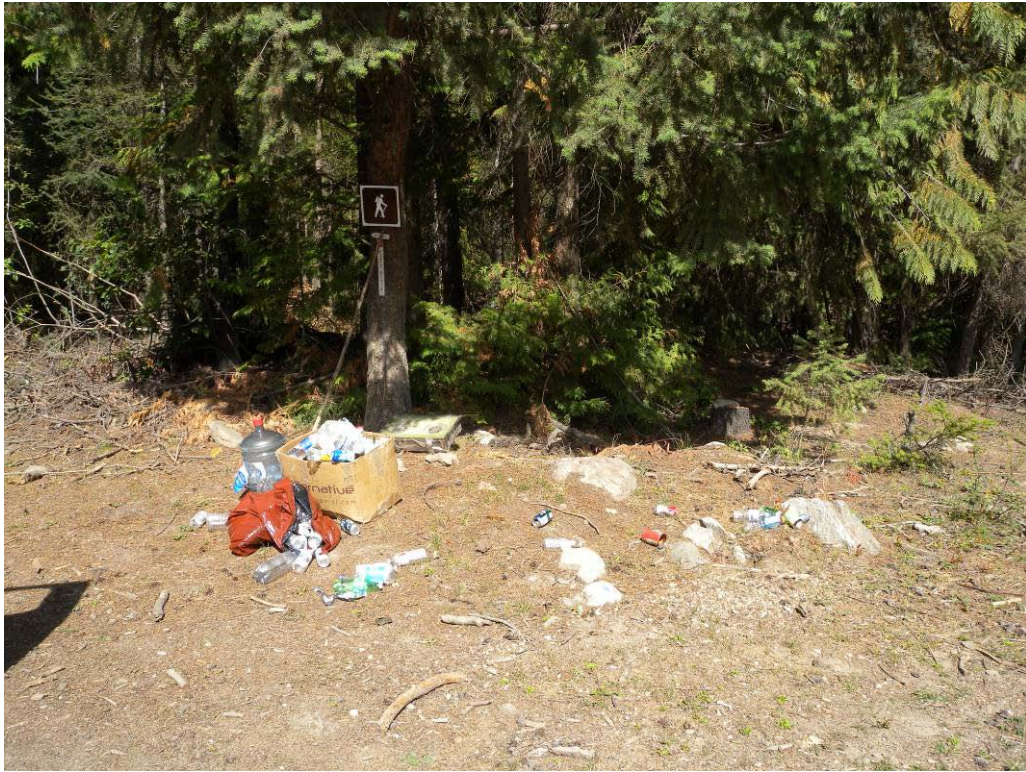
Photo 4: Illustrates garbage which was intentionally dumped along the High Rim Trail.
